行政院及所屬各機關出國報告
(出國類別：考察)

反應爐阻板及模型板螺栓檢查技術與經驗考察

服務機關：台灣電力公司
出國人職稱：核能工程監
姓名：邱德成
出國地區：法國
出國期間：89.12.08 至 89.12.17
報告日期：90.02.15

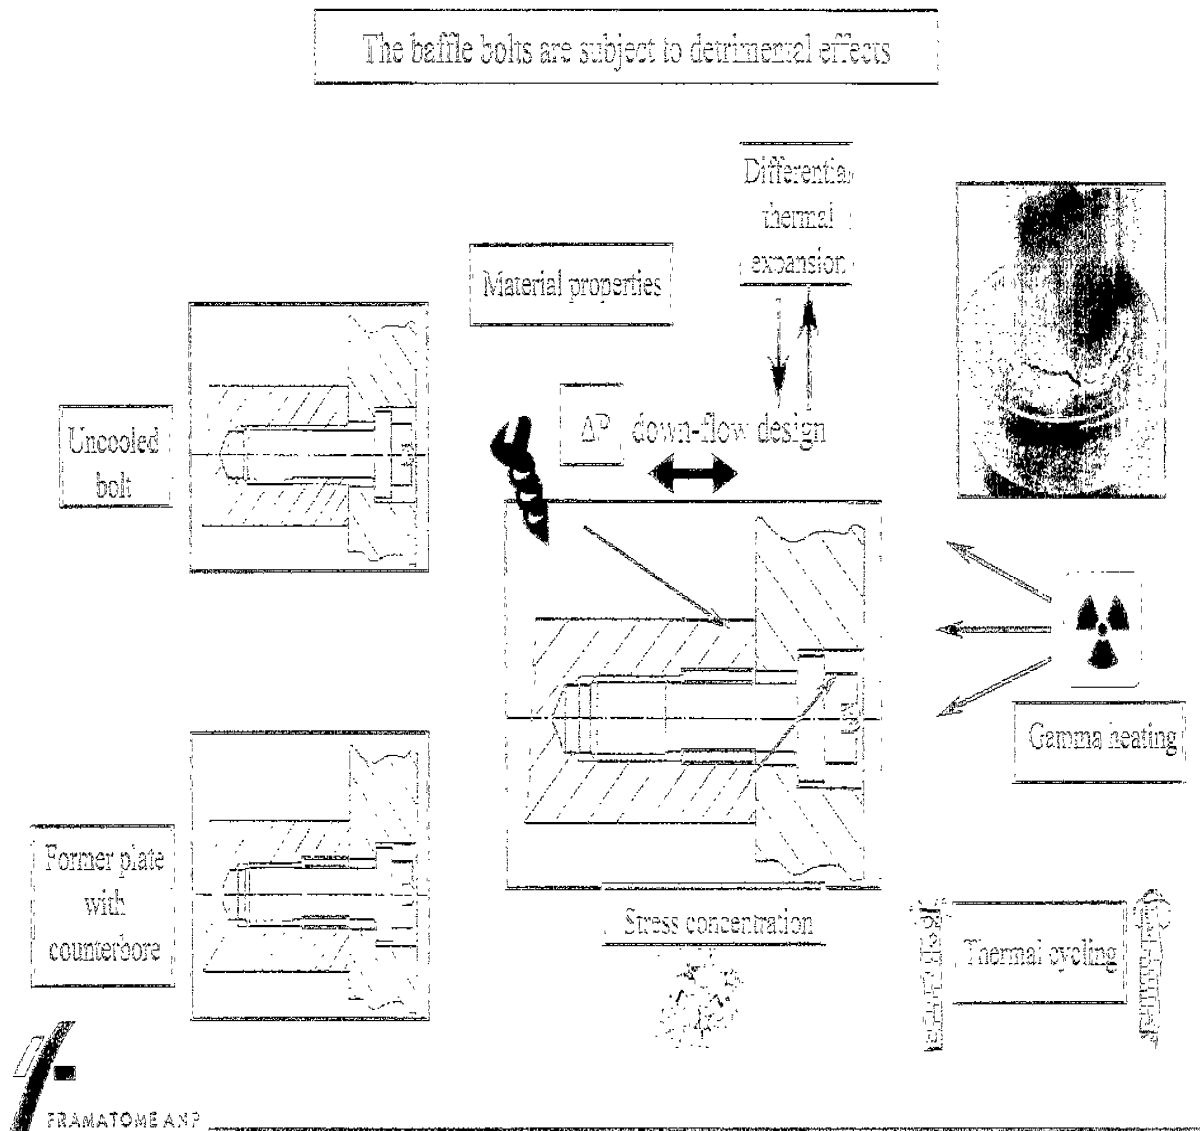
Baffle to former assembly design

- EDF 熱室實驗結果，為輻射促進之應力腐蝕龜裂 (IASCC)：Swelling effect

In the 1980s inspections indicated baffle bolts cracking. The bolts are made of 316 cold worked stainless steels. They failed by intergranular cracking. Normally, 316 steel is not prone to IGSCC in this water environment and all the bolts cracked were initially located in the second and third rows from the bottom, that is exactly the place corresponding to the highest

neutron irradiation. This demonstrates that the neutron irradiation is a significant feature for this cracking, even if the exact mechanism is unknown now. It is difficult to conclude whether the bolts cracked by IASCC or due to irradiation embrittlement, or by other IGSCC phenomena. To date, baffle bolt cracking was observed only in plants with the "down-flow" design.

■ 阻板螺栓承受之不利因素：

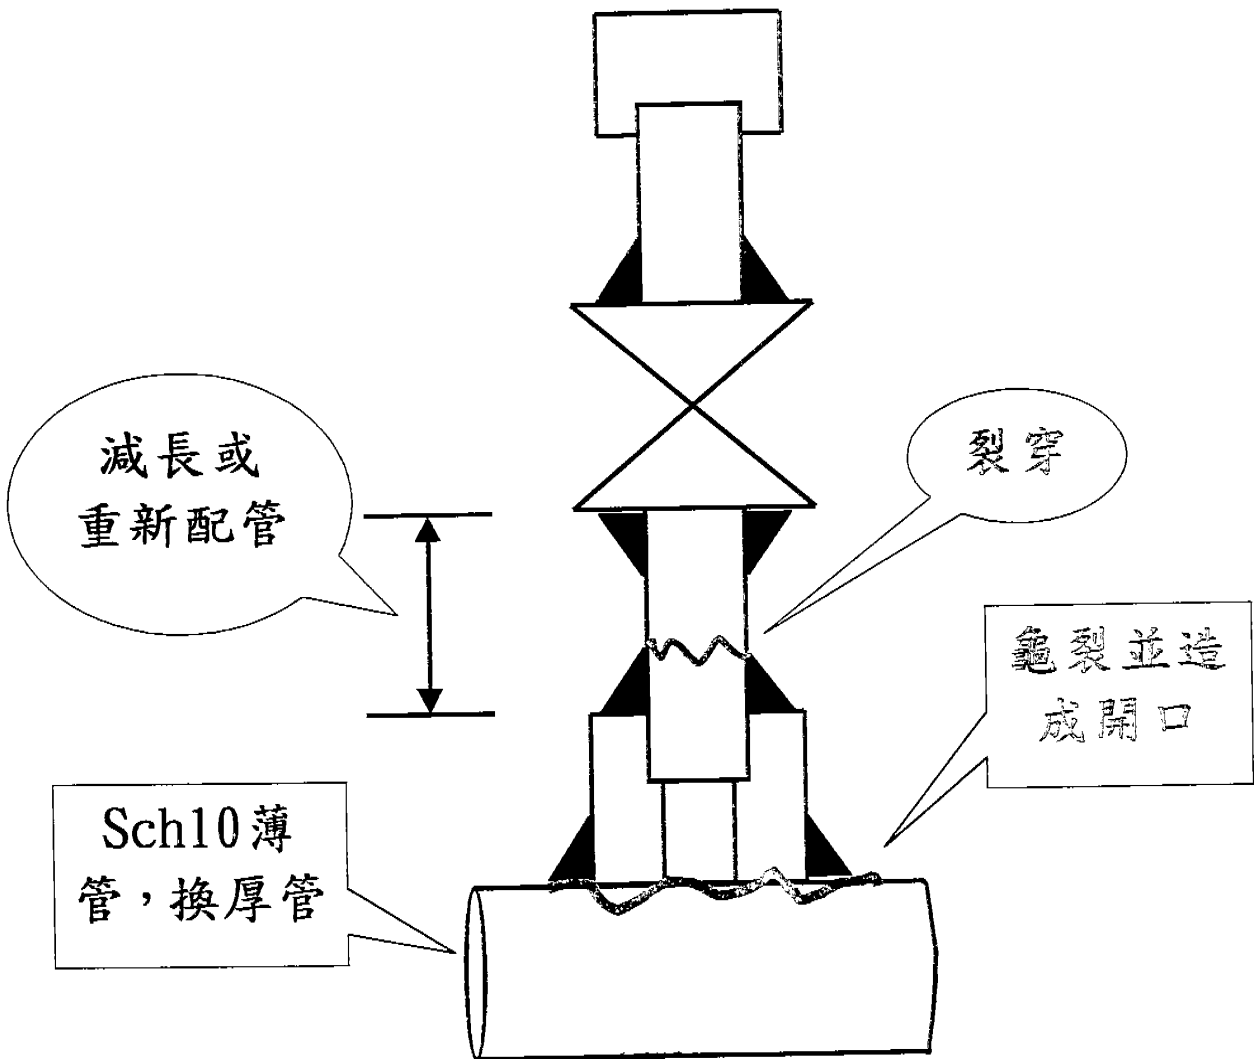
- 洩水及逸氣管路 (Drain & Vent) 因振動引發之高週波疲勞破壞：
- EDF 之經驗及改善方法：
 - 減長或重新配管，消除振動。
 - Sch10 薄管才會發生，換厚管。

- 核三目前作法：
 - 拆除 CCP 後備最小流量管路。
 - 採用 EPRI 之改善方法。

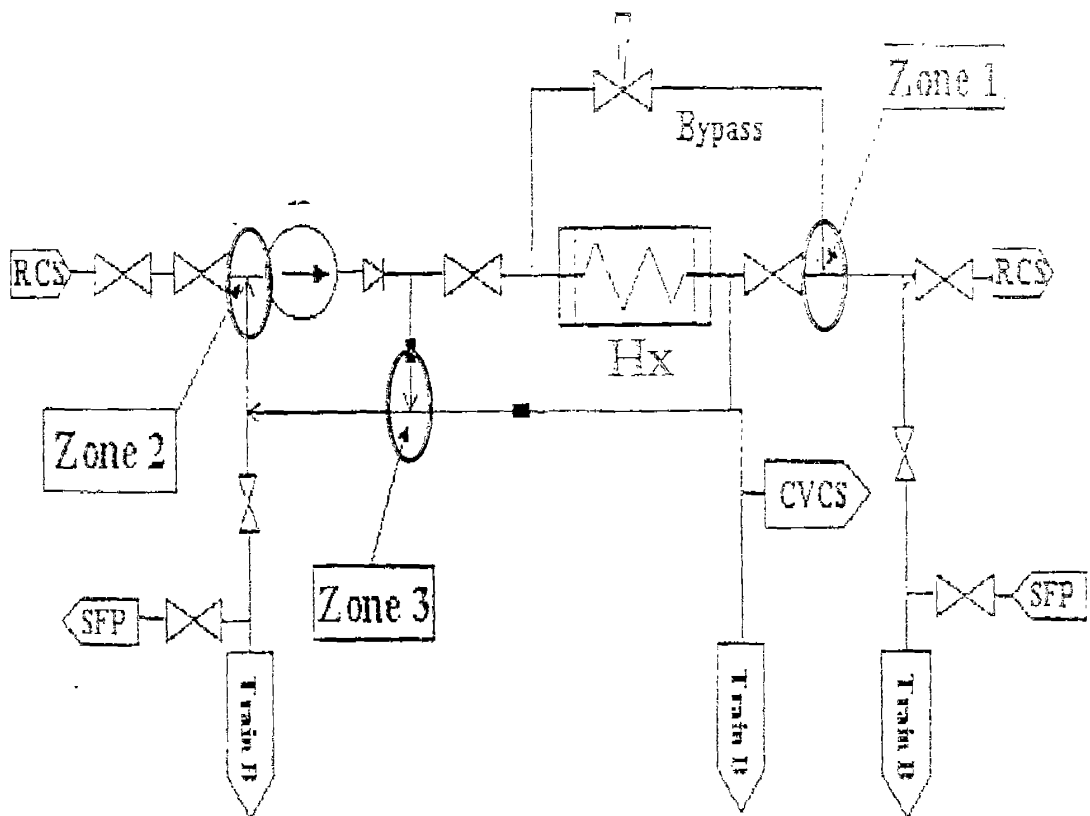
■ 冷熱管交接處之熱疲勞龜裂

- 檢查 8 個機組 (5 個 900MW、3 個 1300MW)，全部發現有龜裂。
- 所有機組全部換管。
- 換下之舊管作為 UT 之 Mock-up。
- UT 探頭為 2.25MHz，有 45°、60°、75°。

- 新管內表面採精密加工，較能抗疲勞。
- 新管內表面精密加工時，特地殘留壓應力。
- 採取運轉限制。
 - RHR 在 77°C 才運轉，出口 55°C，降低 ΔT 。
 - ΔT 最高限制 90°C。
 - 每一 燃料循環 (Cycle) 限定只能運轉 100小時。
 - 每運轉 400小時執行 MUT 一次。

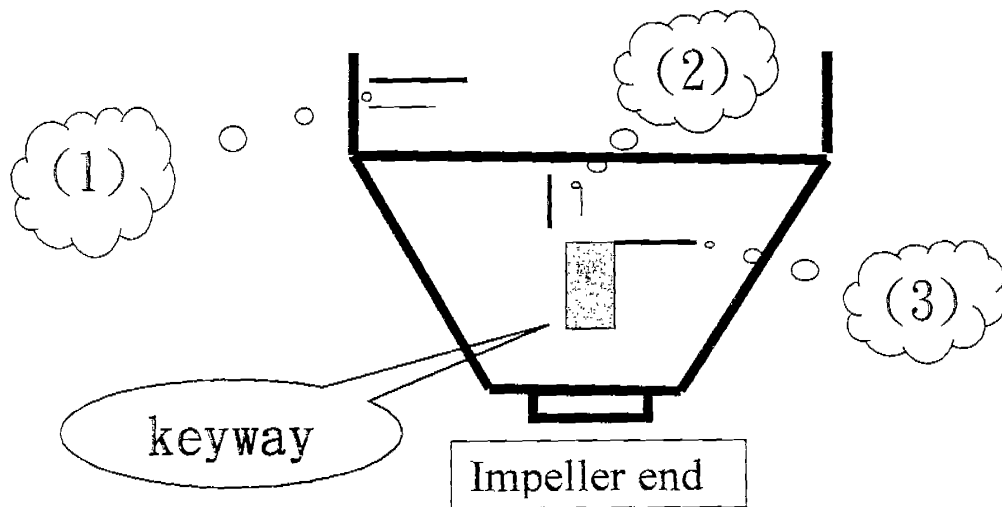
- 軸不必全部分解就可執行。
- 有0°、75° 探頭。
- 目前只能偵測(1)、(2)、(3)之龜裂，尚無法 Sizing。
