赴美國考察土石流防治工程 報 告

服務機關：交通部公路局

赴美國考察土石流防治工程報告

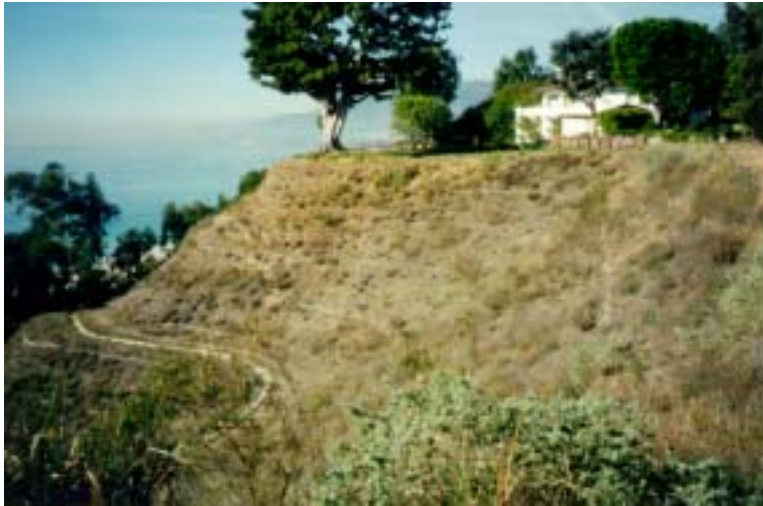
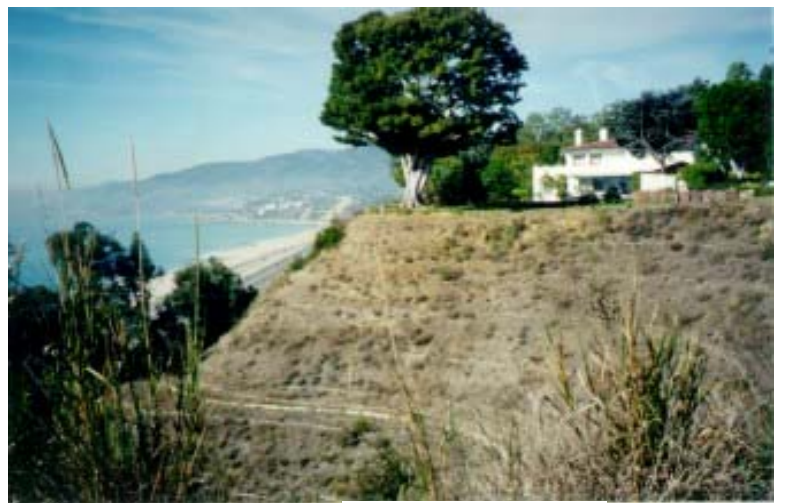
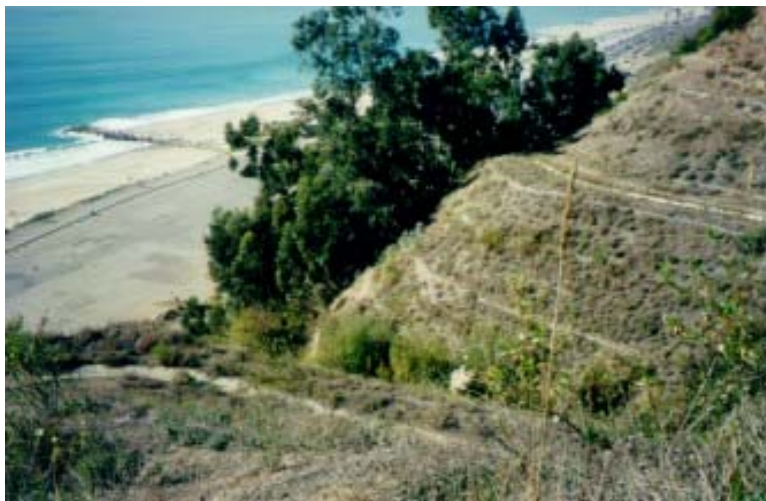
洛杉磯西側海岸公路(Pacific Coast Highway NO.1)山側邊坡曾發生大規模坍塌，大量土石塌落影響下側公路交通並危及坡頂之住宅區，州政府公路廳花費鉅資清除土石，並採台階式開挖加植草處理工法穩定邊坡，四周再加設鋼纜網保護(見照片

洛杉磯西側海岸公路(Pacific Coast Highway NO.1)山側邊坡曾發生大規模坍滑，州政府公路廳花費鉅資清除土石，並採台階式開挖加植草處理工法穩定邊坡，四周再加設鋼纜網保護。

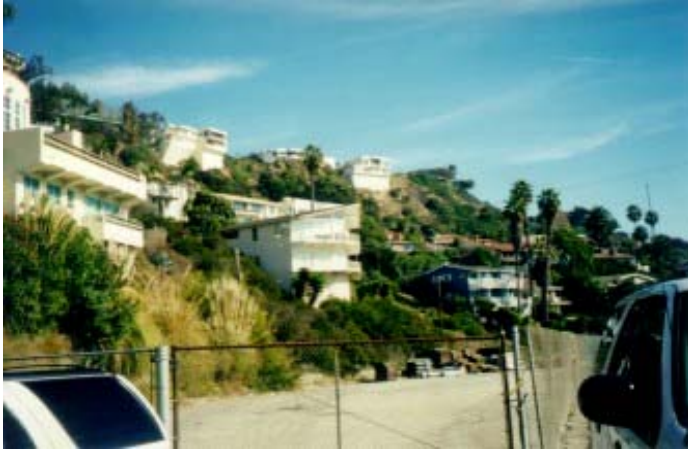
照片 (十二)

加州海岸地質邊坡不穩，惟海岸景觀甚佳，屬高級住宅區，常見住宅建築物以特殊基礎型式矗立於斜坡上。

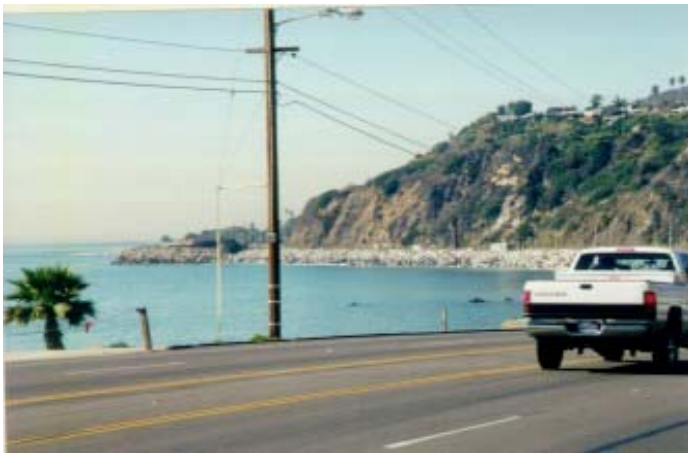
照片 (十三)

海岸公路部分路段受海浪沖蝕，以大量拋石保護路基不被淘空。

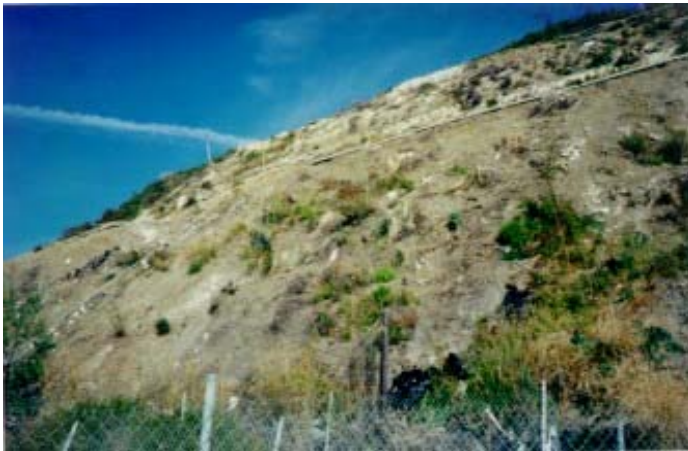
照片 (十四)

部分邊坡風化受雨水沖蝕嚴重，以加強地下排水及設台階截流溝防治。

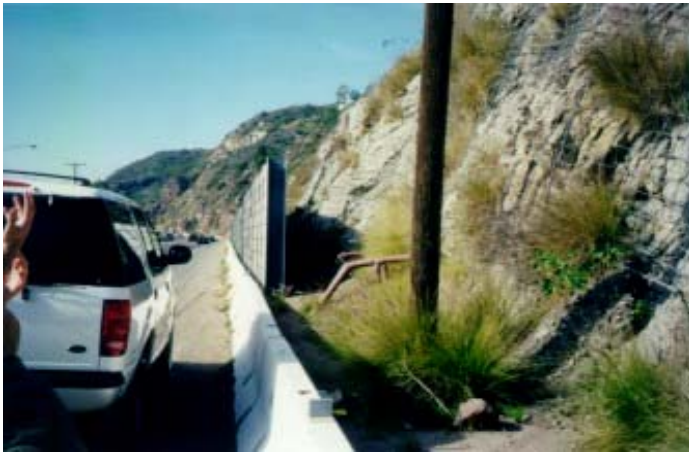
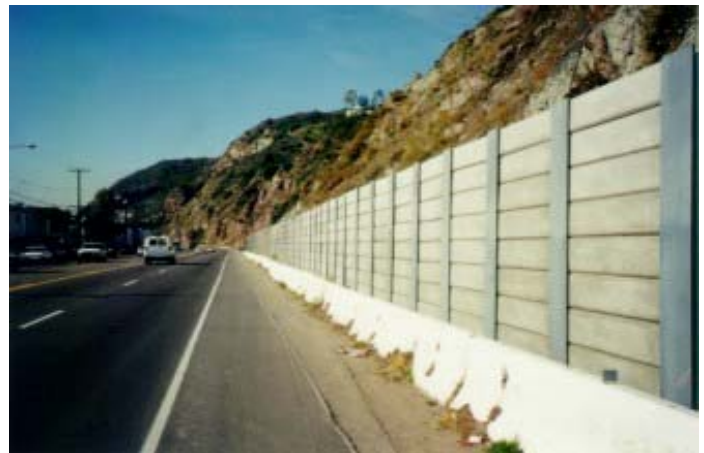
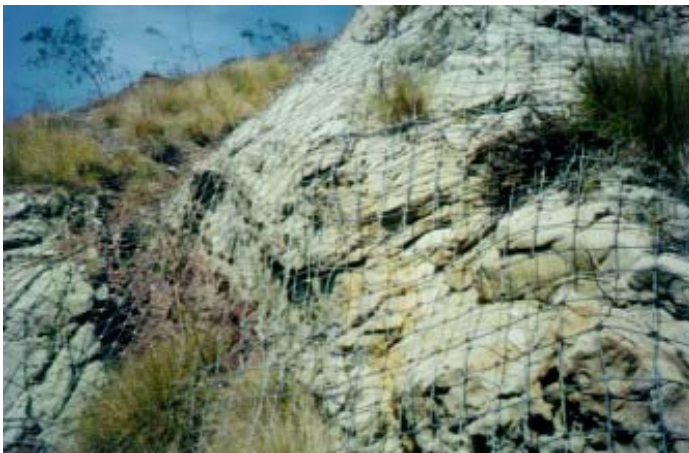
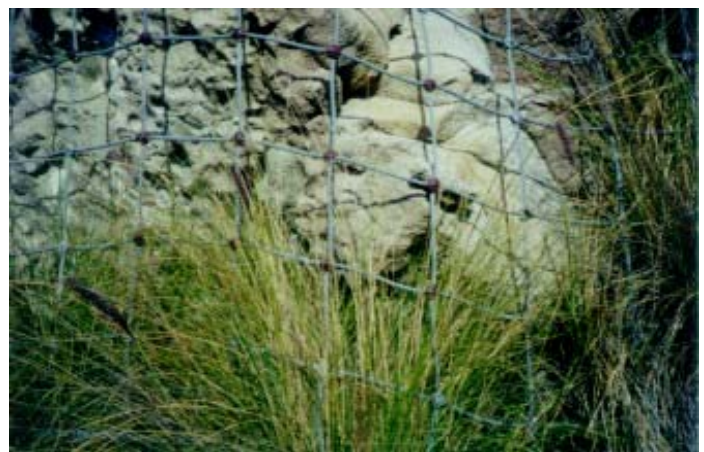
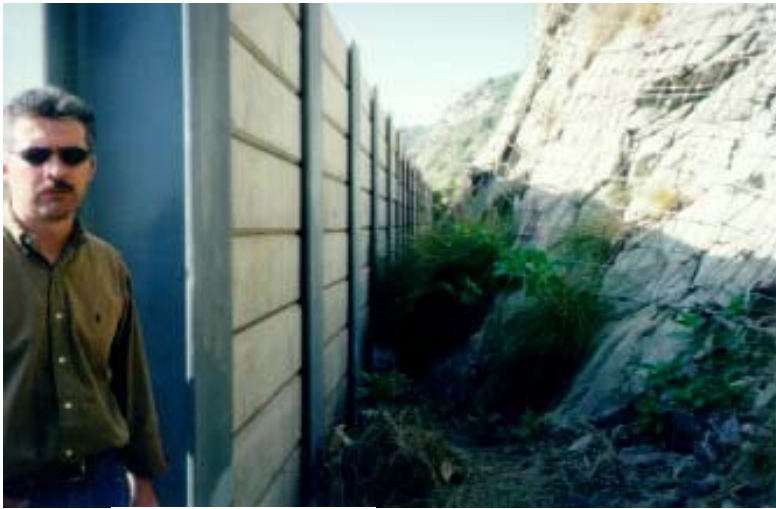
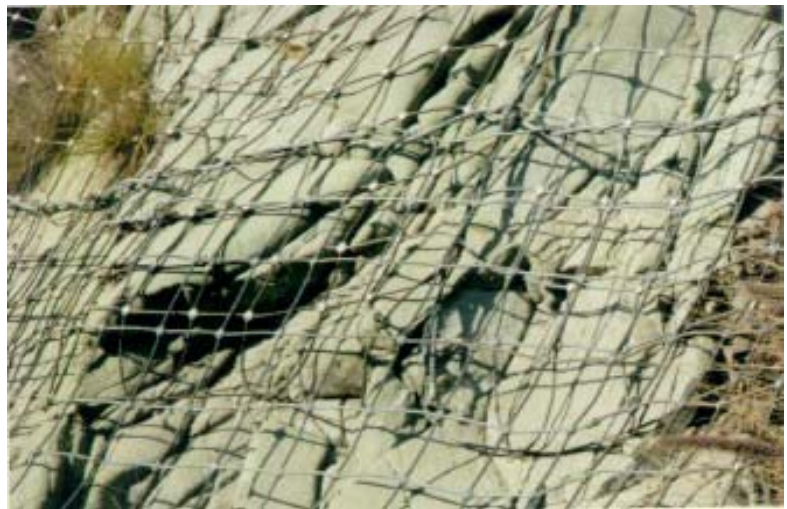
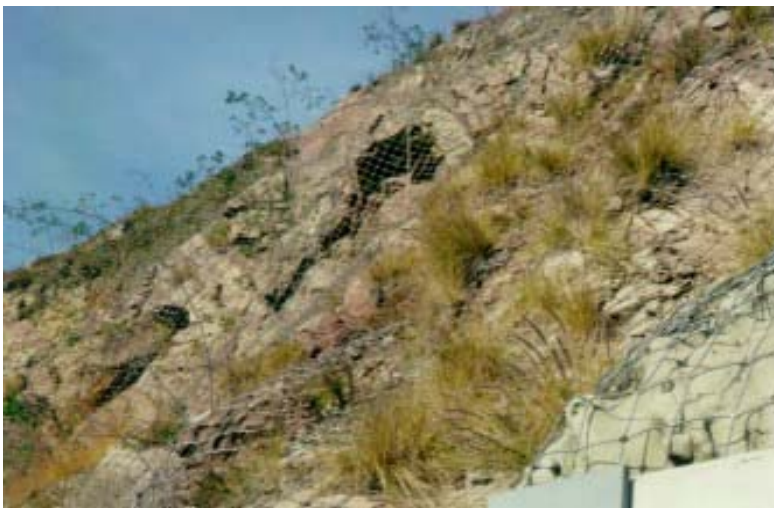
部分路段邊坡岩石風化崩落，以鋼纜編織成網後再以直昇機輔助吊掛固定，纜徑 0.5 吋，網目寬 6 吋。邊坡下方另加設混凝土板擋土牆防止落石危及公路安全，效果極佳，值得台灣地區類似邊坡防治之參考(見照片十六 ~ 二十二)。

部分路段邊坡岩石風化崩落，以鋼纜編織成網後再以直昇機輔助吊掛固定，纜徑 0.5 吋，網目寬 6 吋。邊坡下方另加設混凝土板擋土牆防止落石危及公路安全，效果極佳，值得台灣地區類似邊坡防治之參考。

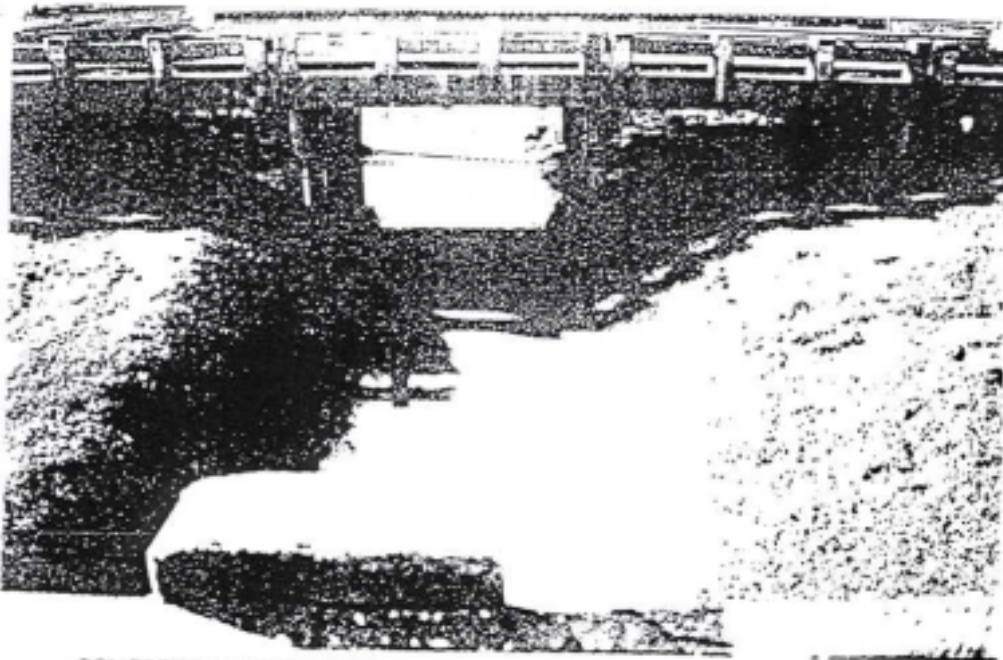
DAT
COUNTY
CON
STRUCTURE
Upstream View
Looking NW

CONCRETE RAIL CRACKED.

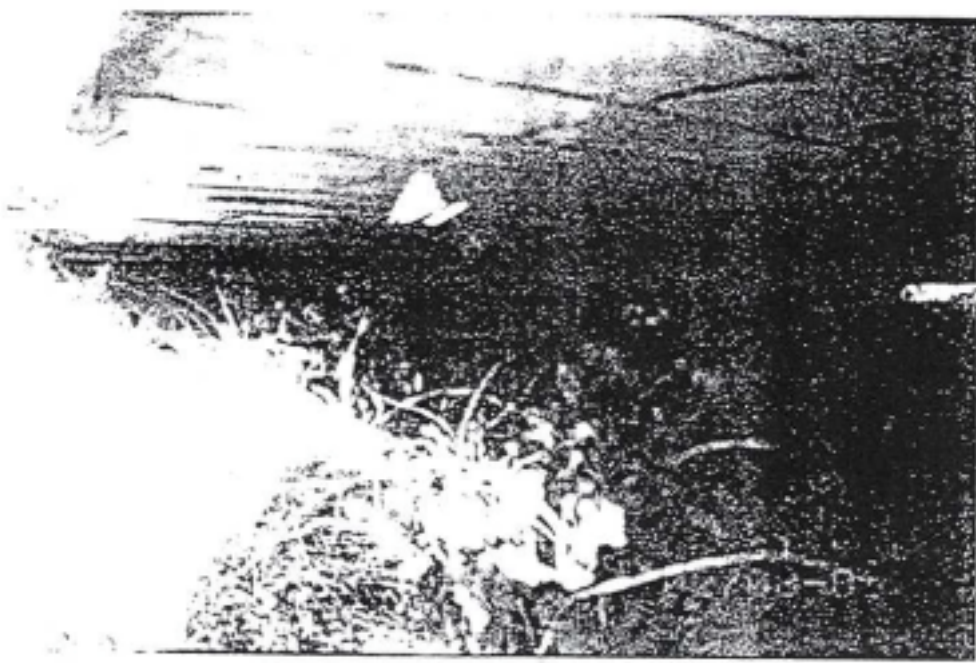
East Abattoir
Looking E

FLAT SLAB HAS DELAMINATIONS ON UNDERSIDE.

PART OF STRUCTURE	RECOMMENDED ACTION
Roadway - Wearing Surface	
Roadway - Deck	FLAT SLAB DECKING HAS DETERIORATION CRACKING, DELAMINATION AND SPALLS ON UNDERSIDE WITH EXPOSED REBARS, AND NEEDS EPOXY PATCHING.
Roadway - Other	DECKSIDE GUTTERS NEED CLEANING UP ALL THE SAND, DEBRIS, AND WEEDS. CONCRETE RAIL AND POSTS HAVE SPALL & CRACK AND NEED GROUT.
Superstructure - Main Members	FLAT SLAB HAS DETERIORATION CRACKS AND SPALLS WITH EXPOSED REBARS, AND NEEDS EPOXY PATCHING ON UNDERSIDE.
Superstructure - Bearings	
Superstructure - Other	
Substructure - Abutments	
Substructure - Bents & Piers	SPALLED AND DELAMINATED BENT CAPS NEED GROUTING WITH HIGH STRENGTH CEMENT.
Substructure - Other	
Channel & Channel Protection	
Retaining Walls	
Approaches	
Other

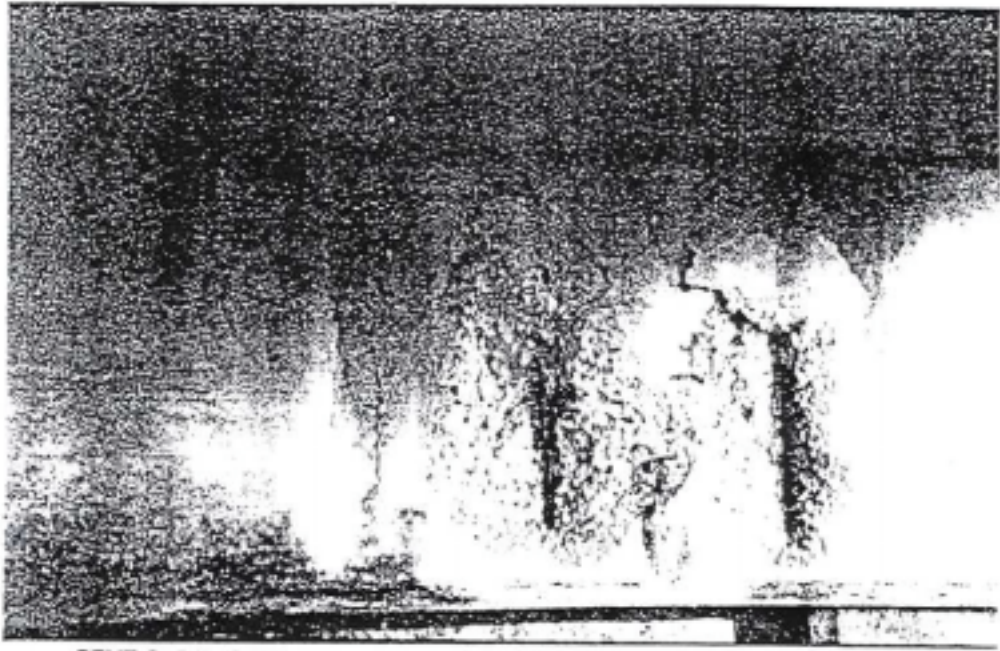
Looking W

Comments: 1. Concrete wingwalls have insignificant spalling.
2. Generally, interior bent concrete caps have minor cracking. The West interior bent cap has delamination and spalling with exposed rebar due to deterioration of concrete (see photo).

BENT CAP HAS DELAMINATION AND SPALLS WITH EXPOSED REBARS.

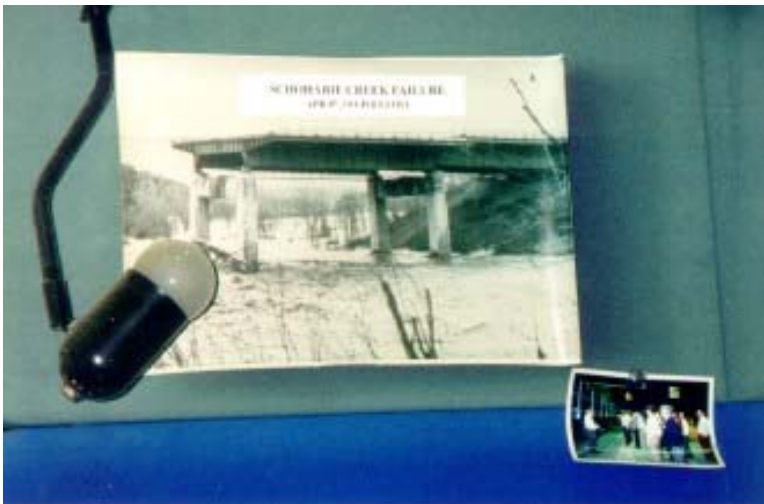
照片 (五十七)

美國 SCHOHARIE CREEK 河
川橋 1987 年 4 月被洪水沖
毀，造成 10 人死亡。

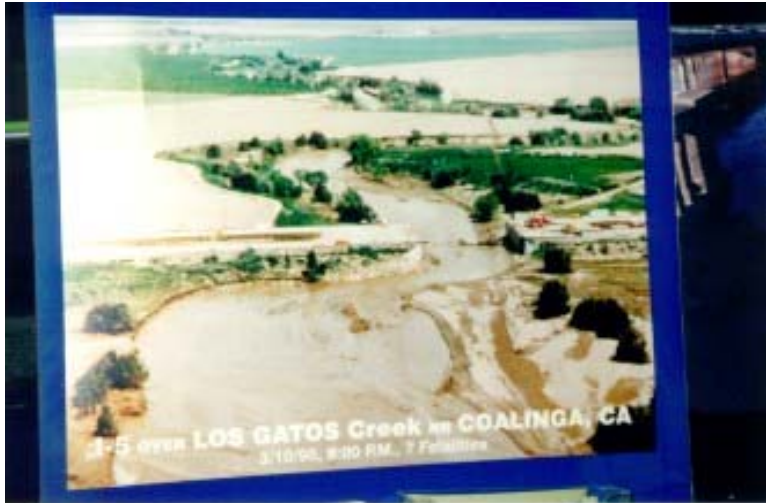
照片 (五十八)

加州公路橋樑遭洪水沖毀

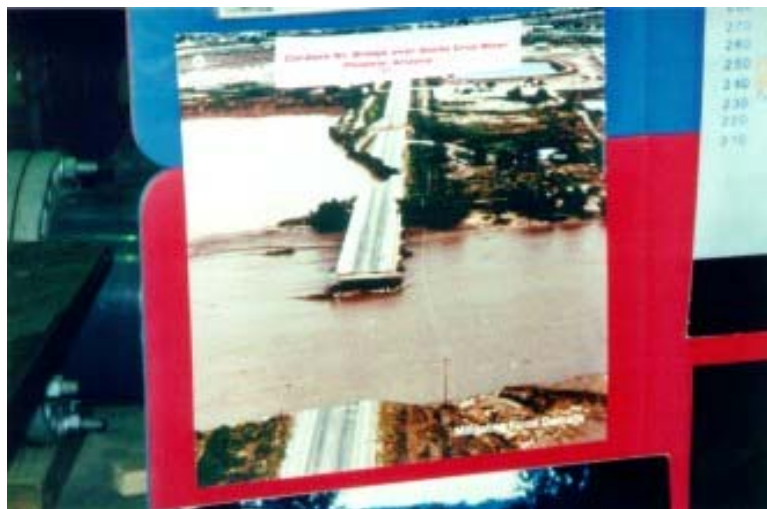
照片 (六十)

美國亞歷桑那州鳳凰城 Cardova ST. Bridge over Santa River 1985 年遭洪水沖毀

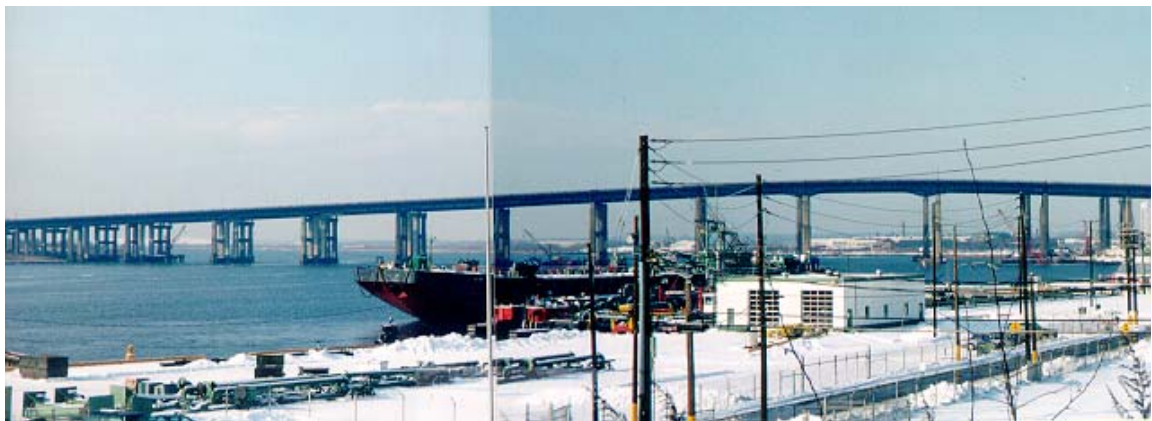
照片 (七十六)

紐約地區常見之鋼橋，橋齡甚長，維修保養不易。
