赴美國考察土石流防治工程 報 告

服務機關：交通部公路局
局長室：局 長 梁 樾
總工程司室：副總工程司 楊金澤
出國地區：美國
出國期間：八十九年十二月二十六日至
九十年元月八日
報告日期：九十年四月

赴美國考察土石流防治工程報告

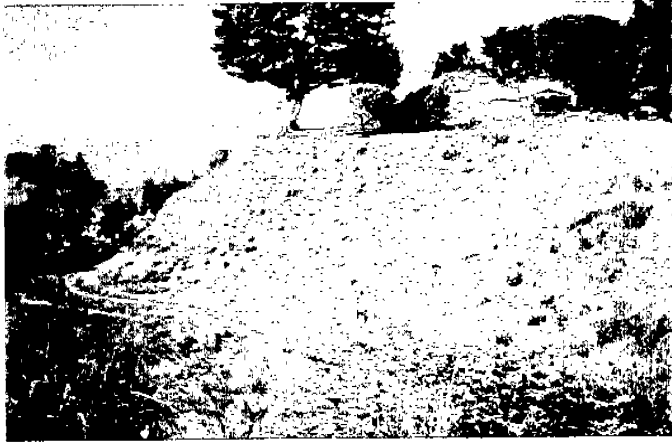
洛杉磯西側海岸公路(Pacific Coast Highway NO.1)山側邊坡曾發生大規模坍塌，大量土石塌落影響下側公路交通並危及坡頂之住宅區，州政府公路廳花費鉅資清除土石，並採台階式開挖加植草處理工法穩定邊坡，四周再加設鋼纜網保護(見照片一~三)。

洛杉磯西側海岸公路(Pacific Coast Highway NO.1)山側邊坡曾發生大規模坍塌，州政府公路廳花費鉅資清除土石，並採台階式開挖加植草處理工法穩定邊坡，四周再加設鋼纜網保護。

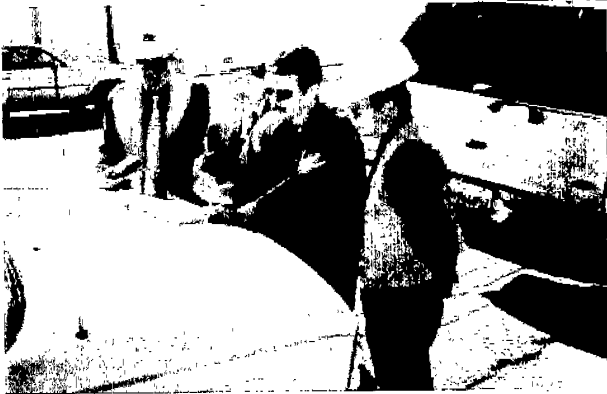
加州運輸部資深地質師 R. Gustavo Ortega, 現場向局長及團員說明邊坡坍塌原因及整治工法。

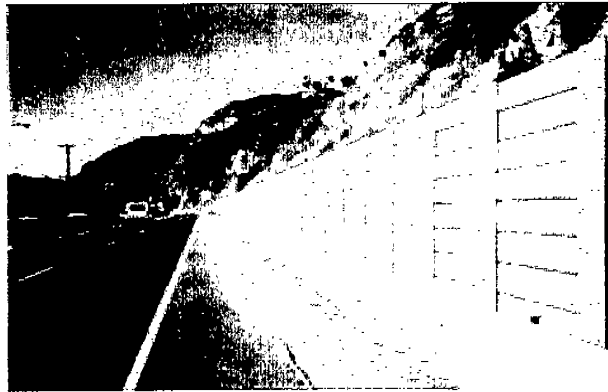
部分路段邊坡岩石風化崩落，以鋼纜編織成網後再以直昇機輔助吊掛固定，纜徑0.5吋，網目寬6吋。邊坡下方另加設混凝土板擋土牆防止落石危及公路安全，效果極佳，值得台灣地區類似邊坡防治之參考(見照片十六~二十二)。

部分路段邊坡岩石風化崩落，以鋼纜編織成網後再以直昇機輔助吊掛固定，纜徑 0.5 吋，網目寬 6 呎。邊坡下方另加設混凝土板擋土牆防止落石危及公路安全，效果極佳，值得台灣地區類似邊坡防治之參考。

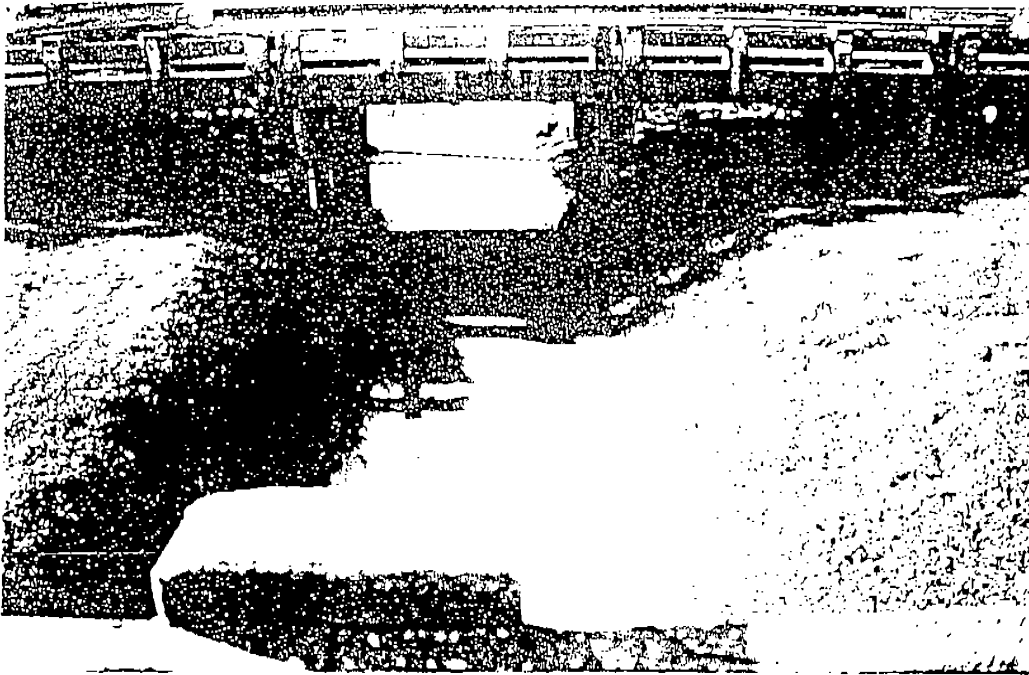
CONCRETE RAIL CRACKED.

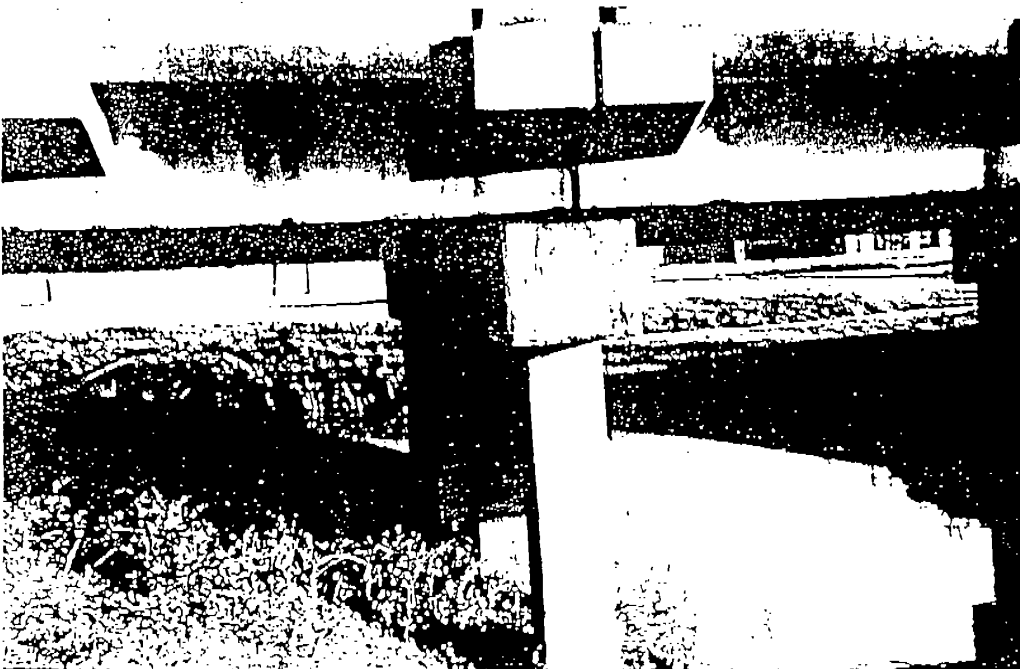
COLUMN/PILING HAS DRIFT IMPACT SPALL WITH 8% SECTION LOSS. BENT CAP CRACKED CONCRETE RAIL POST SPALLED WITH EXPOSED REBAR.

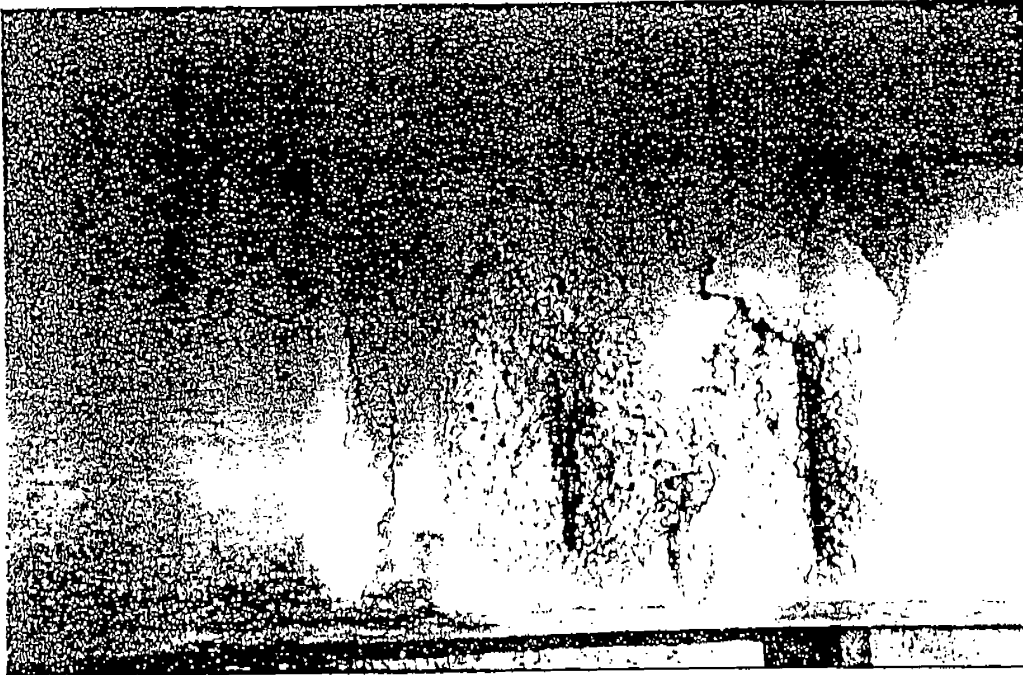
2. Generally, interior bent concrete caps have minor cracking. The West interior bent cap has delaminations and spalling with exposed rebars due to deterioration of concrete (see photo).

- 340 TIMBER GUARDFENCE POSTS GENERALLY HAVE MODERATE WEATHERING AND DECAY.
- 60 GOOD CONDITION.
- 321 GOOD CONDITION
- 215 GOOD CONDITION
- 234 GENERALLY INTERIOR BENT CONCRETE CAPS HAVE MINOR CRACKING. THE WEST INTERIOR BENT CAP HAS DELAMINATIONS AND SPALLING WITH EXPOSED REBARS DUE TO DETERIORATION OF CONCRETE.

BENT CAP HAS DELAMINATION AND SPALLS WITH EXPOSED REBARS.
