經濟部暨所屬機關因公出國人員報告書
(出國類別：洽公)

M9401 煉製事業部大林廠汽柴油品質
提昇投資計畫赴反應器設備製
造廠監辦

出國人：服務機關：中油公司興建工程處
職務：一般工程師、設備檢查員
姓名：莊志誠、柯裕民

Proect: CPC/Talin Refinery Disel HDS R-1001 Reactor

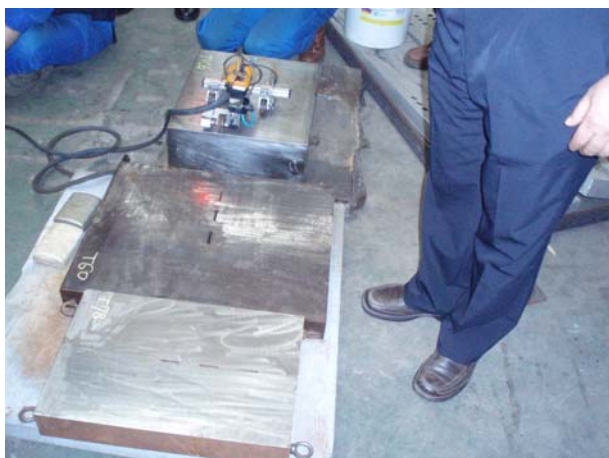
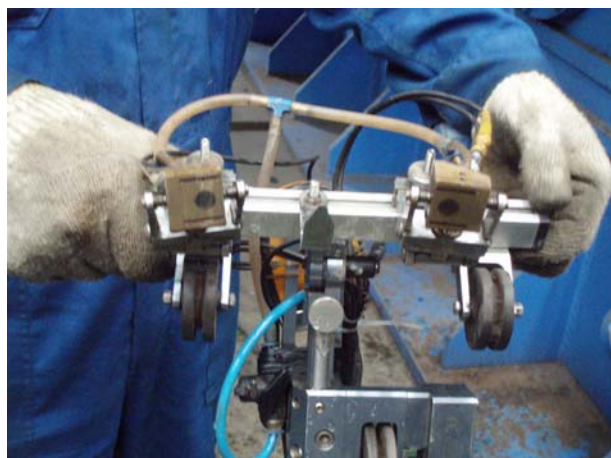
三種厚度之參考規塊與 TOFD 超音波探頭

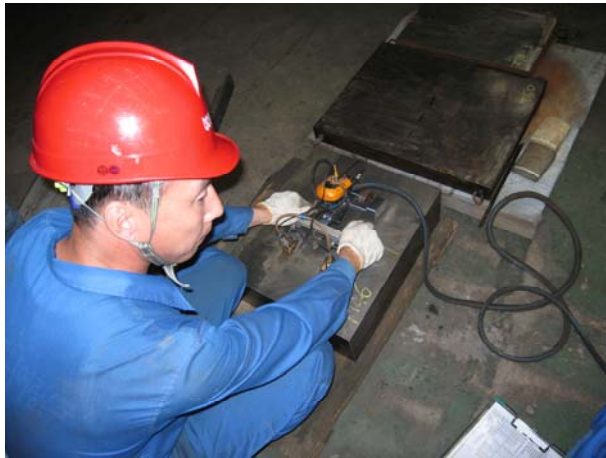
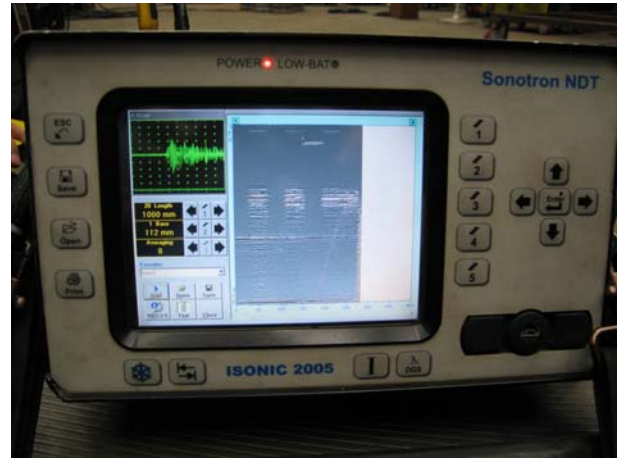
本次實際見證其操作，以缺陷模擬試片作校正，由波束的顯示中，証實該項檢測技術的可信度。並於實際施行檢測動作時，在執行及判讀上的動作均已顯現得相當純熟，且當時檢測執行係由高級檢測師 (Level III) 操刀。

校正作業 二(螢幕上為檢測到參考規塊之人工瑕疵)

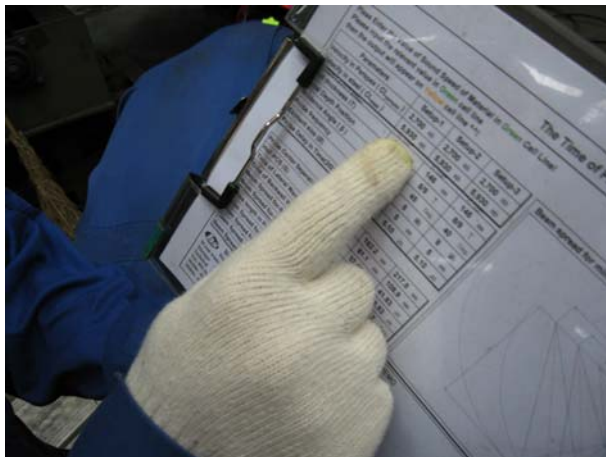
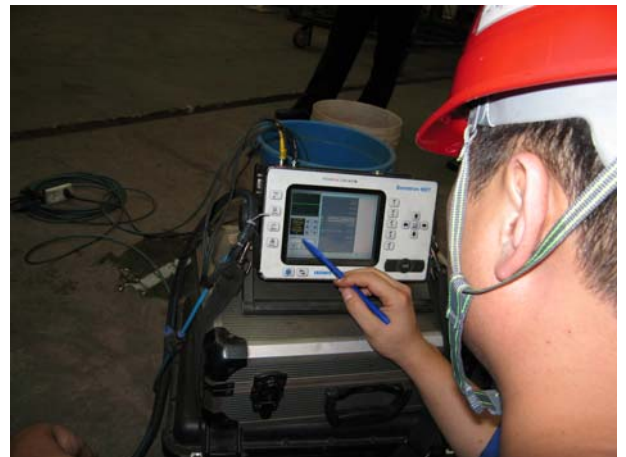
校正作業 三(檢測人員解說檢測道之人工瑕疵)

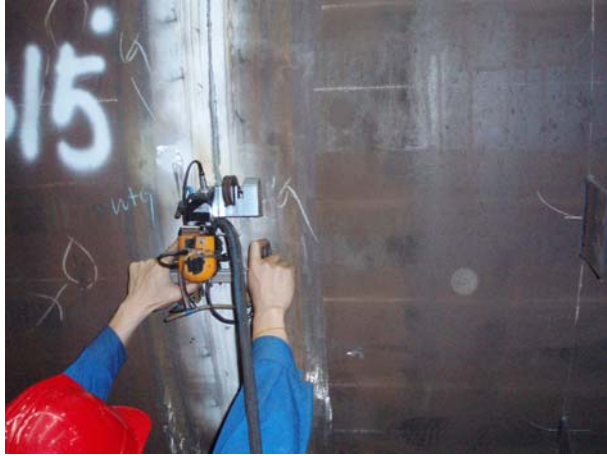
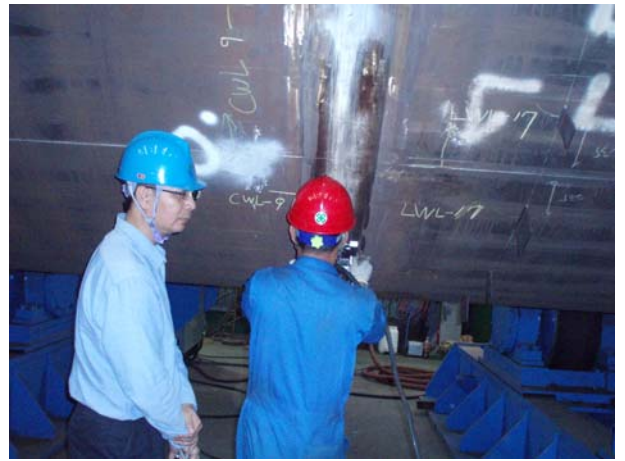
圓周銲道 TOFD 檢測情形

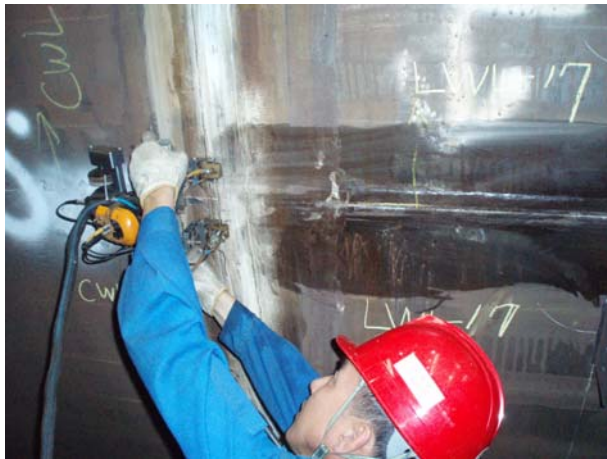
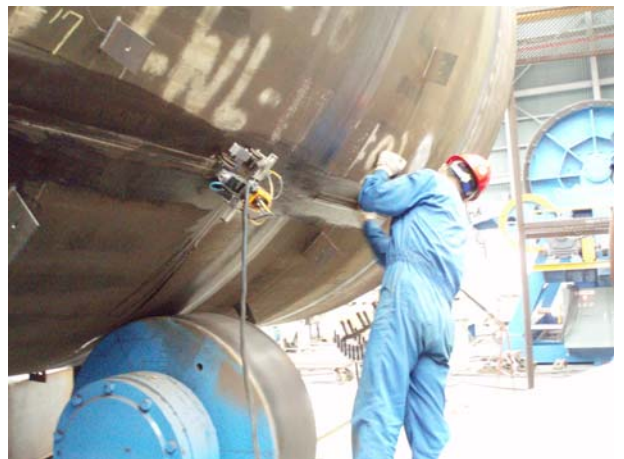
縱向銲道 TOFD 檢測情形

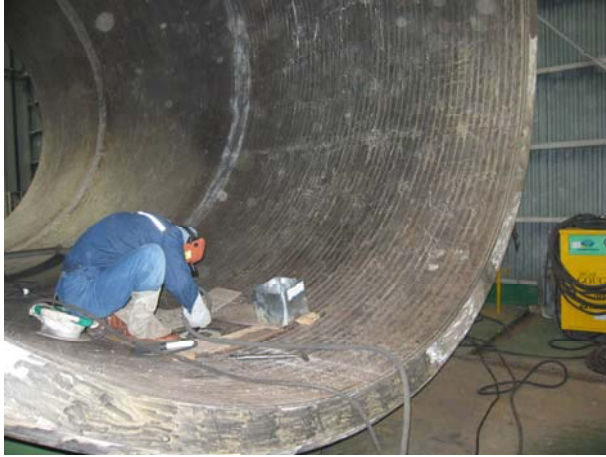
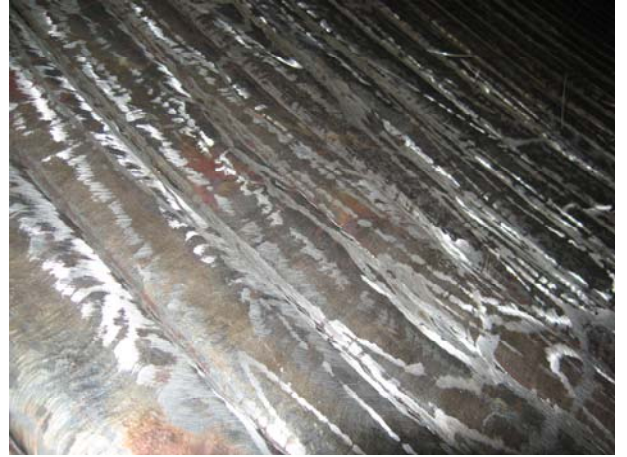
Overlay 銲接施作情形

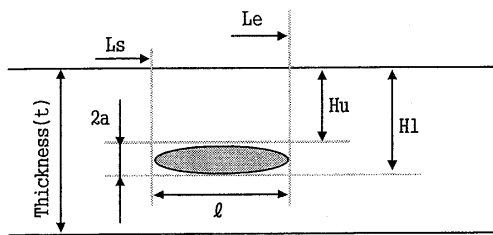
1. Indication Marking (Subsurface Indication)

확인번호 Identification No.		위치 Location(mm)		길이 Length (mm) l	깊이 Depth(mm)		높이 Height (mm) a or $2a$	결정의종류 Type of Flaw	a / l	a / t	평가 Evaluati on	검사방법 Technique
Joint No.	Ind. No.	Start Ls	End Le		Upper Hu	lower Hl						
LWL-17-1	1	253.1	289.1	36	73.2	75.2	2.0	Subsurface	0.02778	0.00685		Tec. 1,2,3
LWL-17-2		No Recordable Indication										Tec. 1,2,3
LWL-18-1		No Recordable Indication										Tec. 1,2,3
LWL-18-2		No Recordable Indication										Tec. 1,2,3
- B L A N K -

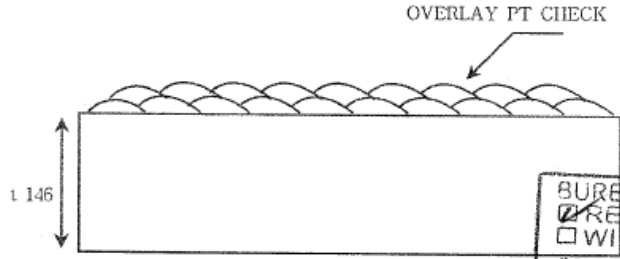
Black Light / UV Meter S/No. 자외선등 / 자외선 강도계 N/A		Black Light Source-to-Object Distance 자외선등조명거리/강도 N/A cm / μW/cm ²		
Identification No. 확인 번호	Accept 합격	Reject 불합격	Interpretation 판독	Remarks 비고
SHELL (LWL-3.4)	V		NO RECORDABLE INDICATION	
			-BLANK-	
*PT CHECK POSITION .all surface (overlay welded part)

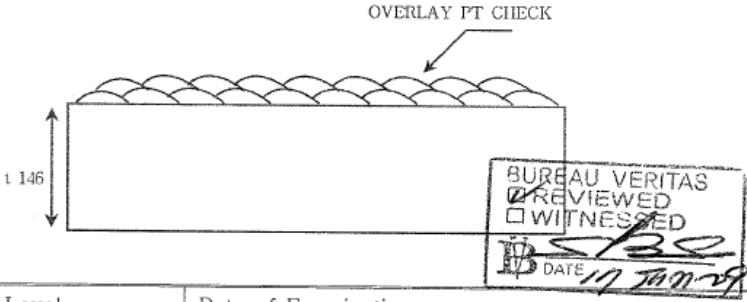
Black Light / UV Meter S/No. 자외선등 / 자외선 강도계 N/A	Black Light Source-to-Object Distance 자외선등조명거리/강도 N/A cm / μW/cm ²			
Identification No. 확인 번호	Accept 합격	Reject 불합격	Interpretation 판독	Remarks 비고
SHELL (LWL-3.4)	V		NO RECORDABLE INDICATION	
			-BLANK-	
*PT CHECK POSITION .all surface (overlay welded part)

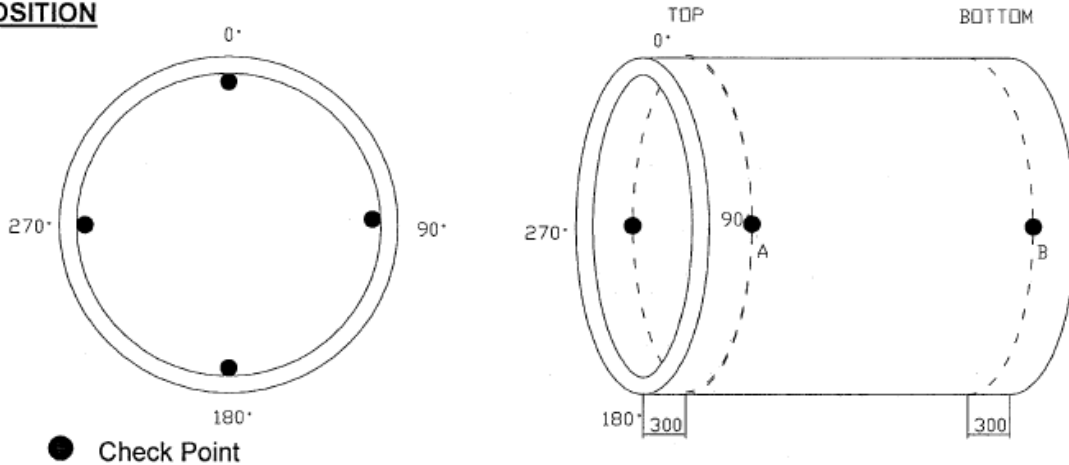
1. TEST POSITION

POINT	VALUE (%)			REMARK
0°-A	6.5	6.2	6.7	
0°-B	7.4	6.5	6.9	
90°-A	6.4	6.4	7.1	
90°-B	6.9	7.2	6.5	
180°-A	7.3	7.2	6.8	
180°-B	6.5	6.6	7.1	
270°-A	6.4	7.3	7.1	
270°-B	6.9	6.6	6.9

Test Value : Engineering Specification, DS-103-0002-0, 7.1.5 (Ferrite Range : Max. 10%)

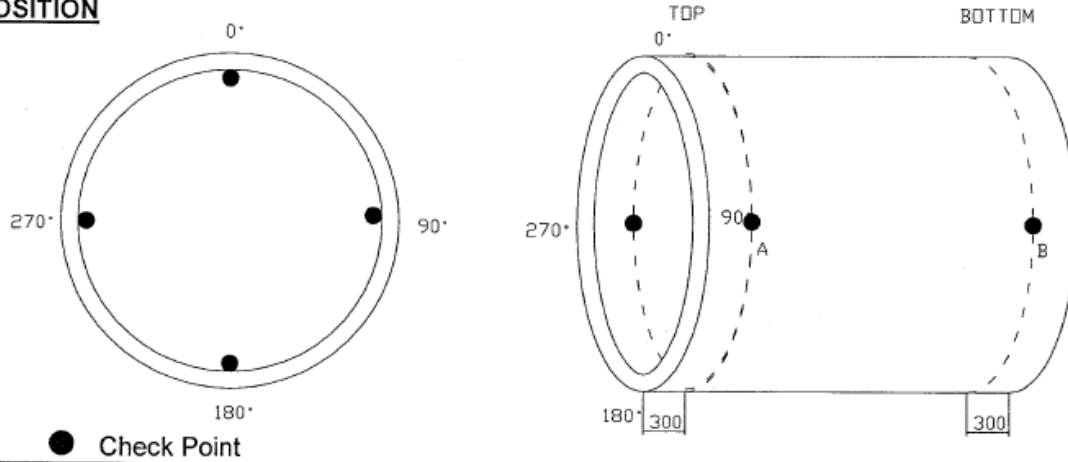
1. TEST POSITION

POINT	VALUE (%)			REMARK
0°-A	6.7	7.2	6.6	
0°-B	6.7	6.6	7.0	
90°-A	6.5	7.5	7.1	
90°-B	7.1	7.0	6.7	
180°-A	7.8	7.1	6.6	
180°-B	6.6	6.6	6.5	
270°-A	6.7	7.3	7.0	
270°-B	7.1	6.6	6.4

Test Value : Engineering Specification, DS-103-0002-0, 7.1.5 (Ferrite Range : Max. 10%)
