出國報告(出國類別：國外承攬)

關島 CABRAS 電廠#1 機汽機大修

服務機關：台灣電力公司電力修護處

2017 關島 CABRAS # 1 STEAM TURBINE 大修報告

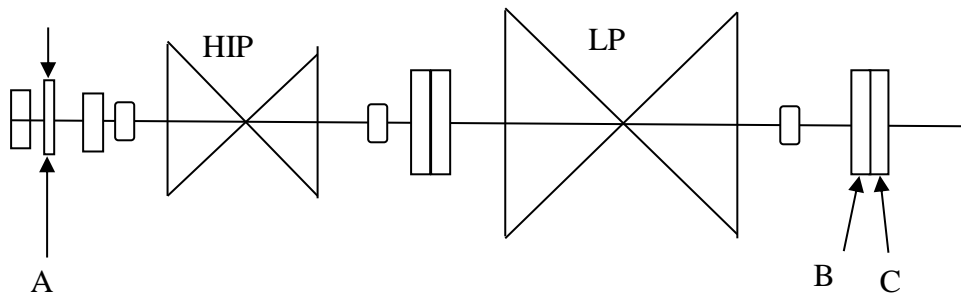
2.2 Run out check within the 0.002"

A	B	C
1	NA	19	22
2	NA	20	23
3	NA	23	22
4	NA	22	22
5	NA	22	22
6	NA	22	23
7	NA	22	22
8	NA	20	21

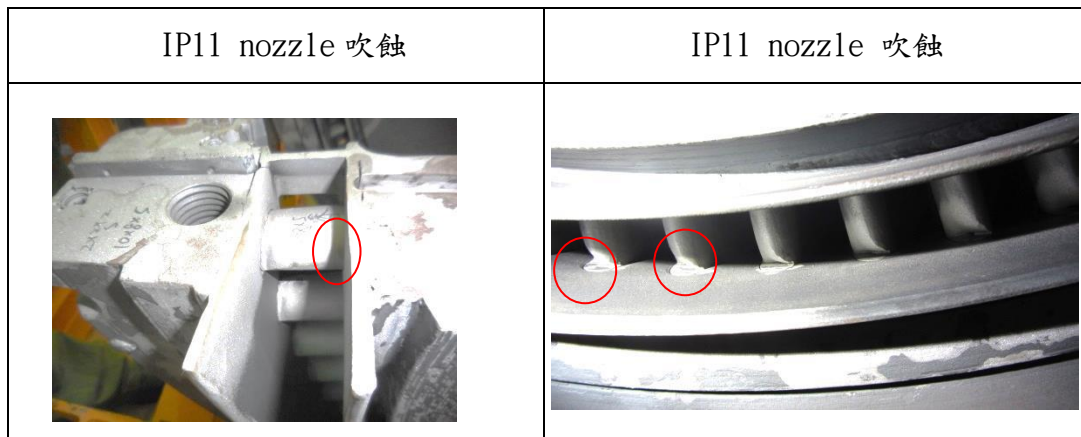
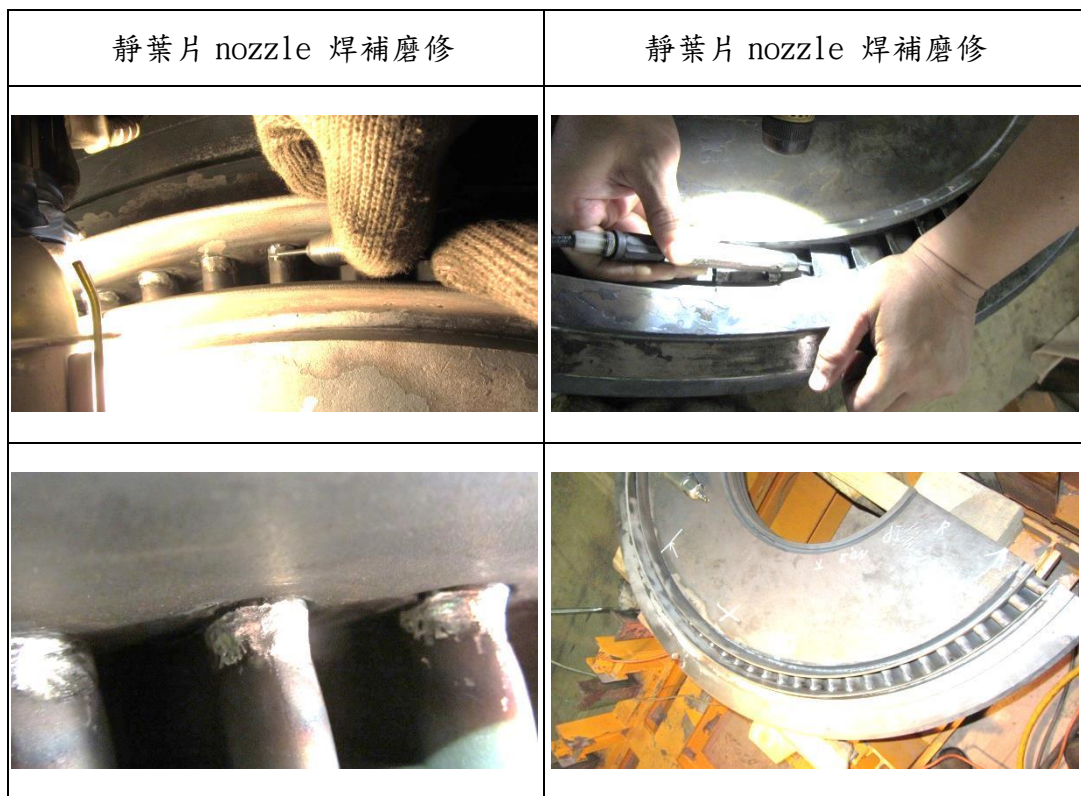
3 : Nozzle block and buckets

3.1 IP 11(toper and lower half) and IP10 (lower half) nozzle van found some erosion and need to repair., the other nozzle van are good.

在動葉與靜葉檢查，並未發現葉片或葉根有裂縫需更換。僅有中壓第十一級上下半靜葉環與中壓第十級靜葉環下半葉片有些吹蝕現象，經過焊補磨修與 PT 檢查後，將其回裝。汽機汽封更換方面，本次檢查發現只有 HP7 之 Packing ring 有些微變形，將其更換為新品。因應電廠要求，低壓外缸安全膜片也做了更換。因電廠輔機系統與飼水泵在大修後啟動有些問題，第一次並聯時間為 8/28 19:42，發電量為 0.4MW。

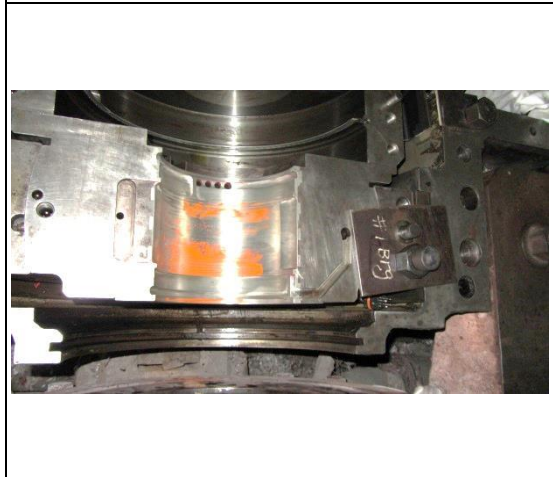
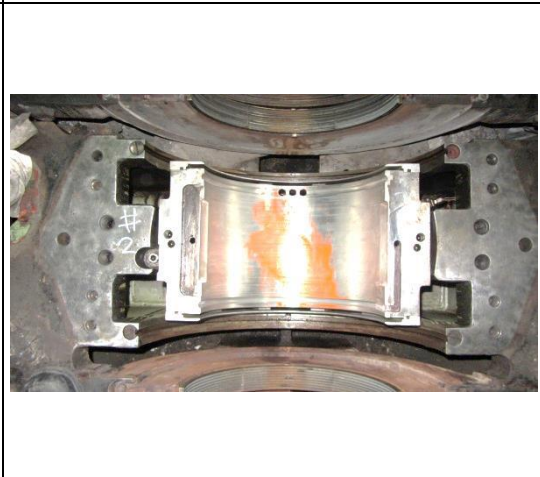
#1 BRG 與軸頸接觸面試驗	#2BRG 與軸頸接觸面試驗

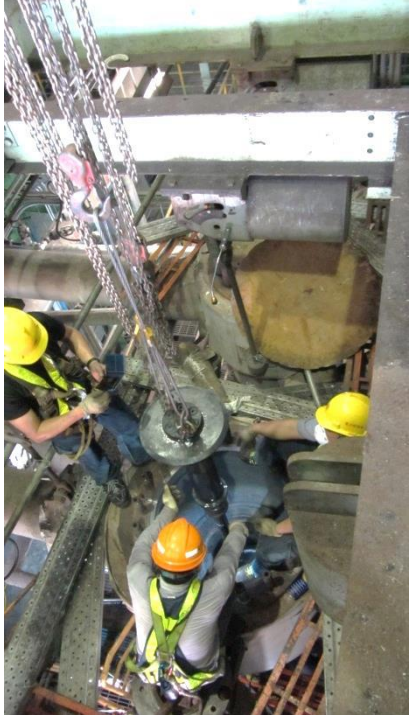
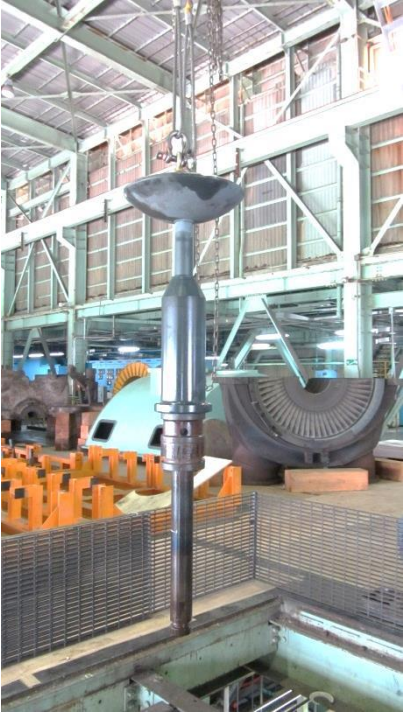
<p>RSV 拆除</p>	<p>RSV disc & stem</p>

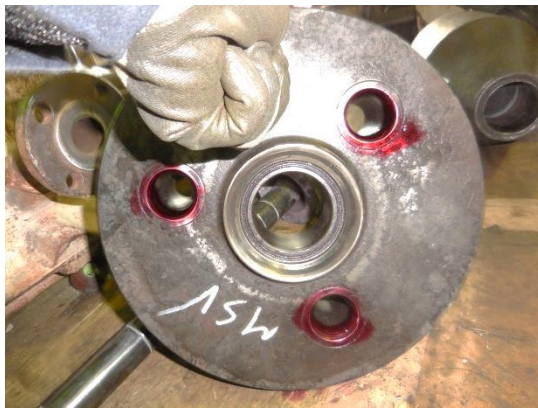
轉子吊出後，經由 NDT 檢查，確認並無任何葉片受損需更換，另汽機主閥全部拆卸檢修。MSV 嚮導閥 SEAT 與 RSV DISC 在經過 NDT 檢查後發現有裂痕(線性指示)，此次大修將 MSV 嚮導閥 SEAT 與 RSV DISC 更換成新品。此外因 CV#1 在拆解過程中無法將 STEM 從閥體中取下，所以將其切割取下後更換成新品(STEM 與 DISC)。

MSV pilot valve seat PT

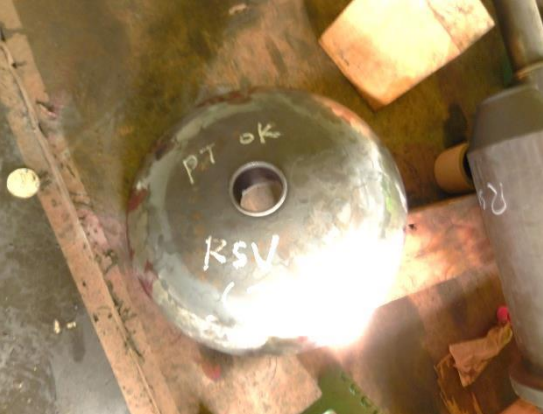
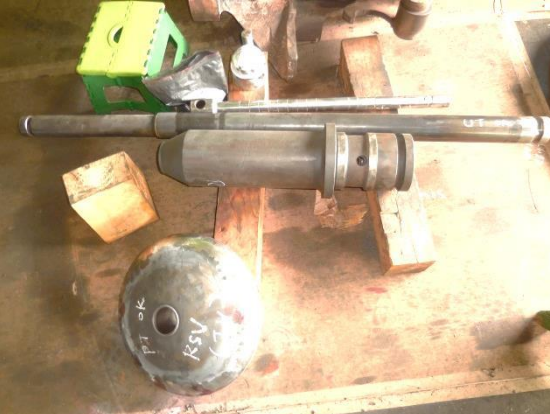
<p>RSV 閥座 PT CHECK</p>	<p>RSV 閥座 PT CHECK</p>

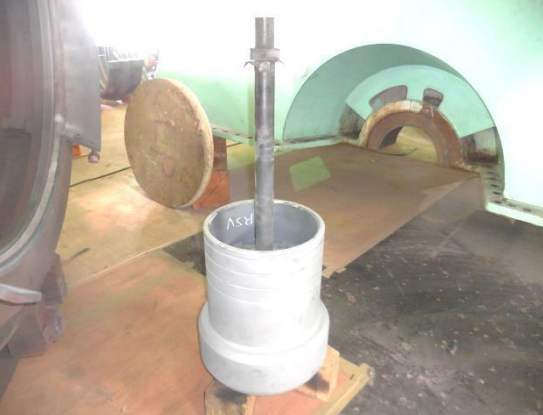
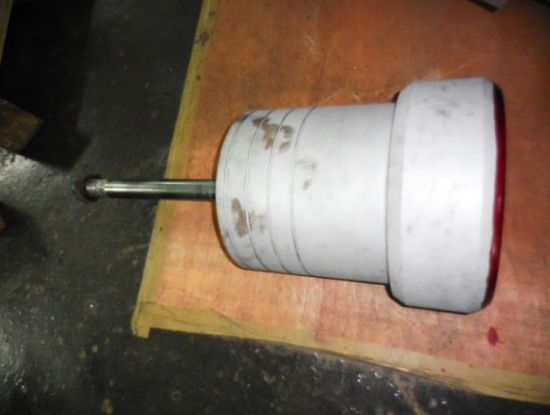
<p>IV PT CHECK</p>	<p>IV PT CHECK</p>

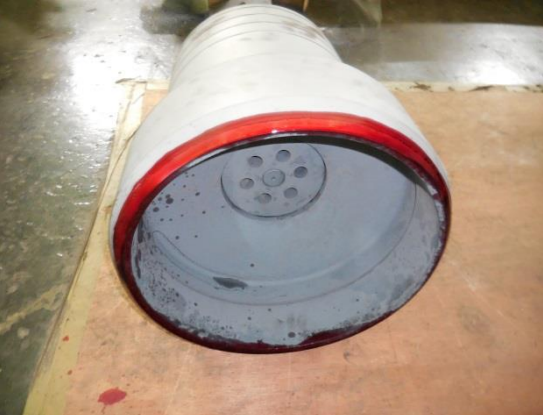
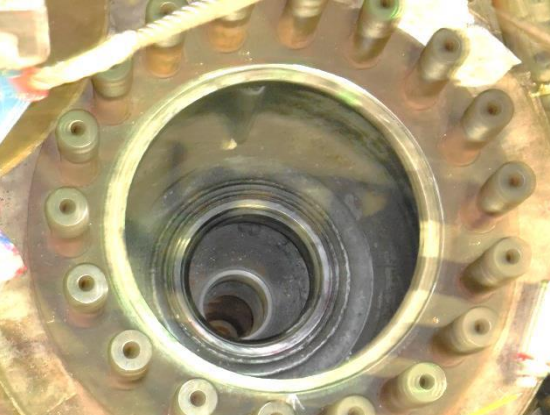
<p>IV DISC PT CHECK</p>	<p>IV&RSV 閥座 PT CHECK</p>

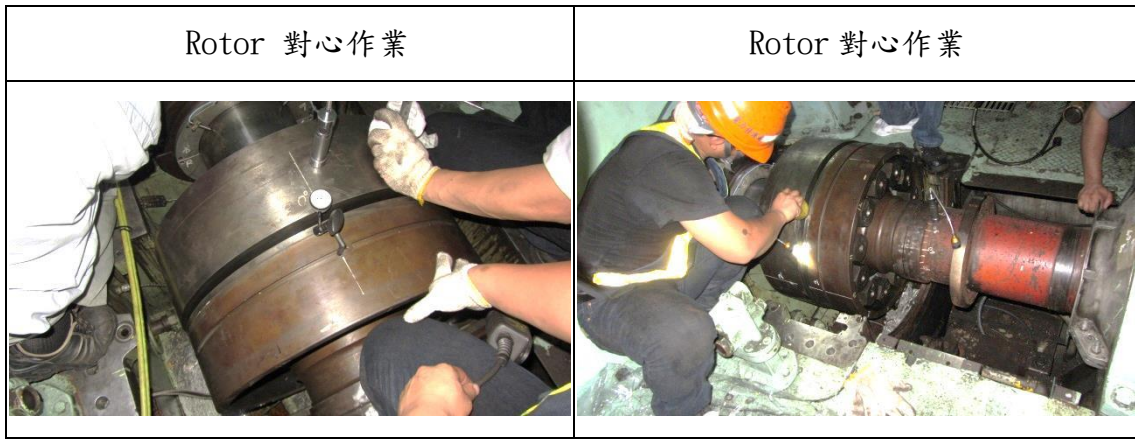
1 : TB-GEN alignment

Face	T	B	L	R
0°	19.77	19.75	19.70	19.73
90°	19.72	19.76	19.74	19.70
180°	19.33	19.32	19.31	19.32
270°	19.80	19.78	19.78	19.80
Ave	19.65	19.65	19.63	19.64

The design data is that the offset is zero and the generator is 0.53mm low to the turbine. A mounted on the generator reading to the turbine, and with parallel gage to measure all face.

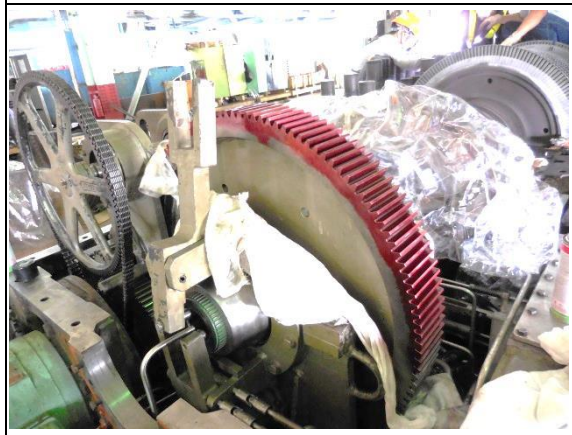
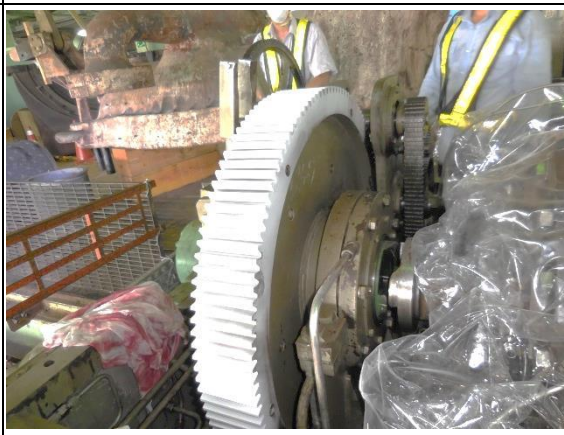
<p>慢車齒輪 PT check</p>	<p>慢車齒輪 Gear PT check</p>

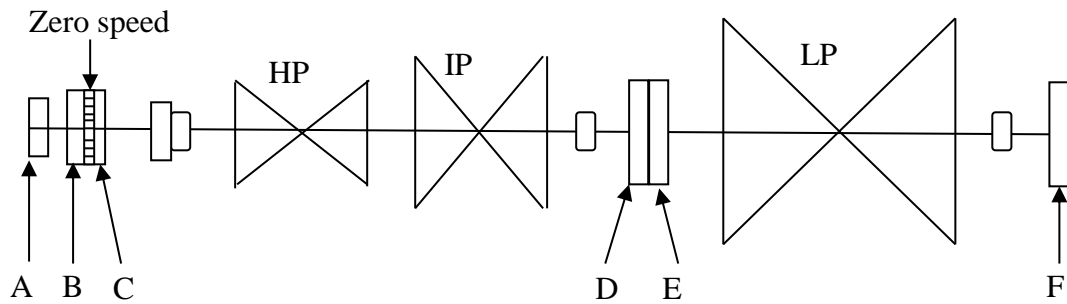
RUNOUT CHECK

A	B	C	D	E	F
1	NA	NA	NA	19	22	NA
2	NA	NA	NA	20	23	NA
3	NA	NA	NA	23	22	NA
4	NA	NA	NA	22	22	NA
5	NA	NA	NA	22	22	NA
6	NA	NA	NA	22	23	NA
7	NA	NA	NA	22	22	NA
8	NA	NA	NA	20	21	NA

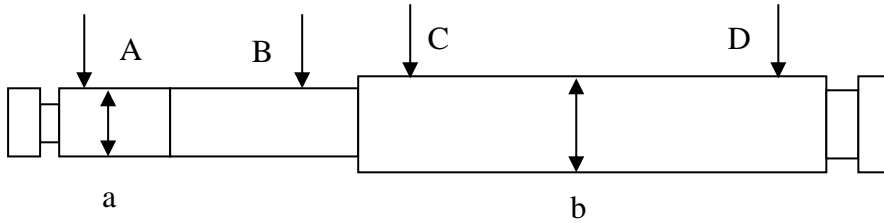
MSV Stem RUNOUT CHECK

A	B	C	D
1	0	0	0	0
2	3	-6	-1	31
3	3	-10	-2	42
4	0	-4	-1	11

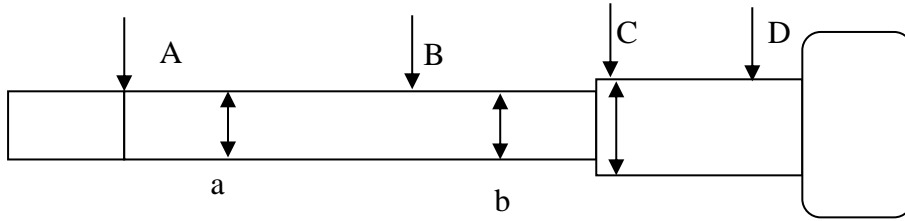
RSV Stem RUNOUT CHECK

A	B	C	D
1	0	0	0	0
2	-8	2	0	0
3	-18	4	0	-2
4	-10	2	0	-2
