STRUCTURE RATING DATA SHEET

BRIDGE NO: 53C1744 LA County Br. No : 2446
Facility Carried : ARTESIA BLVD
Location : 0.3MI W/O SANTA FE AVE
BRIDGE NAME: SP/UP,COMPTON CR.ALAMEDA

Name: SP/UP,COMPTON CR,ALAMEDA
 Struct-Def: Bridge Span Ten (Fire Damage 2020)

Fire Damage Inspection

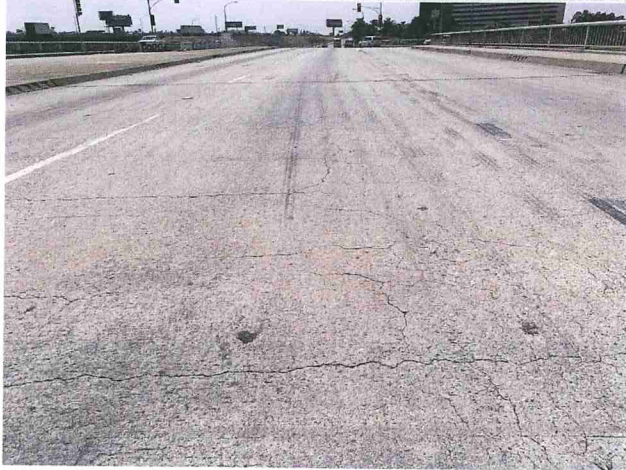
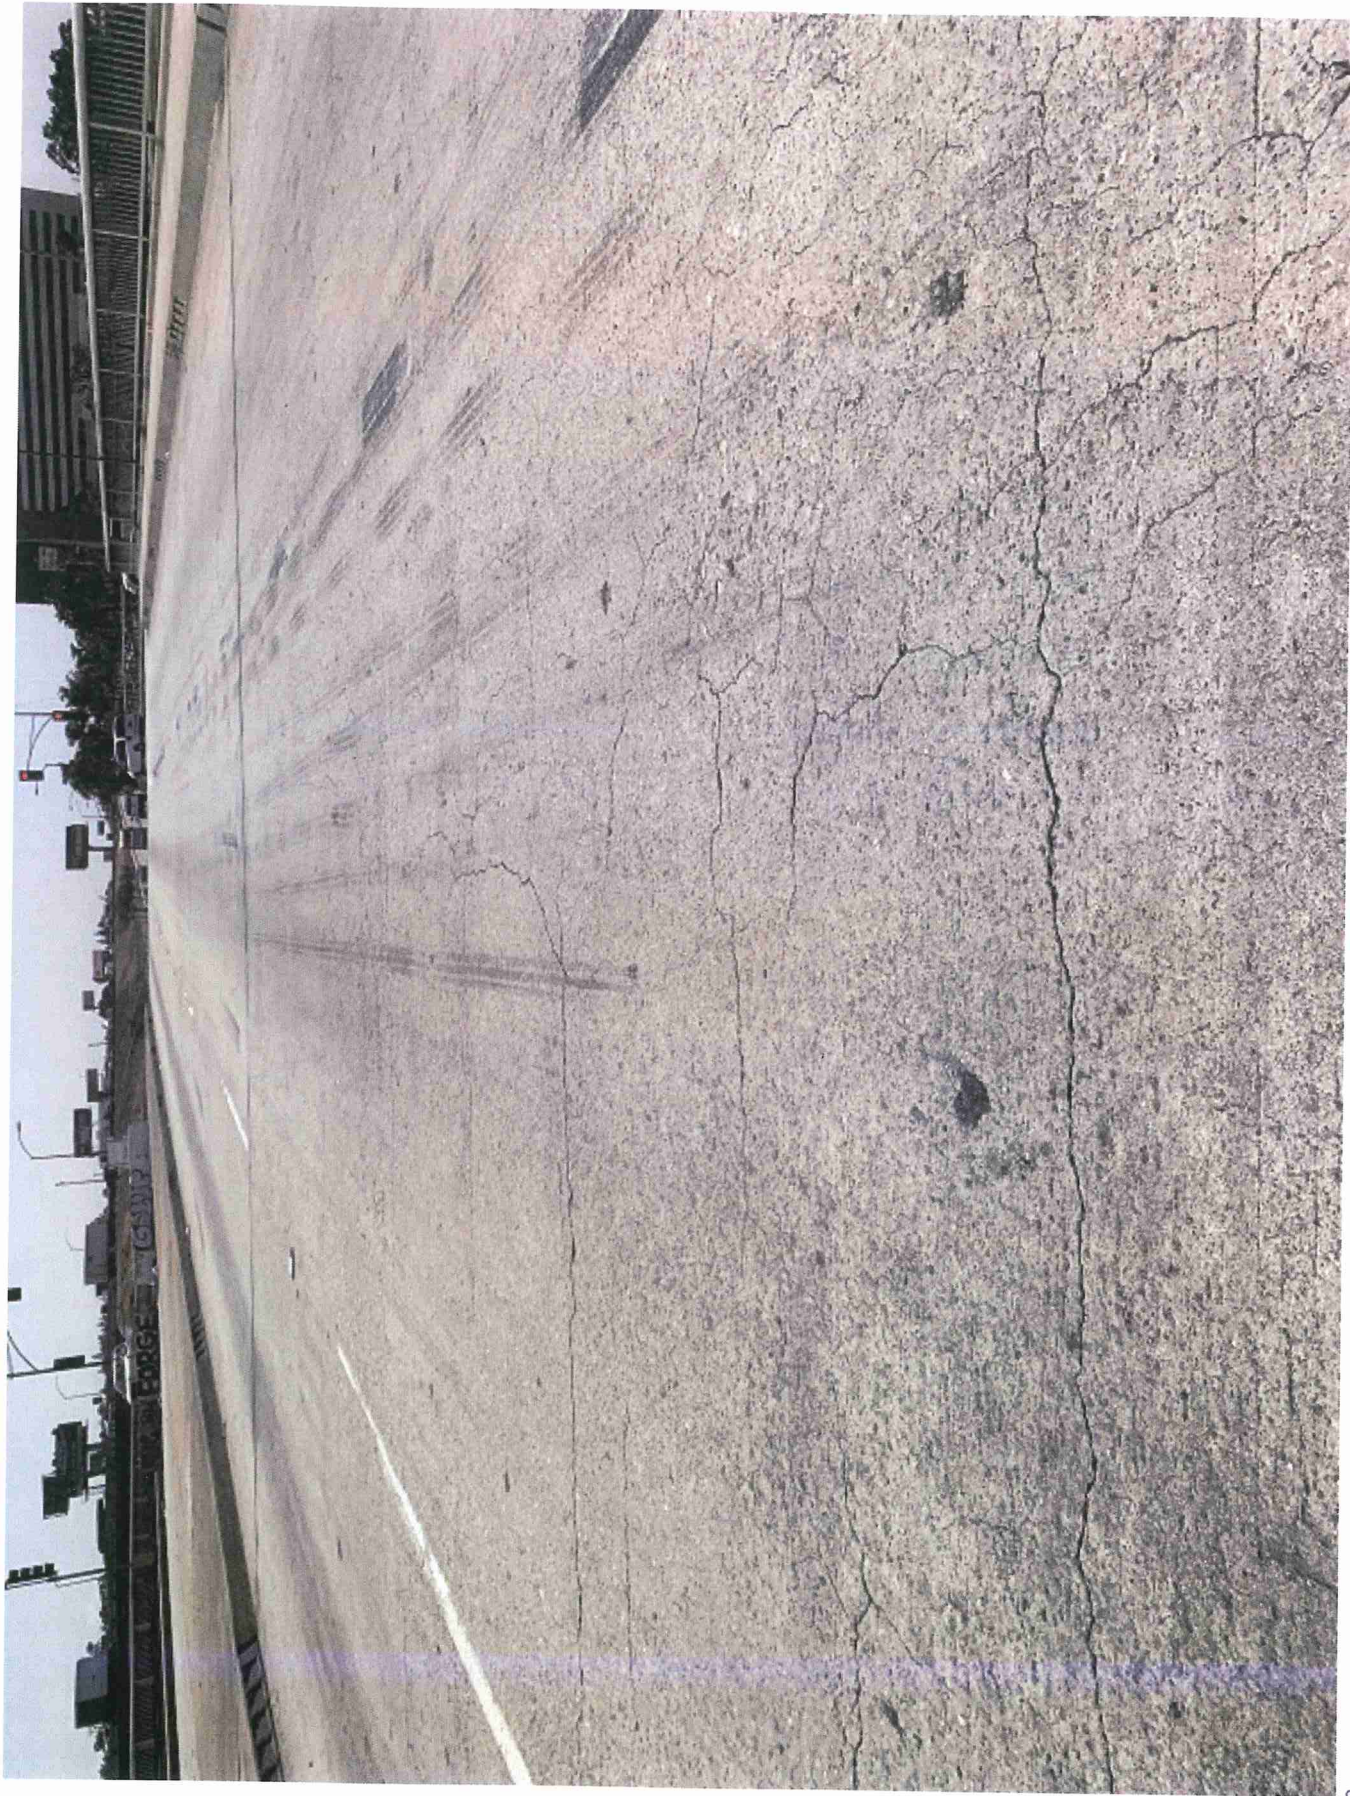
| Elem No. | Defect/Prot Defect | Element Description | Env | Total Qty | Units | Qty in each Condition State | | | |
|---|---|---|---|---|---|---|---|---|---|
| <p>Transverse cracks up to 0.07 inches wide were found along the deck surface. (05/04/2011) (Verified 06/08/2021)</p> | | | | | | | | | |

Photo 3
Deck Cracking

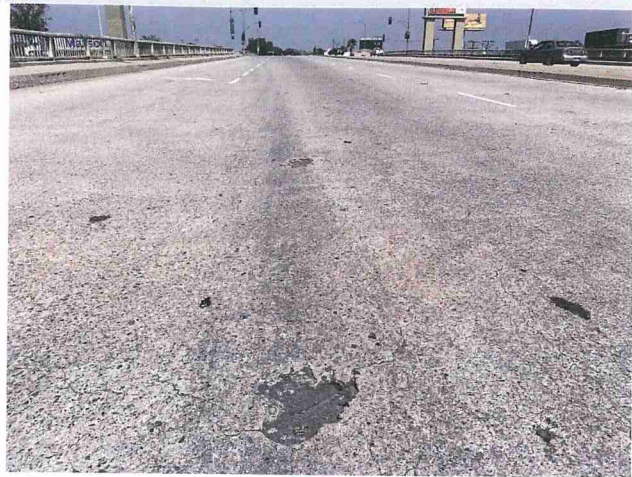
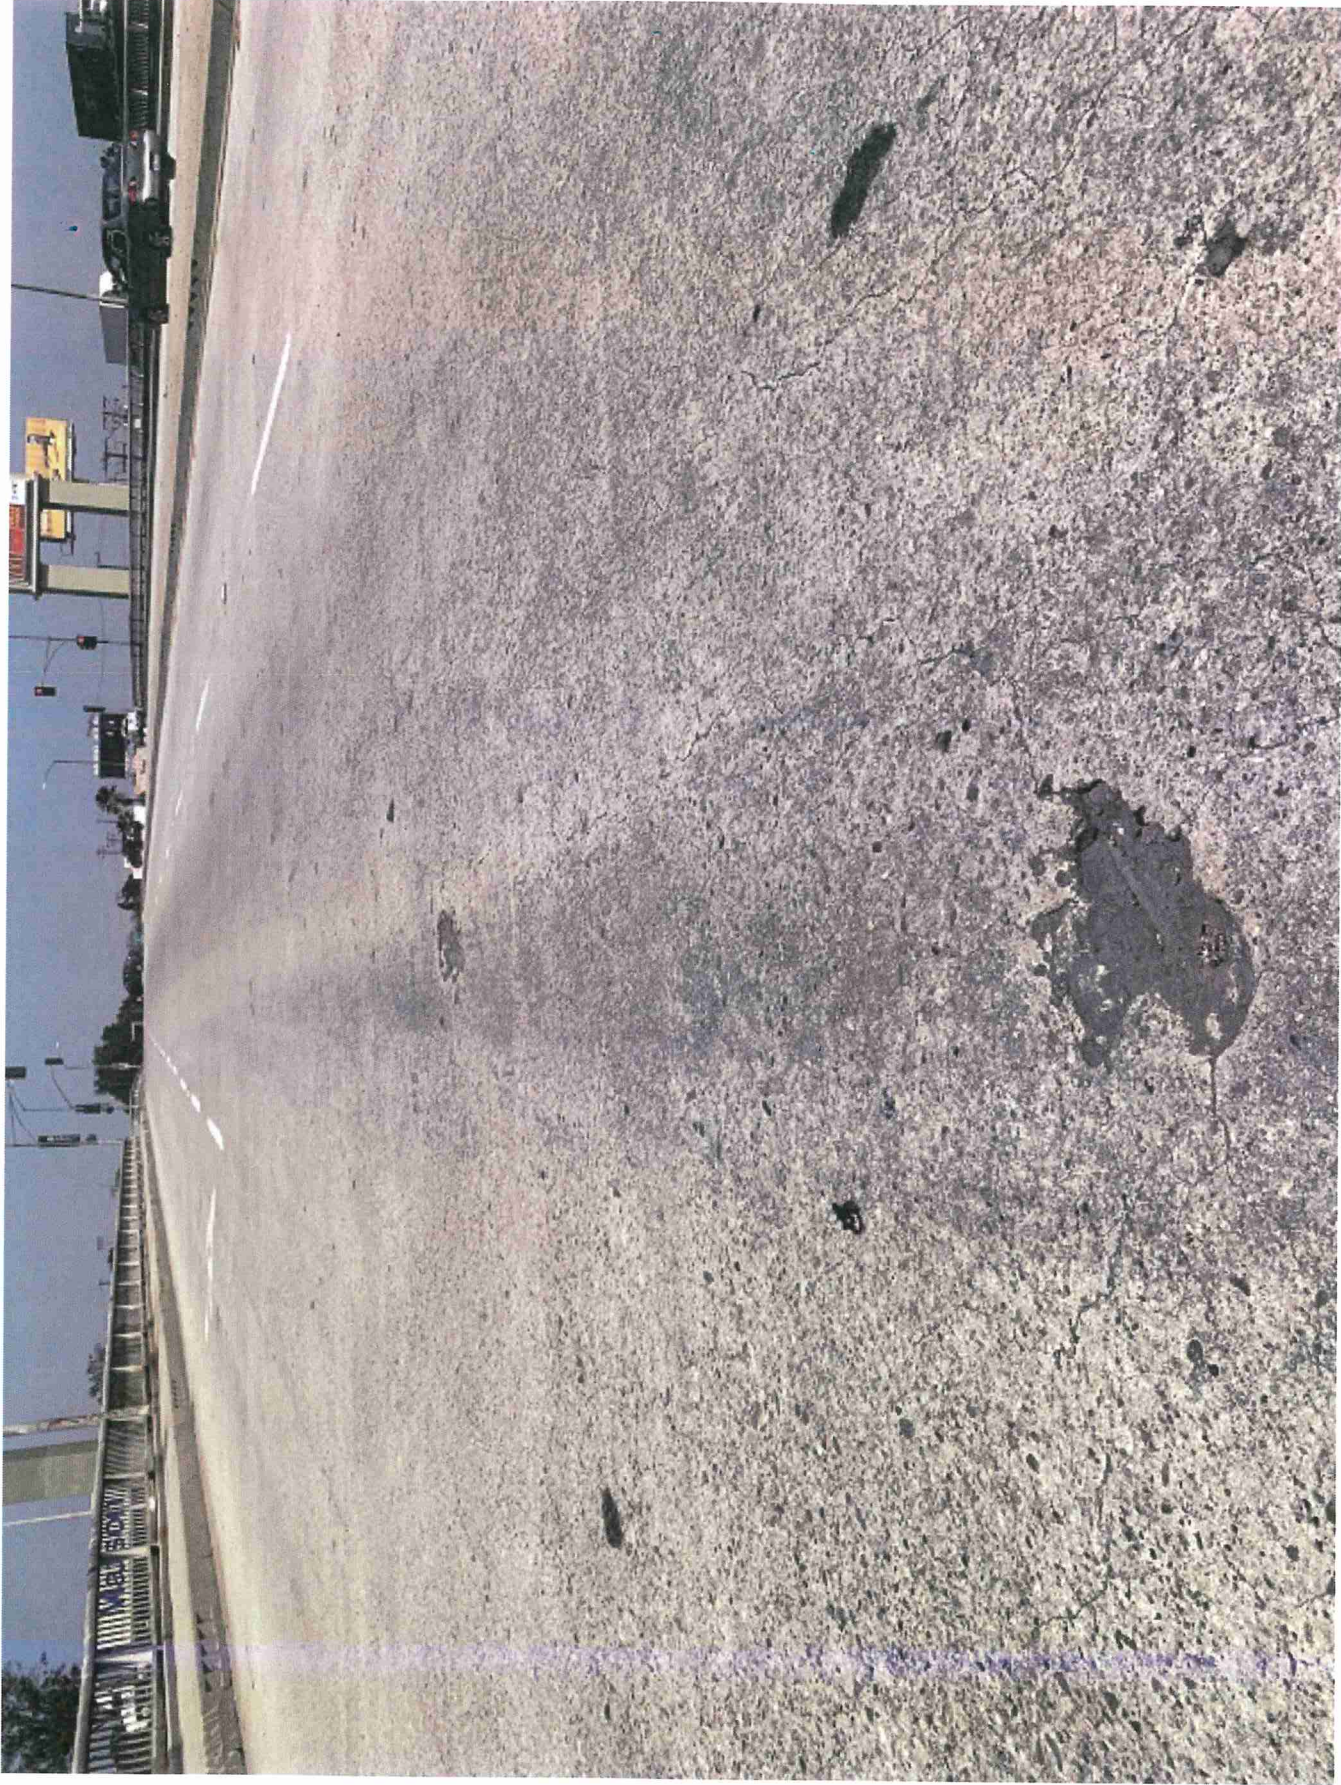
| Elem No. | Defect/Prot Defect | Element Description | Env | Total Qty | Units | Qty in each Condition State | | | |
|---|---|---|---|---|---|---|---|---|---|
| <p>Spalls up to 8 inches in diameter were found in the deck surface near abutment 1 along westbound lanes. (03/21/2001) (Verified 06/08/2021)</p> <p>Several areas of delamination and spalling up to 6 inches in diameter were found along the exterior edge of the north and south sidewalks. The spalls are over traffic lanes of Alameda Street. (04/07/1999) (Verified 06/08/2021)</p> <p>Spalls up to 4 inches in diameter with exposed rebar were found along the curbs. The spalls appear to be caused by insufficient cover of the rebar. (01/29/1990) (Verified 06/08/2021)</p> | | | | | | | | | |

Photo 5
Deck Spalls and Cracking

| Repair spalls and delaminations. | | | | | | |

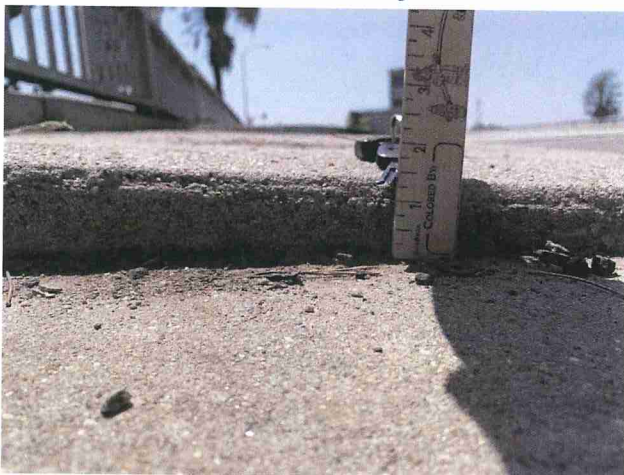
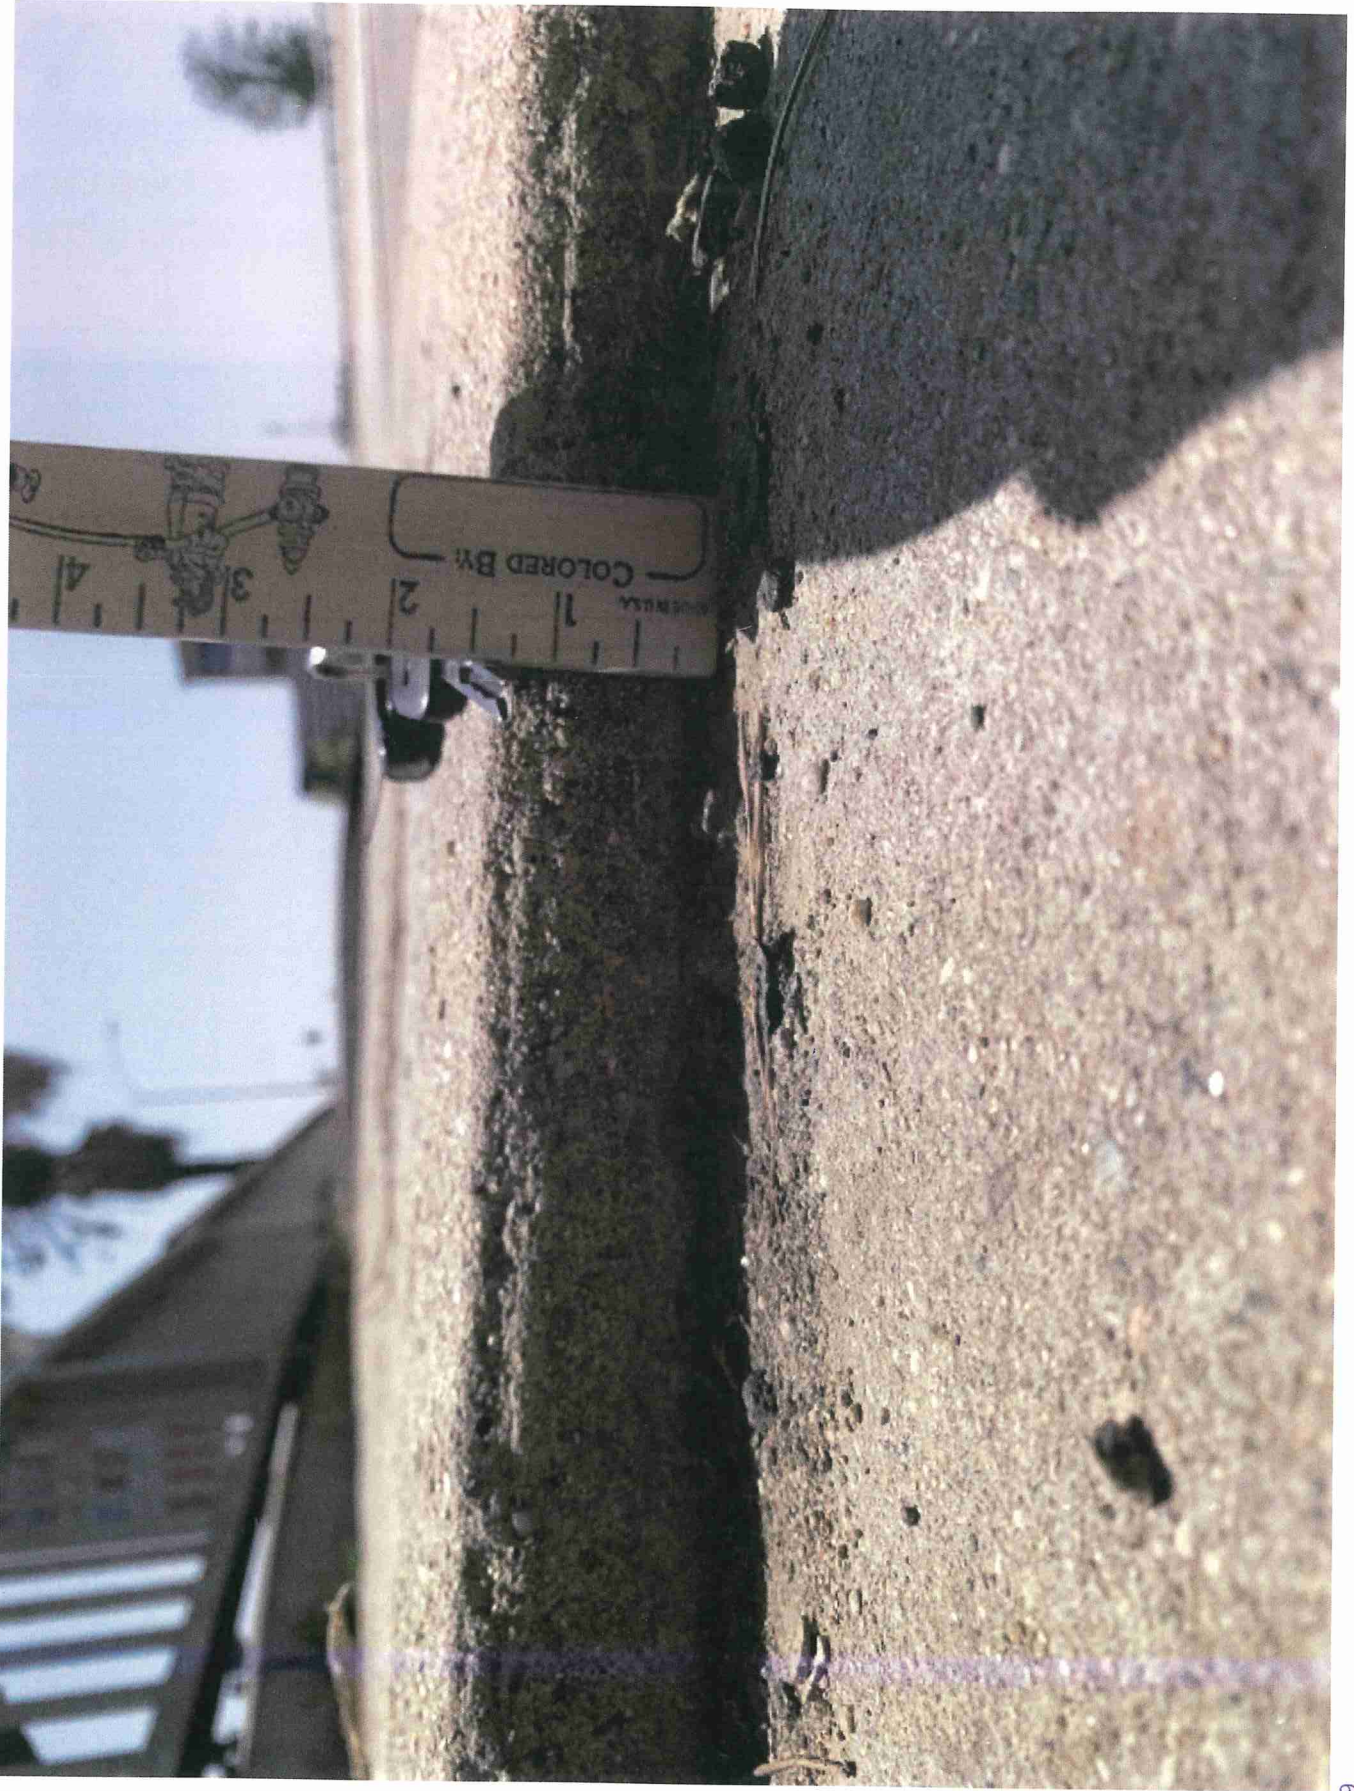
Photo 9
Displacement at SE Approach Sidewalk

| Repair approach sidewalks. | | | | | | |

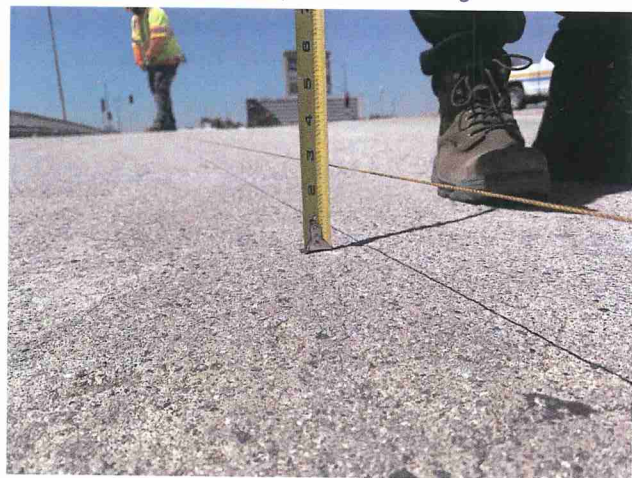
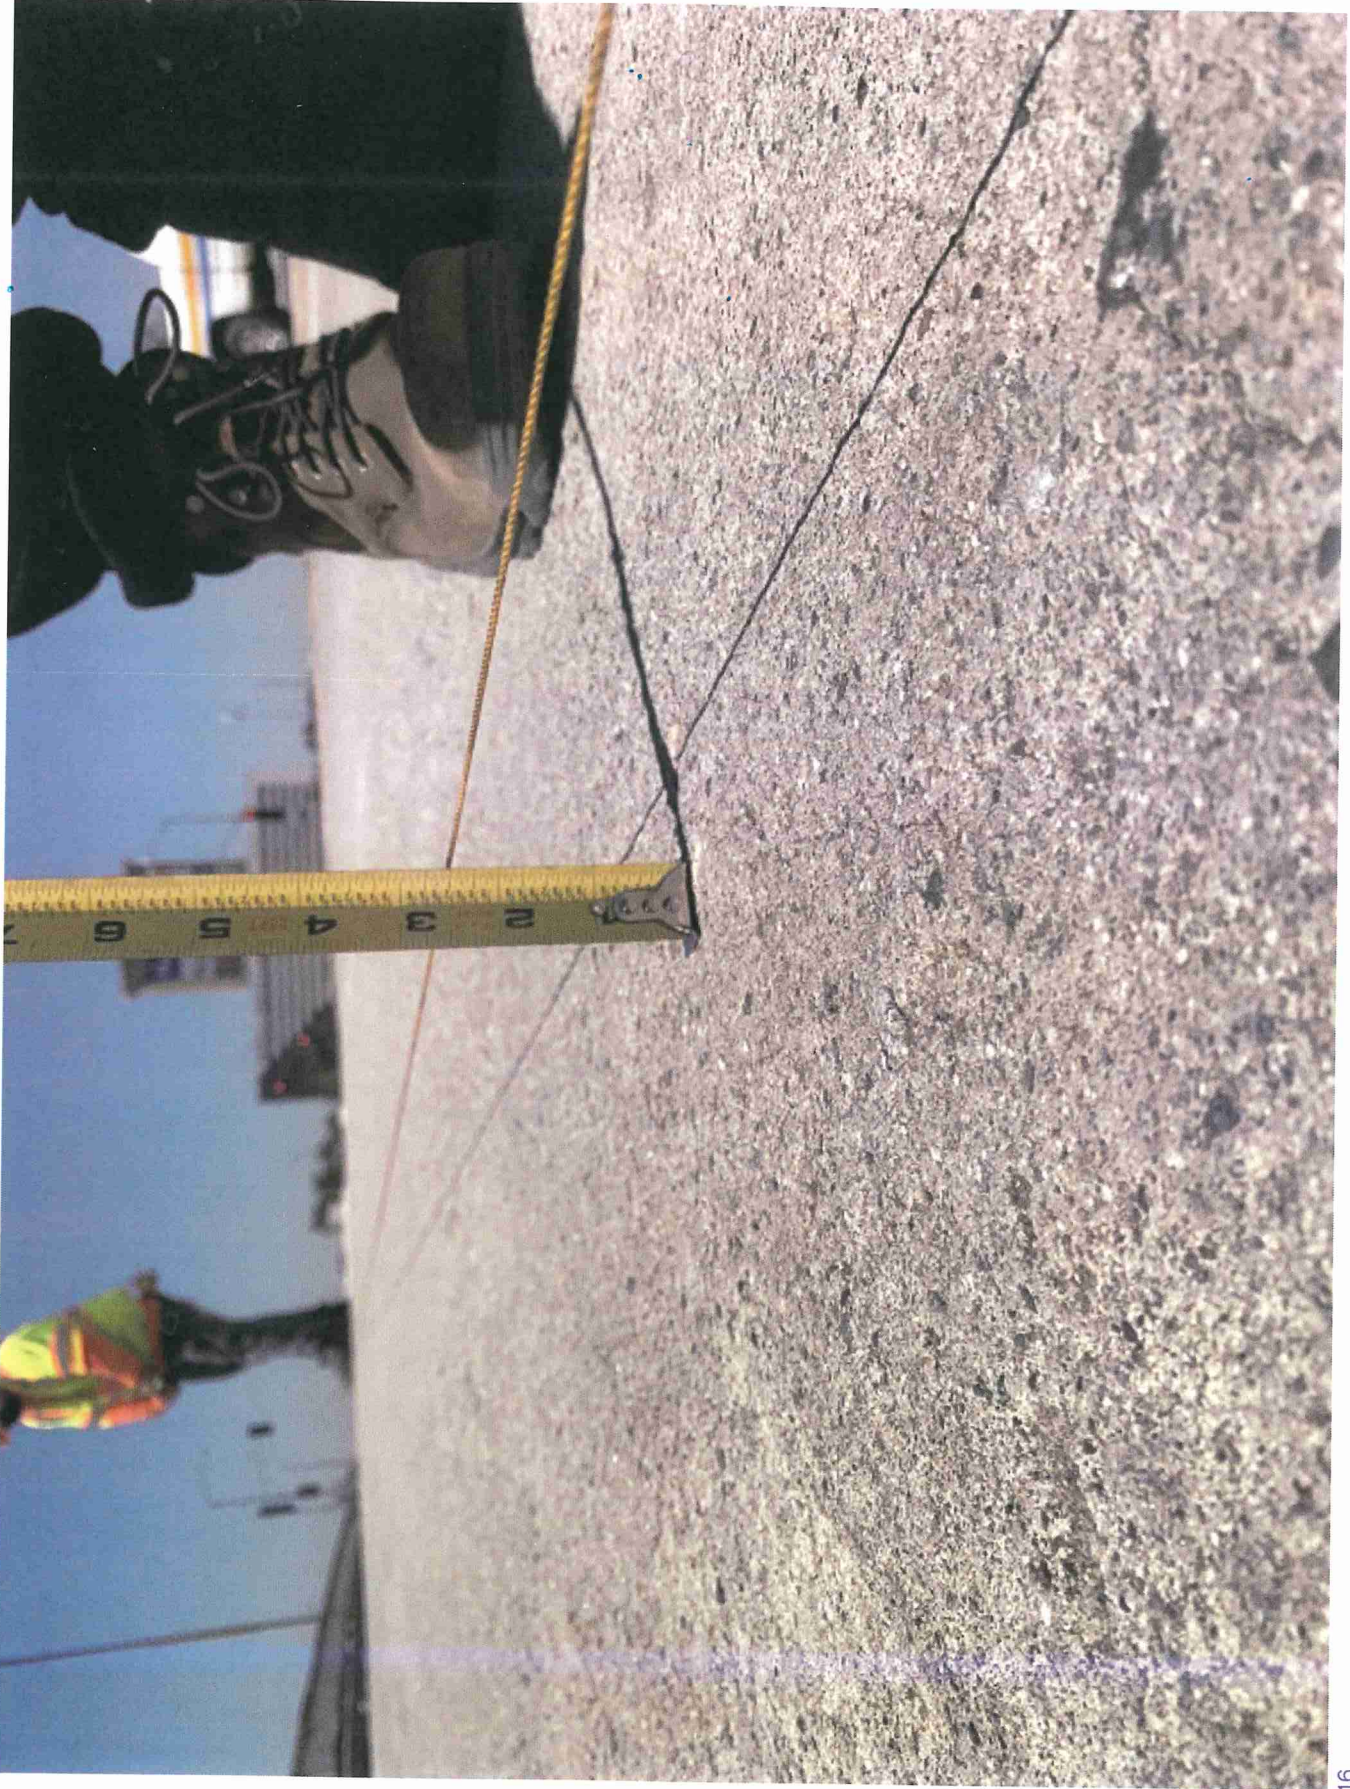
| Elem No. | Defect/Prot Defect | Element Description | Env | Total Qty | Units | Qty in each Condition State | | | |
|---|---|---|---|---|---|---|---|---|---|
| <p>Many scupper drains along the deck surface are plugged with debris. (06/10/2003). (Verified 06/08/2021)</p> <p>Fire damaged the steel girders in span 10, between pier 10 and east abutment and caused the south half of bride deck bulkled up to 2.5 inches. (04/19/2020)(Verified 06/08/2021)</p> | | | | | | | | | |

Photo 16
Buckling of Roadway

However, southside of the roadway of deck above the burn area appeared in distressed and distorted. There was ½-inches gap at the east abutment joint with ½-inches displacement upward of the deck. There was also ½-inches gap at the pier 10 joint with ½-inches displacement upward of the deck. After careful observation and measurement, the roadway portion of southside was found to be concaved down 2.5 inches. (4/19/2021)

| Replace south half of bridge deck in span 10, between pier 10 and east abutment. | | | | | | |

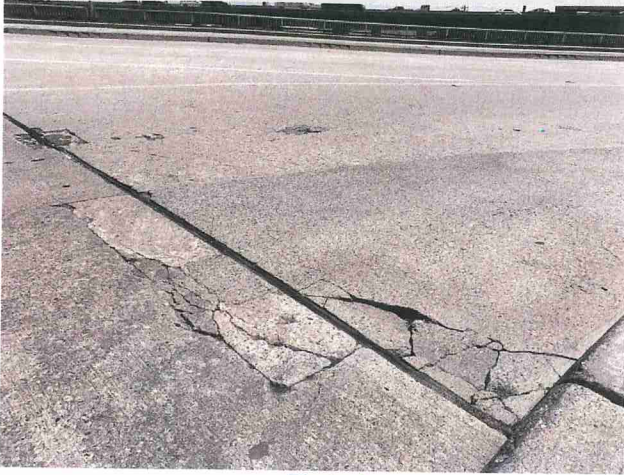
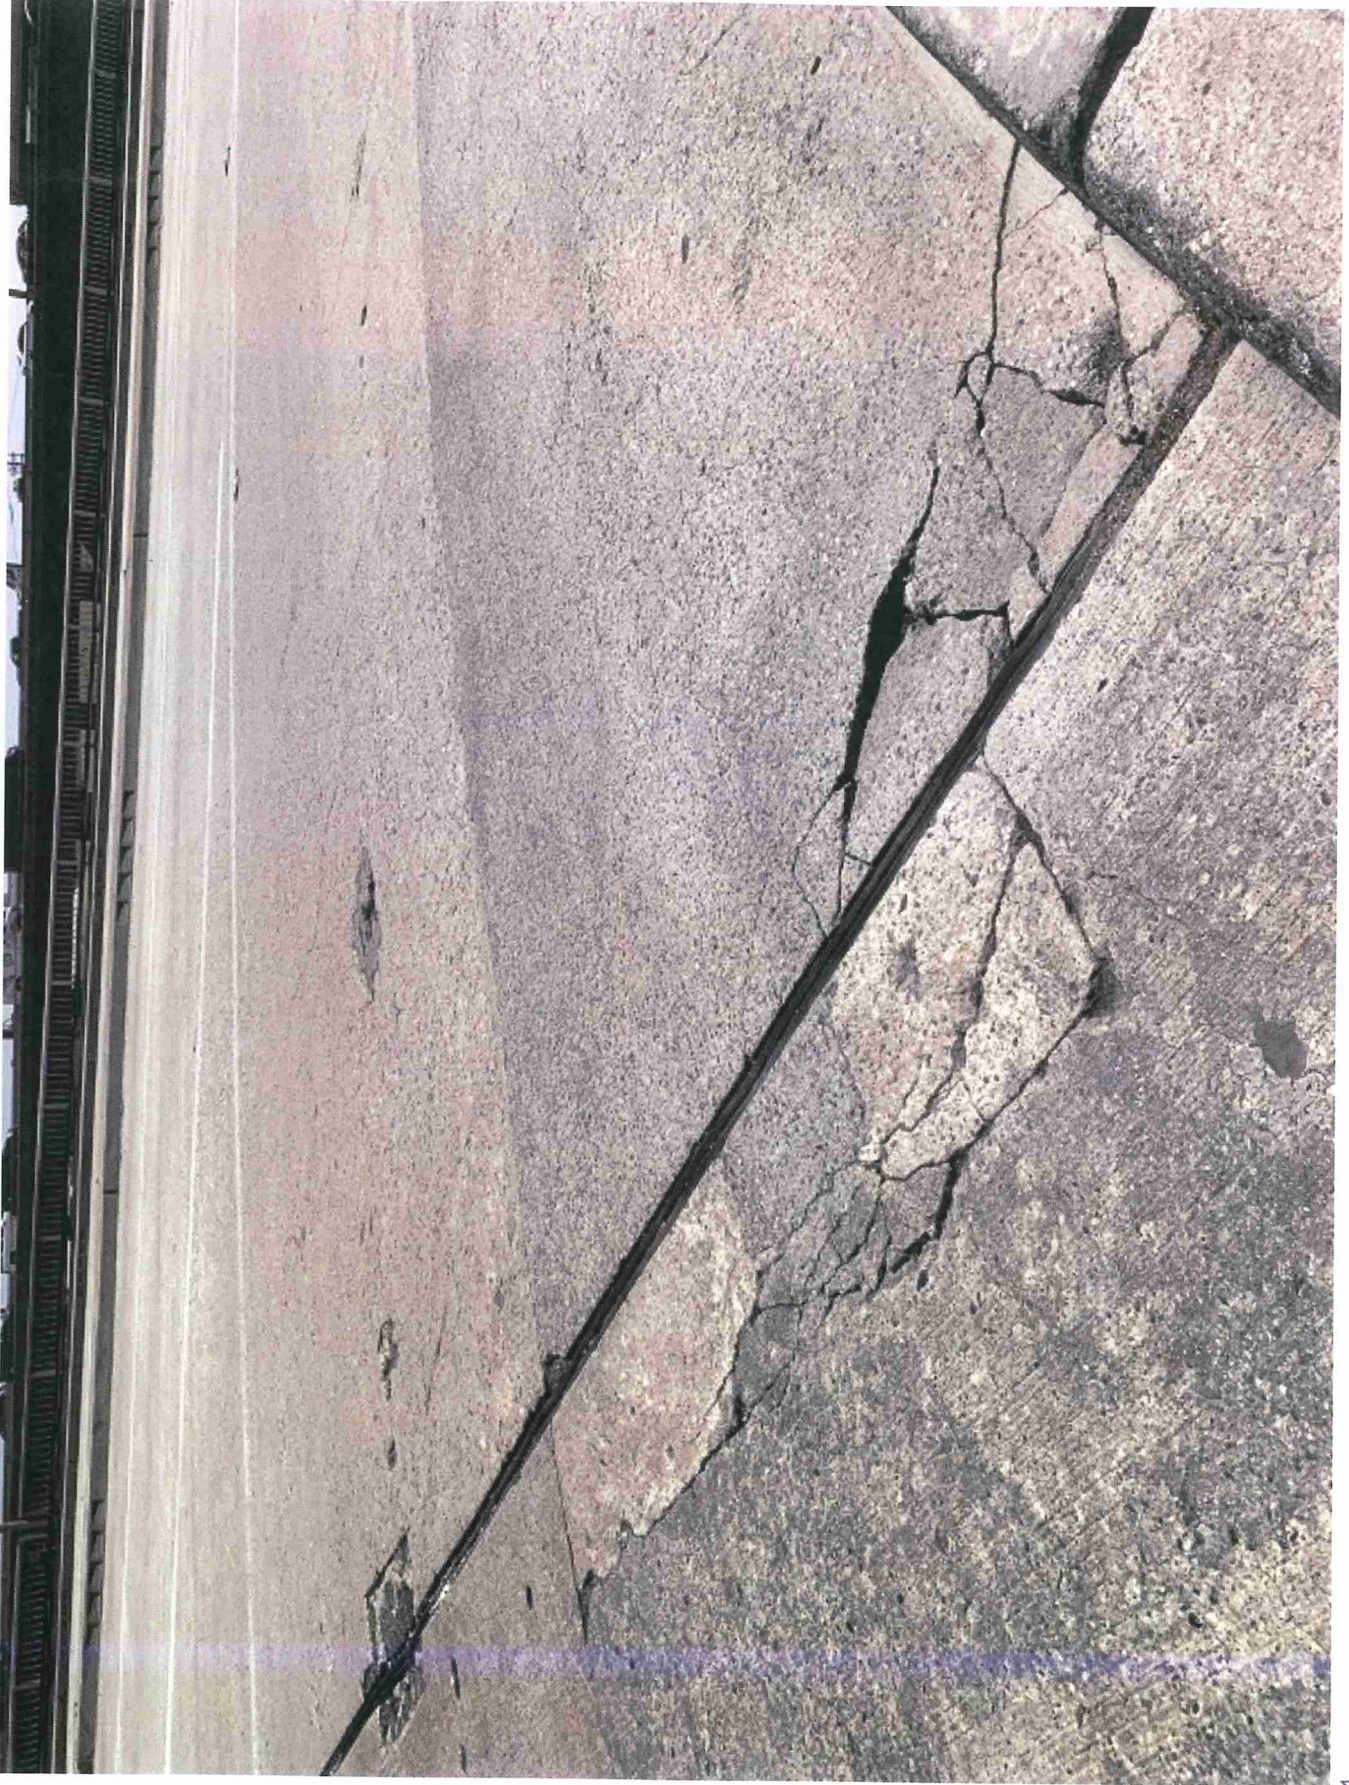
Photo 4
Joint Spalls

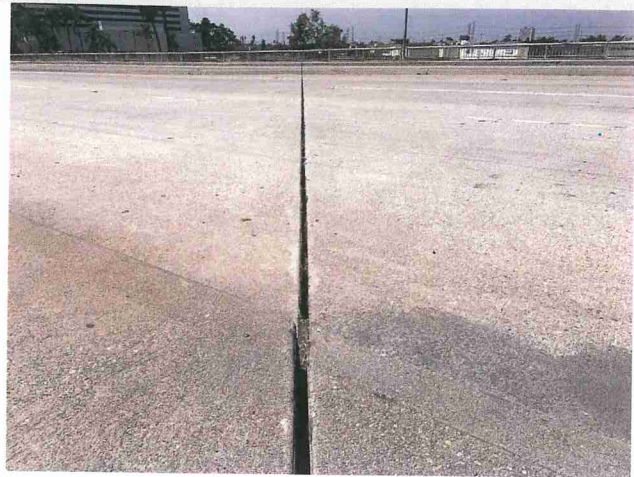
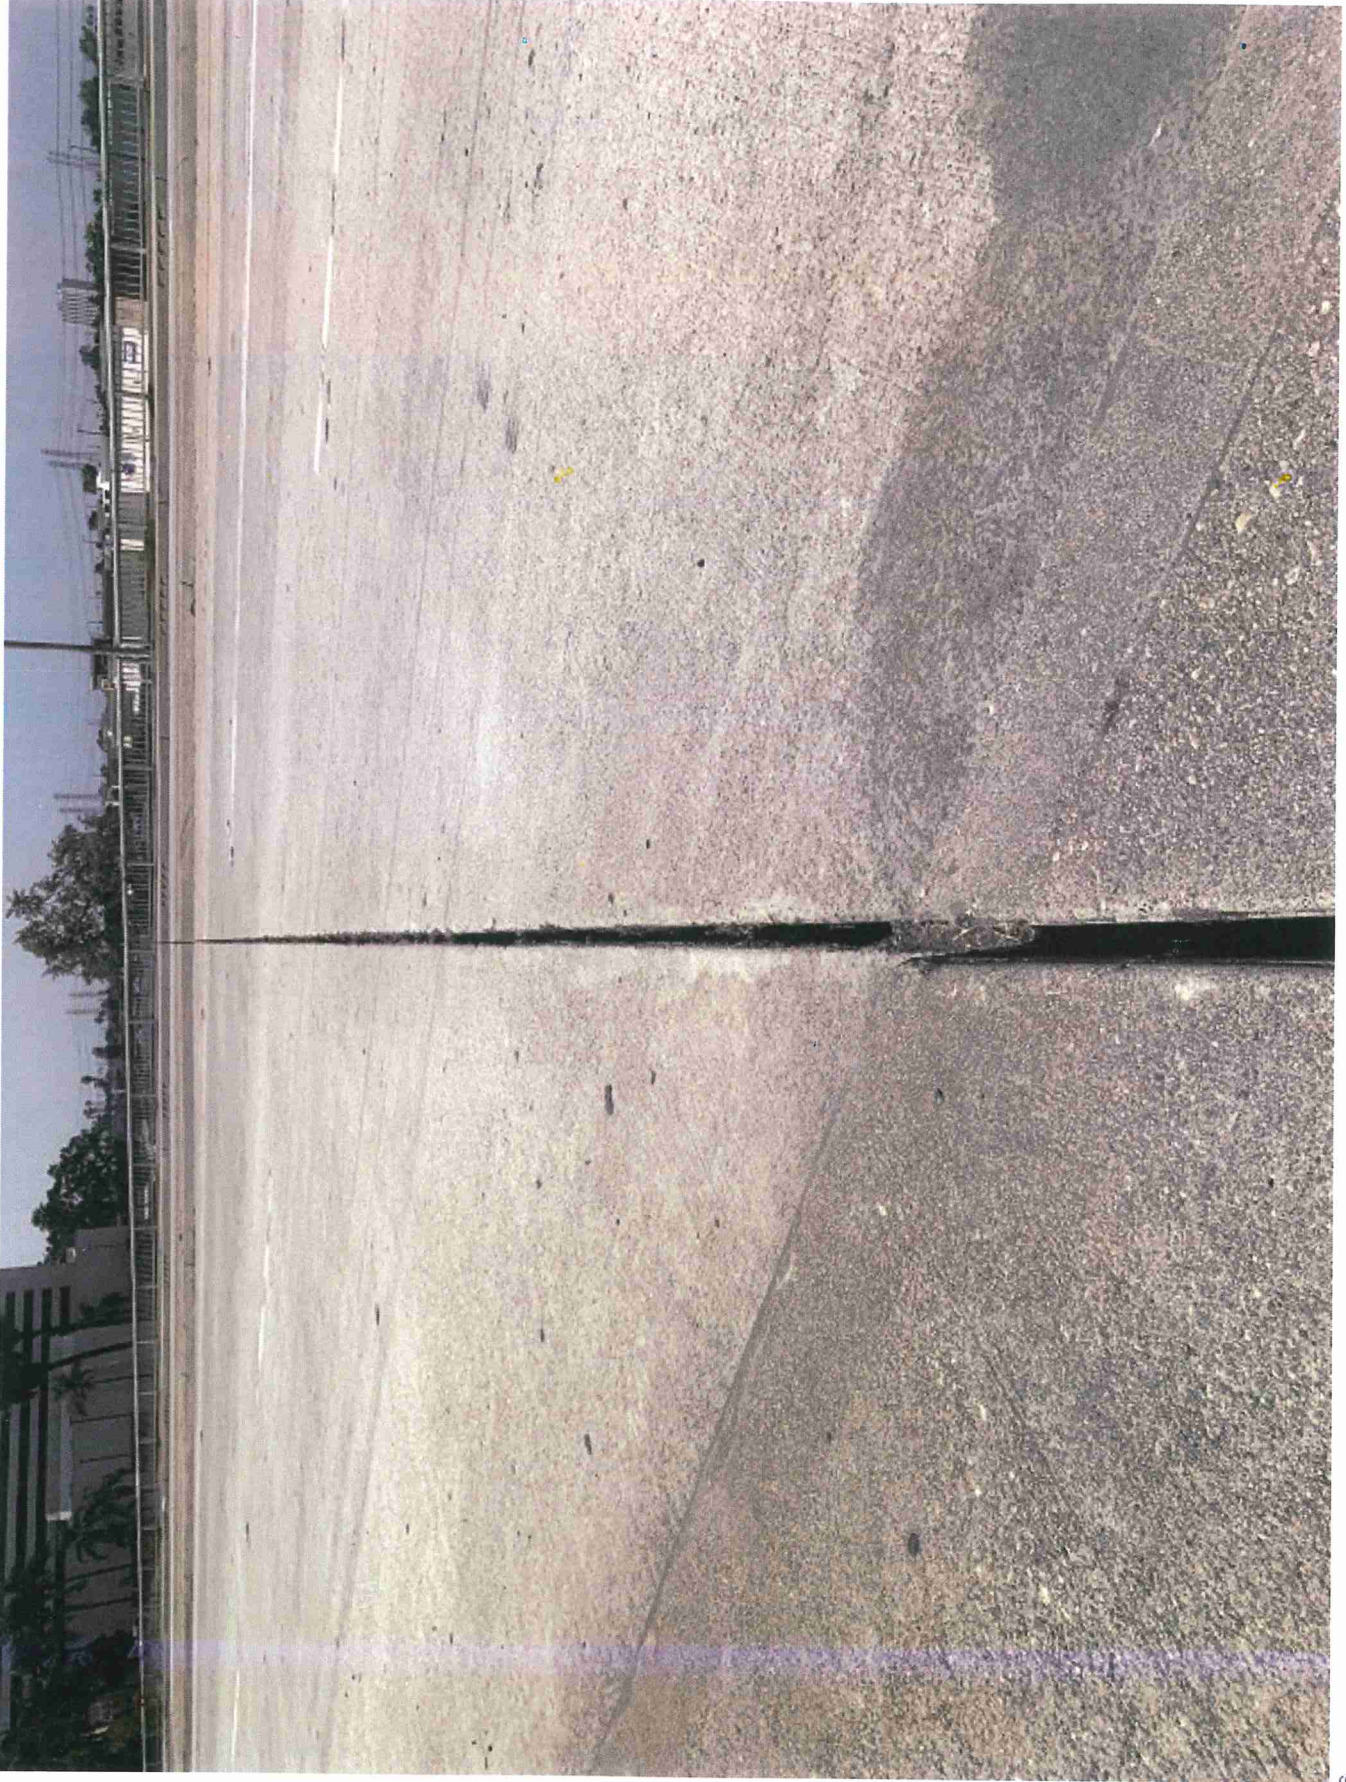
| Elem No. | Defect/Prot Defect | Element Description | Env | Total Qty | Units | Qty in each Condition State | | | |
|---|---|---|---|---|---|---|---|---|---|
| (301-2310) Leakage (Joints) The pourable joint seal has failed and large sections of the seal are missing. (05/04/2011) (Verified 06/08/2021) | | | | | | | | | |

Photo 6
Missing Joint Seal

| Clean the expansion joints and replace the sealant. | | | | | | |

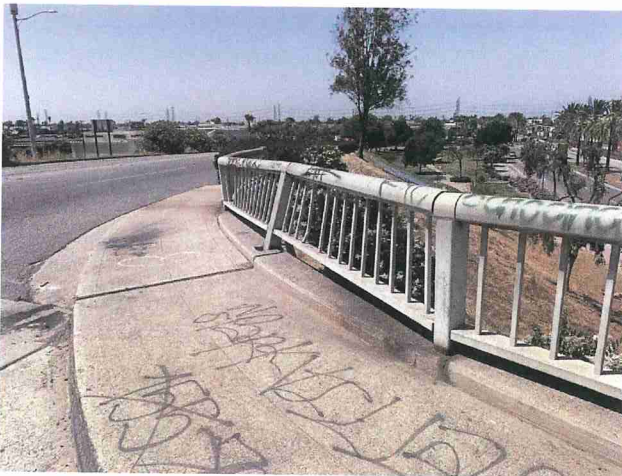
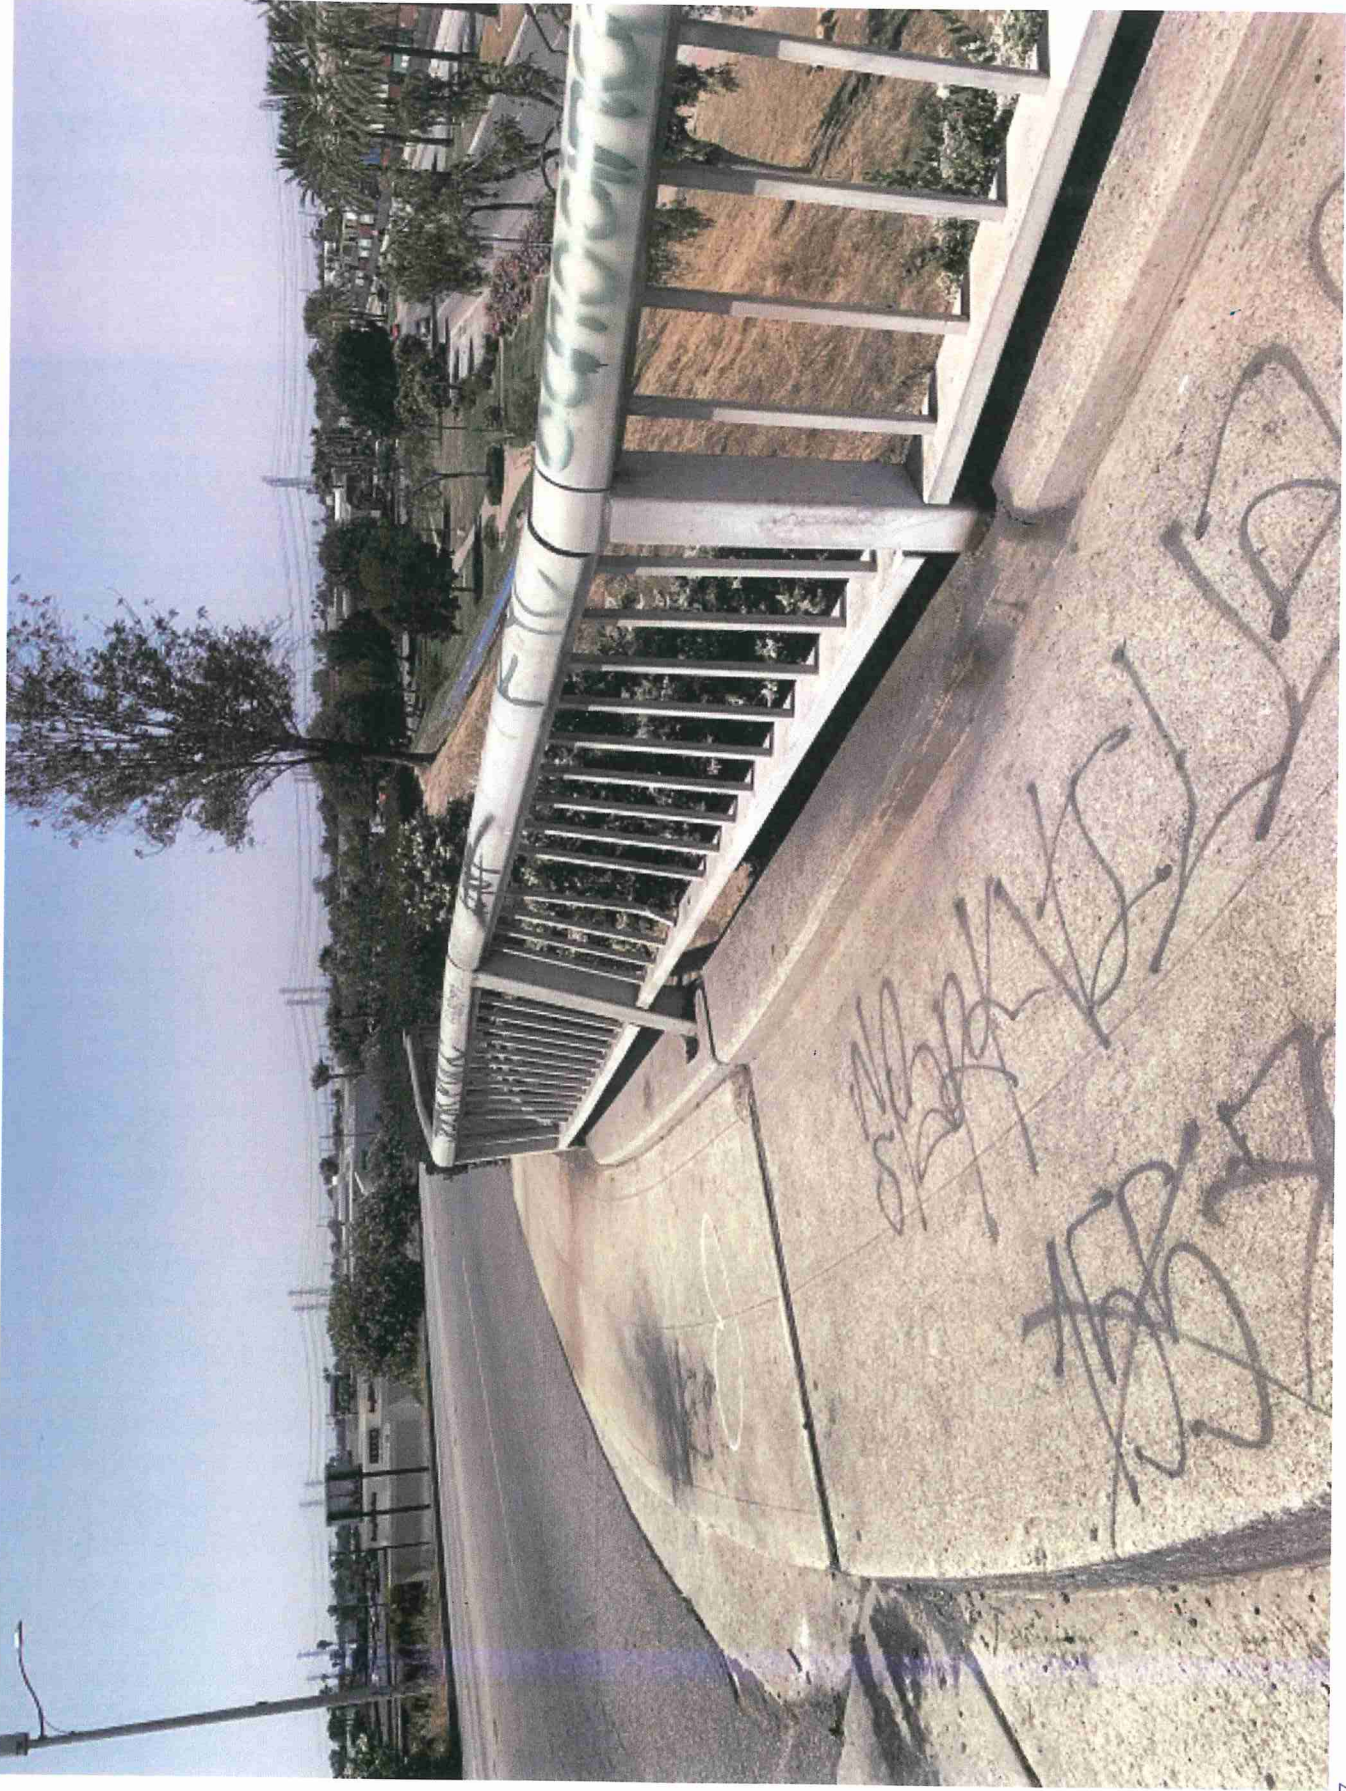
| Elem No. | Defect/Prot Defect | Element Description | Env | Total Qty | Units | Qty in each Condition State | | | |
|---|---|---|---|---|---|---|---|---|---|
| Two sections of the metal handrail at the northeast corner of the intersection with the Alameda Street ramp have been damaged. (01/29/1990) (Verified 06/08/2021) | | | | | | | | | |

Photo 7
Damage Section of Bridge Rail

| Repair the bridge rails. | | | | | | |

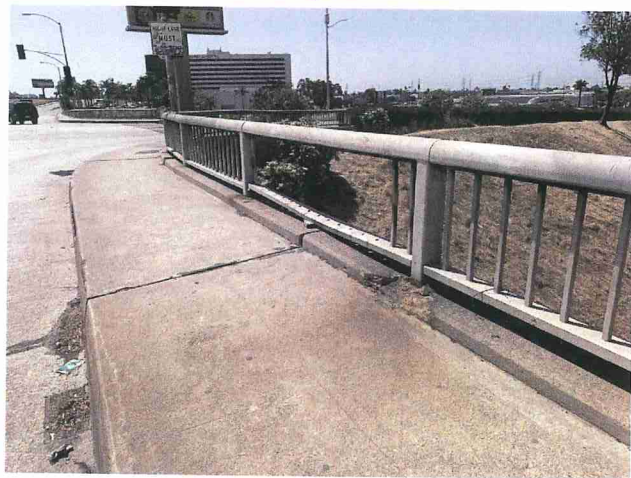
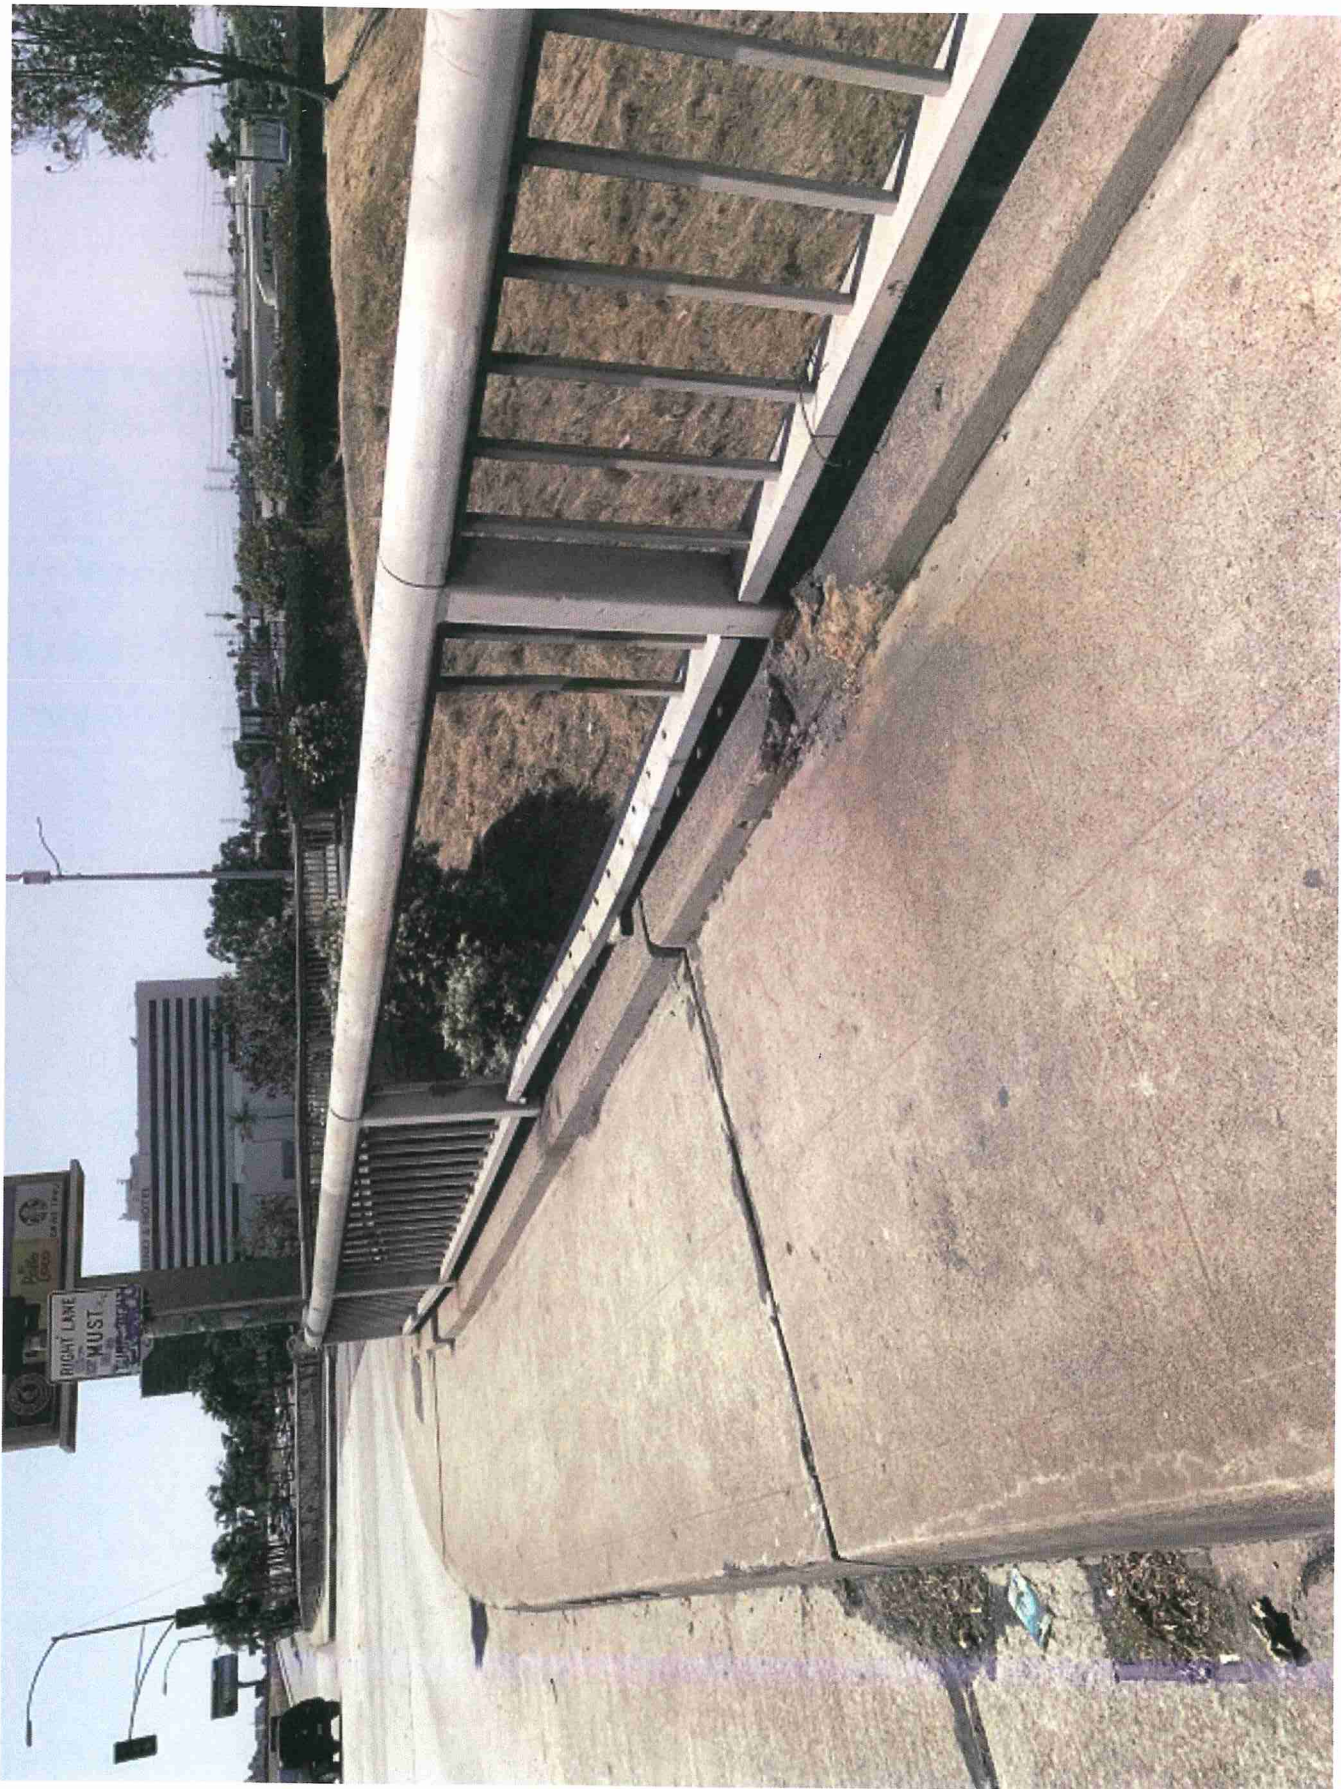
| Elem No. | Defect/Prot Defect | Element Description | Env | Total Qty | Units | Qty in each Condition State | | | |
|---|---|---|---|---|---|---|---|---|---|
| Fourteen consecutive square balusters are missing from the north handrail. Two balusters are badly bent. A temporary repair was made but should be repaired correctly. (06/10/2003) (Verified 06/08/2021) | | | | | | | | | |

Photo 8
Missing Balusters
