STRUCTURE RATING DATA SHEET

BRIDGE NO: 53C1744 LA County Br. No : 2446
Facility Carried : ARTESIA BLVD
Location : 0.3MI W/O SANTA FE AVE
BRIDGE NAME: SP/UP,COMPTON CR.ALAMEDA

Name: SP/UP,COMPTON CR,ALAMEDA
 Struct-Def: Bridge Span Ten (Fire Damage 2020)

Fire Damage Inspection

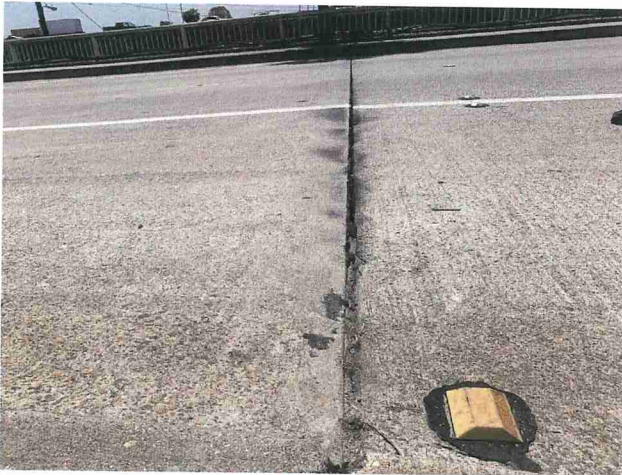
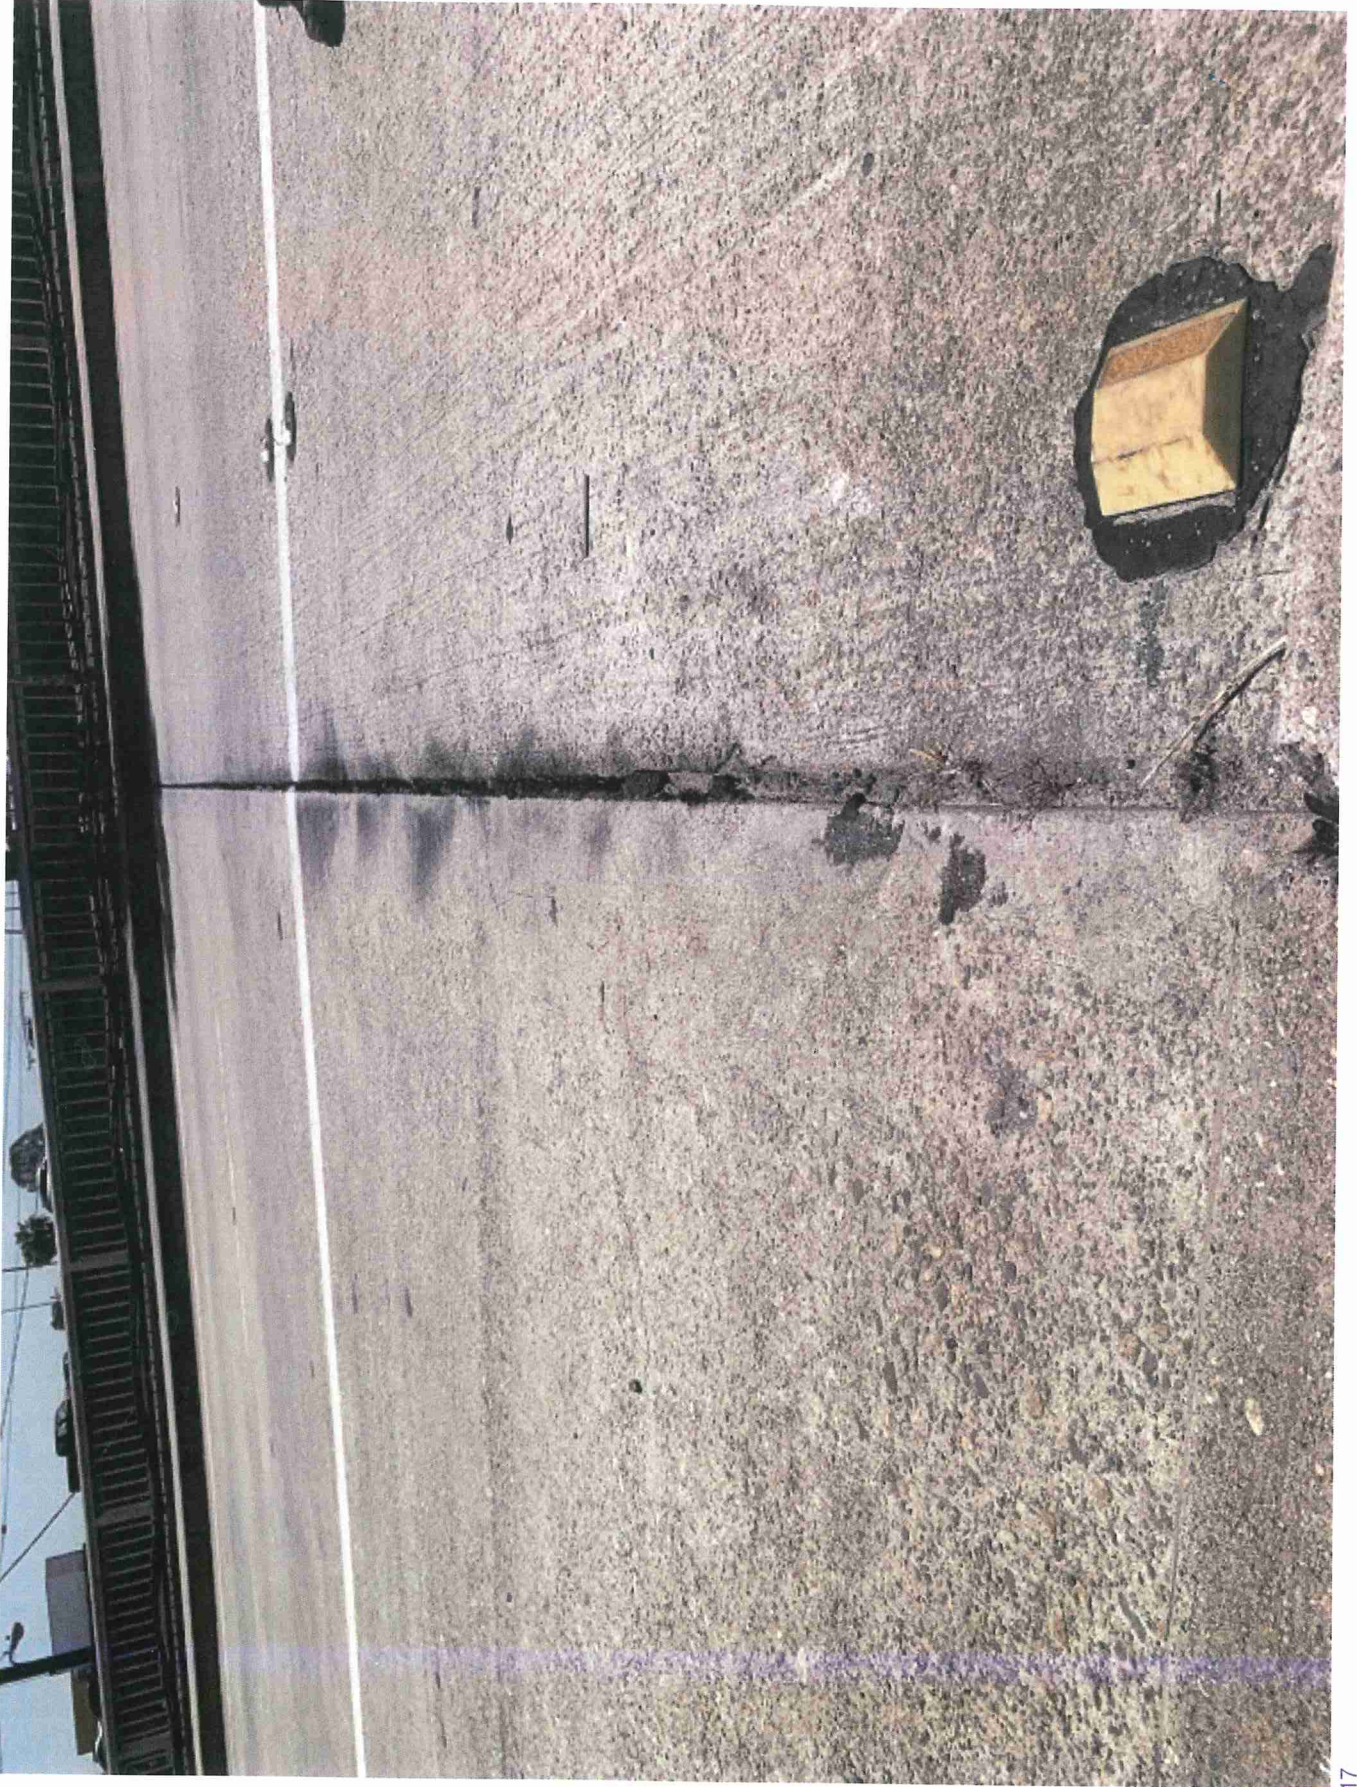
| Elem No. | Defect/Prot Defect | Element Description | Env | Total Qty | Units | Qty in each Condition State | | | |
|---|---|---|---|---|---|---|---|---|---|
| Compression joint seal in east abutment were damaged by fire. (04/19/2021)(Verified 06/08/2021) | | | | | | | | | |

Photo 17
Burned Expansion Joint

| Clean the expansion joints and replace the sealant. | | | | | | |

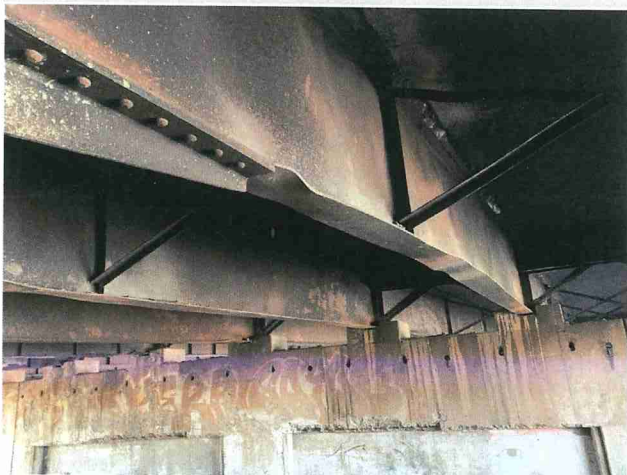
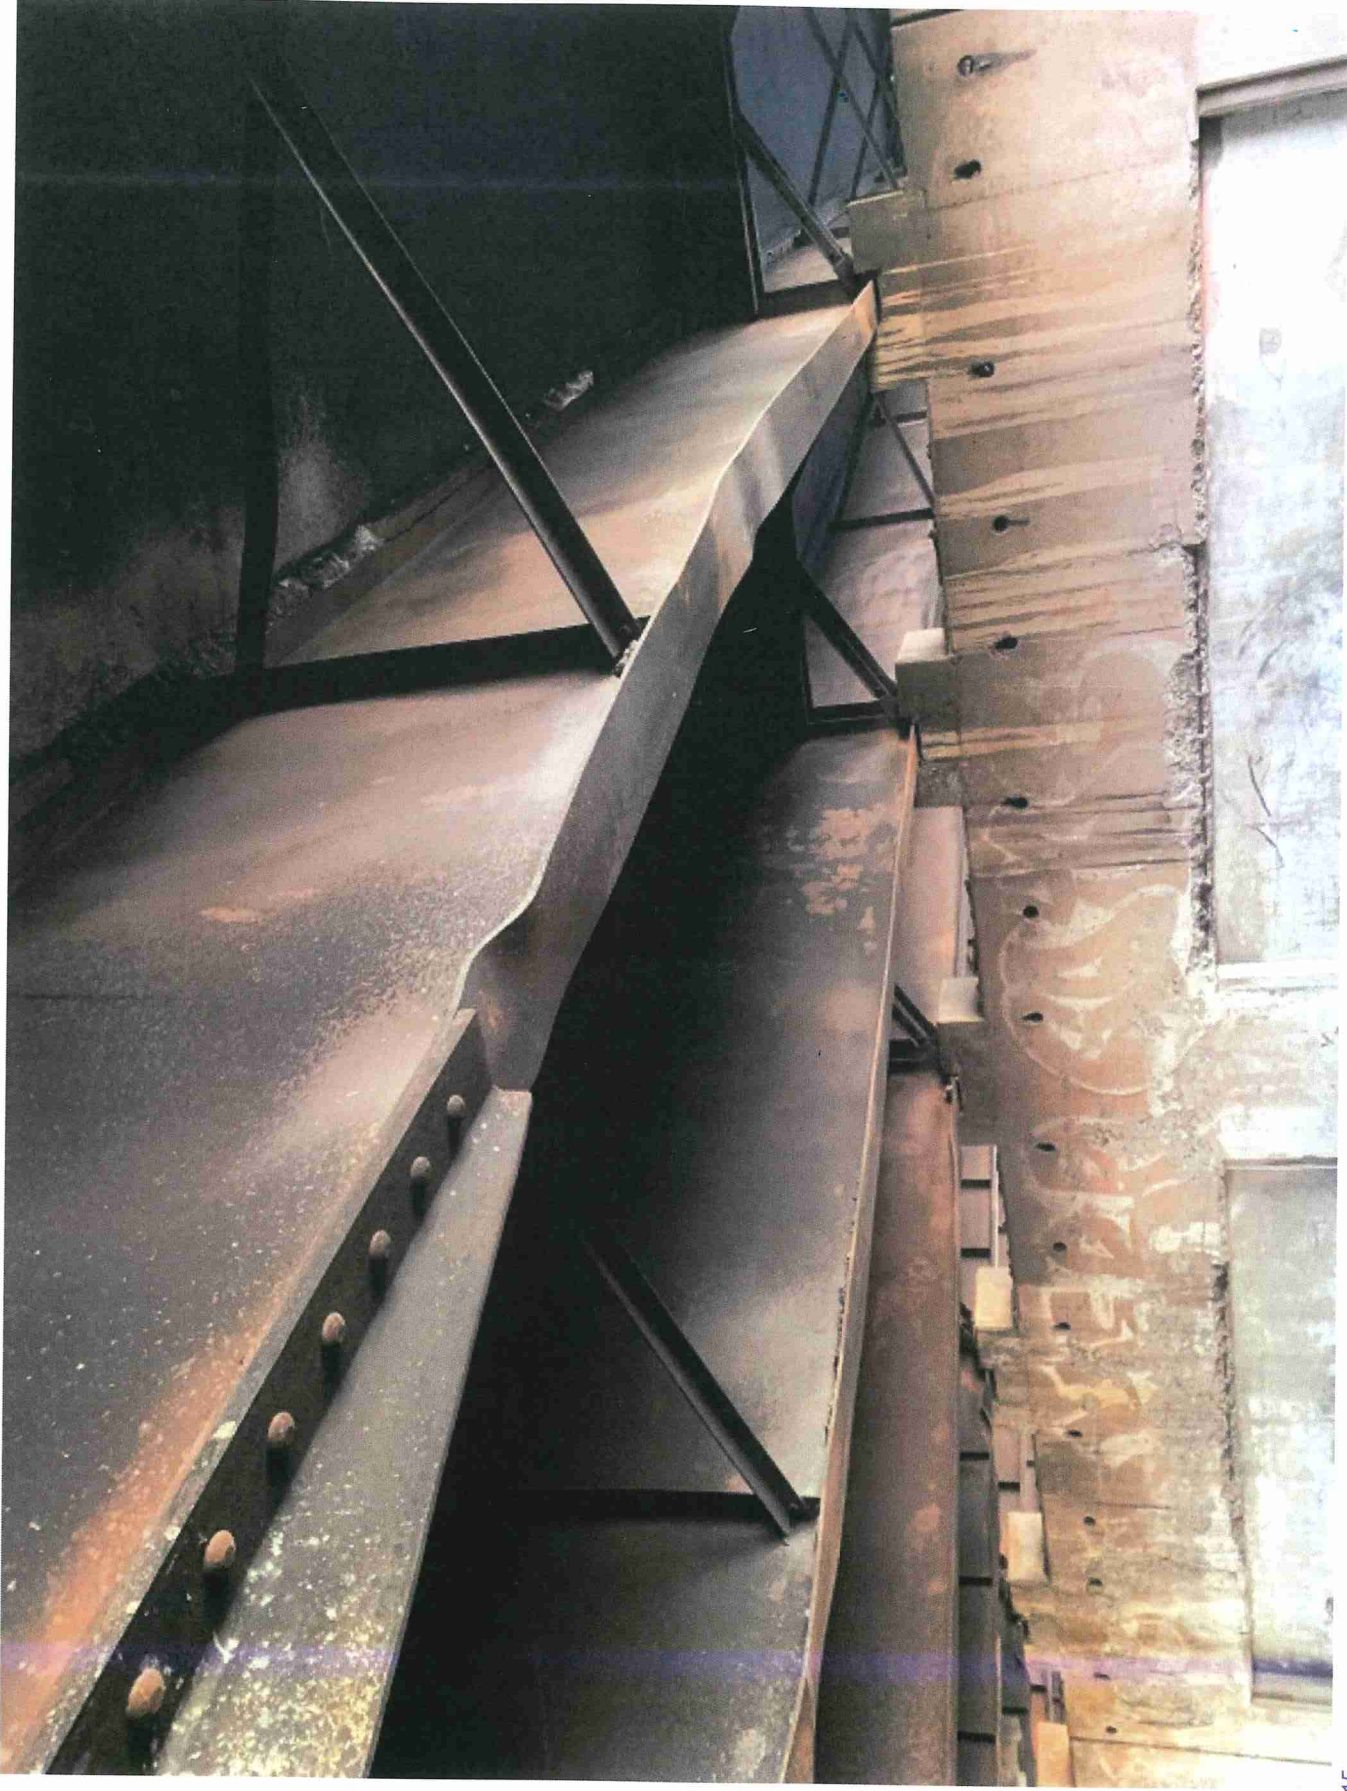
Photo 15
Distorted Lower Flanges and Girder Bracings

Distorted Lower Flanges and Girder Bracings

The fire distorted the all the girders except girder 11 (South end). The distortion includes lateral curving of the lower flange and bulging of the girder web between stiffeners. The web stiffeners appear to have failed to maintained the vertical dimension of the girders in south side of the span. Spalling of the haunch along the top flange of the girder was observed.

| Replace damaged girders (girder #1, 2, 3, 4, 5, 6, 7, 8, 9, 10) in span 10, between pier 10 and east abutment, | | | | | | |

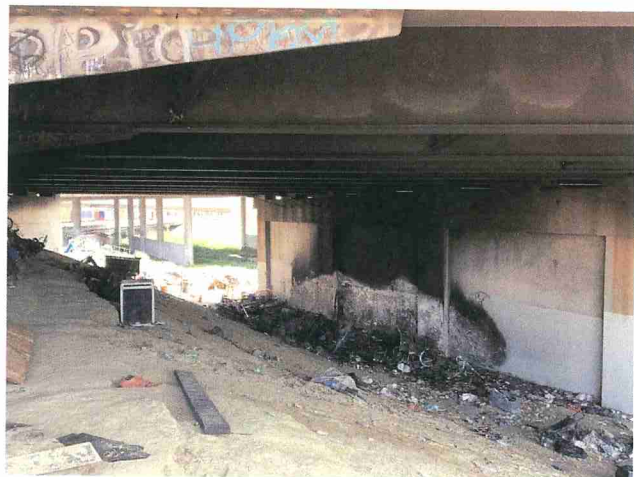
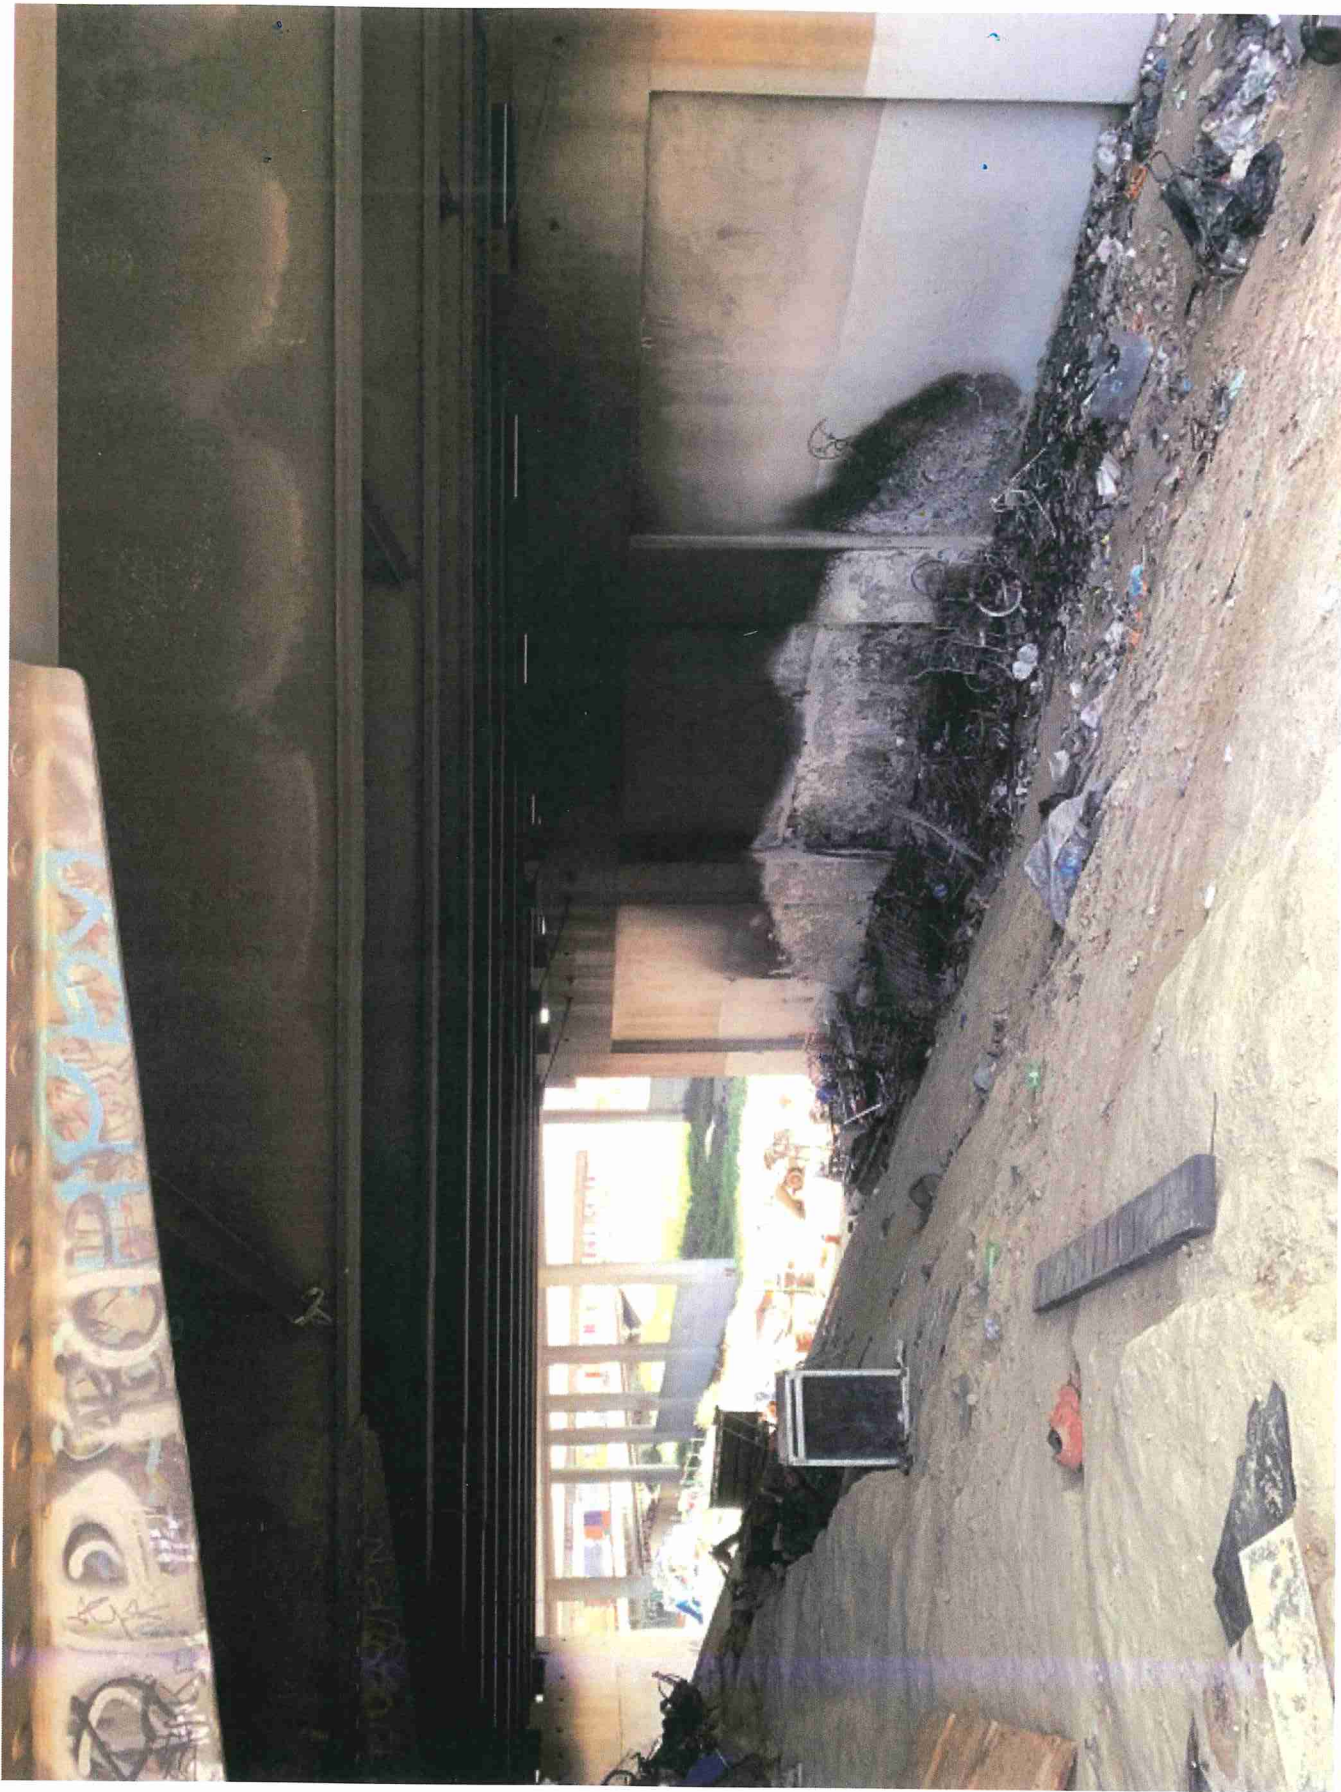
Photo 14
Remains of Burned Trashes

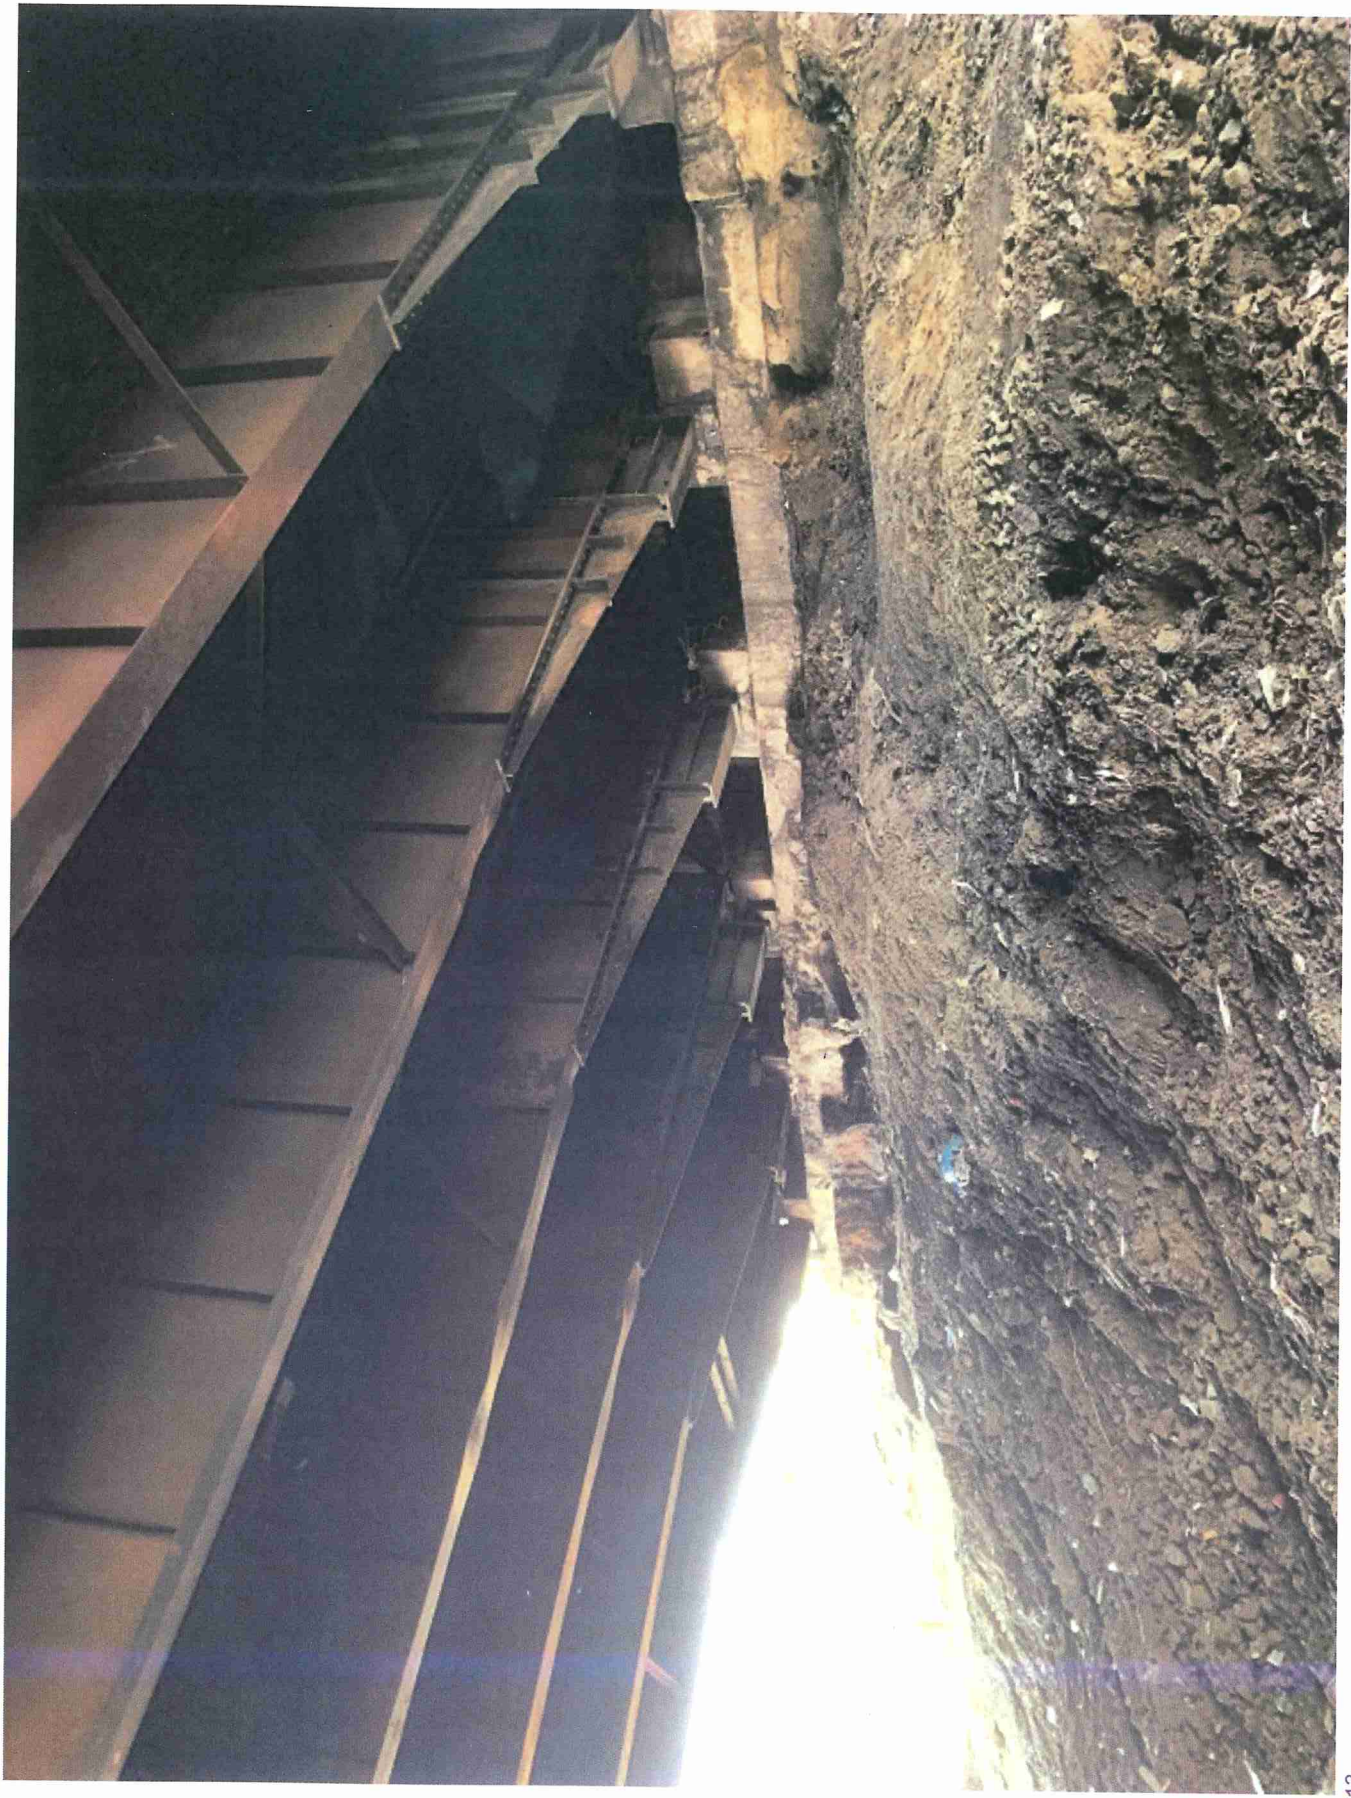
| Elem No. | Defect/Prot Defect | Element Description | Env | Total Qty | Units | Qty in each Condition State | | | |
|---|---|---|---|---|---|---|---|---|---|
| (215) Abutment-RC No significant issues were observed. There were fire burned marks on east abutment. No other defect were observed. (04/19/2021) | | | | | | | | | |

Photo #13
East Abutment Fire Site

| Repair slope protecting east abutment. | | | | | | |

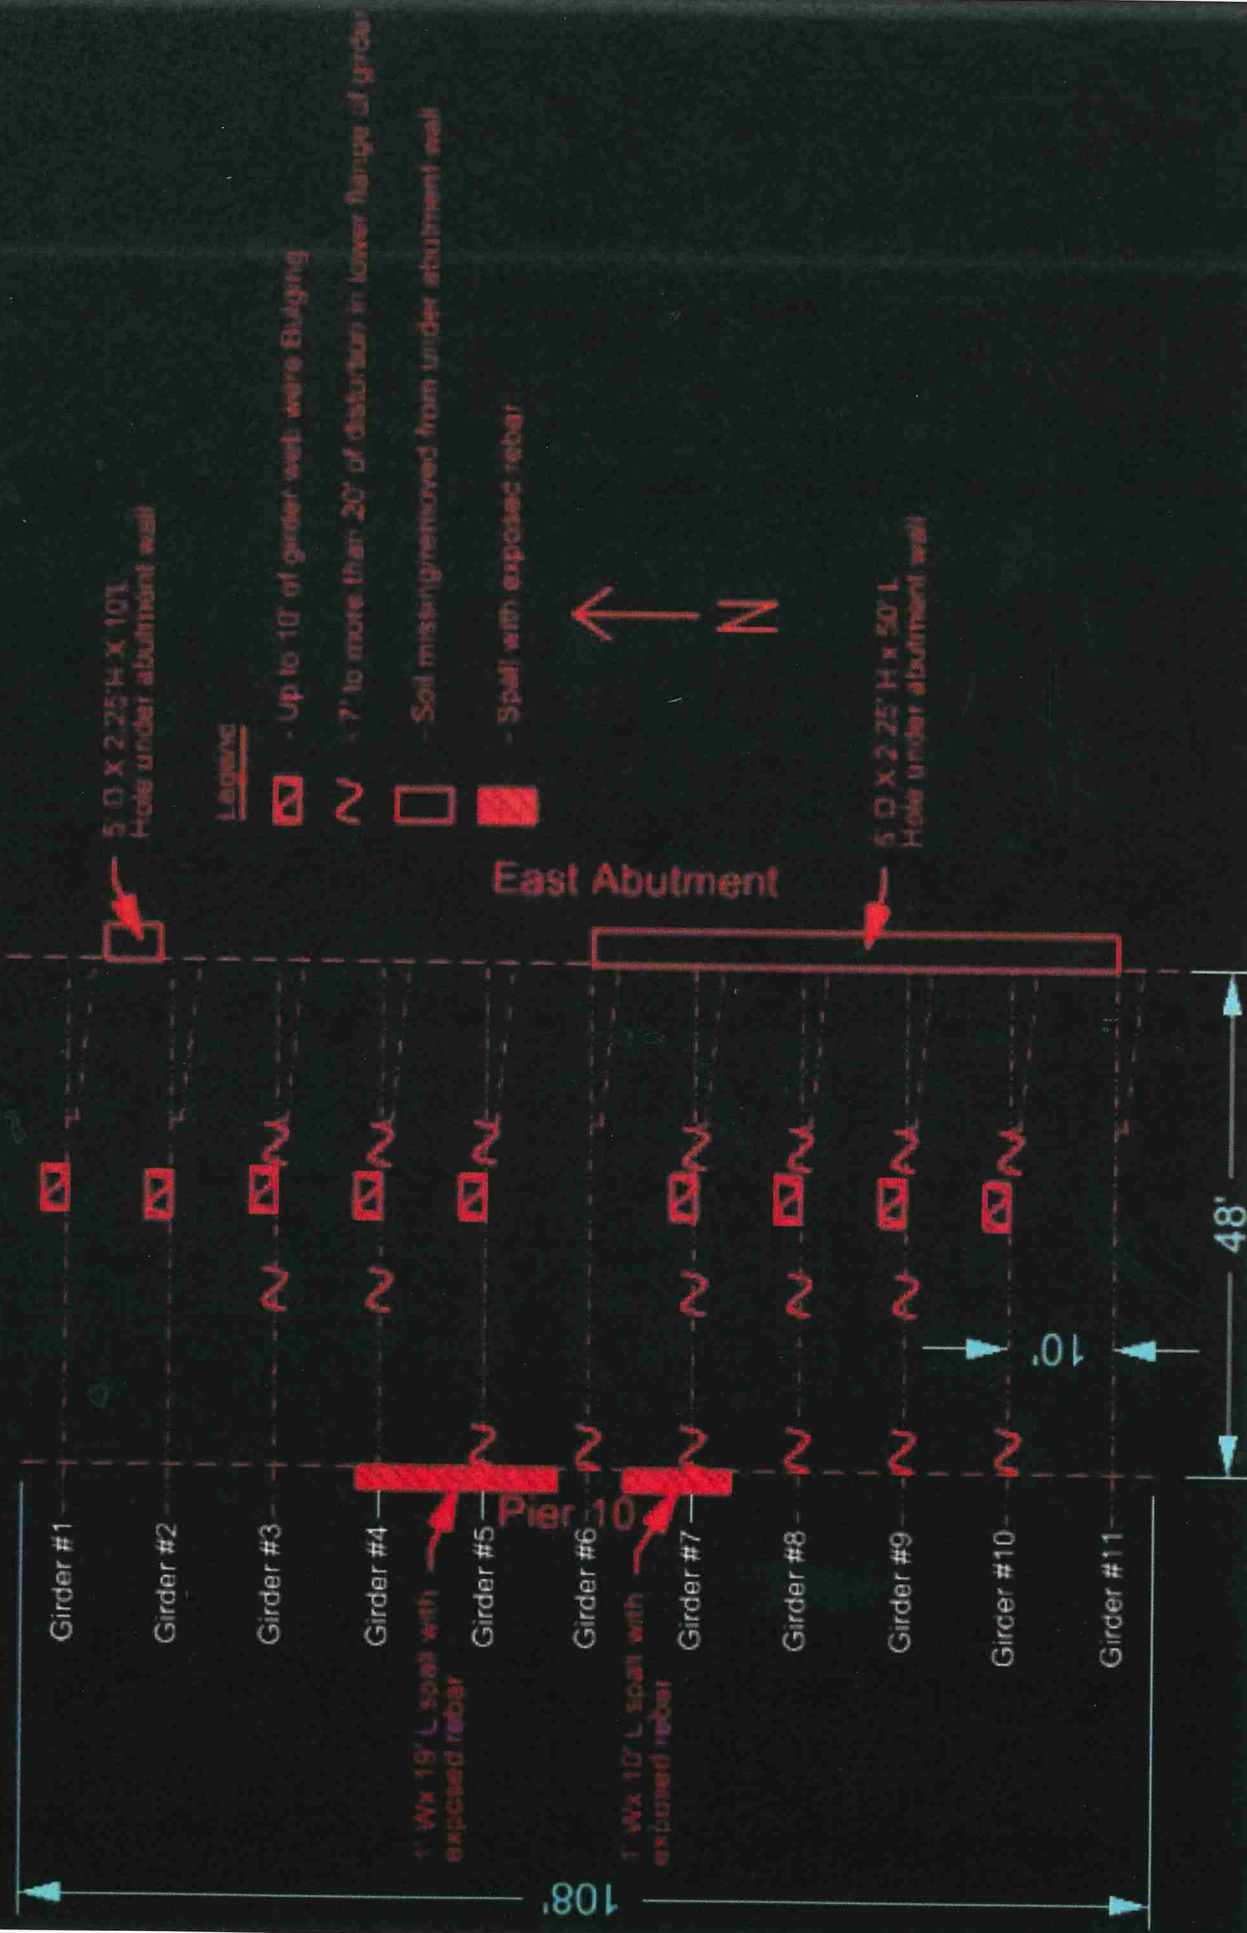
SKETCH (4/19/2021) INSPECTION - 53C1744

More than 50 percent of east face pier cap was covered with facial spalls. Also, there were two large spalls on lower edge of pier cap.

One spall had 1 foot in diameter with 10-foot L and another had 1 foot in diameter with 19 feet.

Soil loss were found in bay 1, 6, 7, 8, 9 and 10. Bay 1 (between girder 1 and girder 2) had 5 feet D x 2.25 feet H x 10 feet L of soil losses and bay 6 to bay 10 (between girder 6 and girder 11) had 6 inches to up 5 feet D x 4 inches to up to 2.25 feet H x 50 feet L of soil removed under abutment wall.

Whole area (48 feet x 108 feet) under span 10 slope needs repair.

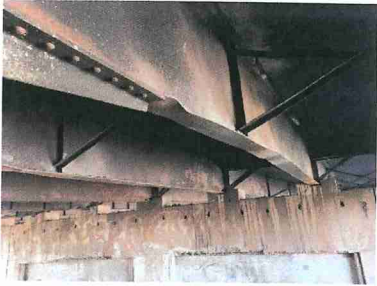
Girder 4- Lower flange and Bay 2 top bracing were distorted

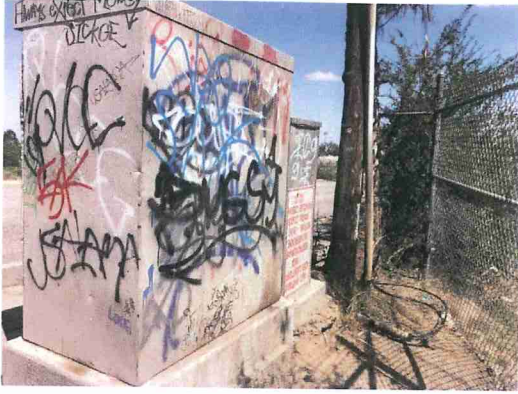
P1_ New panel was installed on damaged utility (Right- on smaller utility box) _ Done

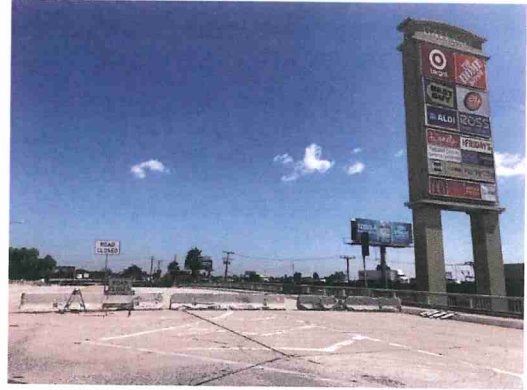
P2_K-Rail was moved back to original position _ Done

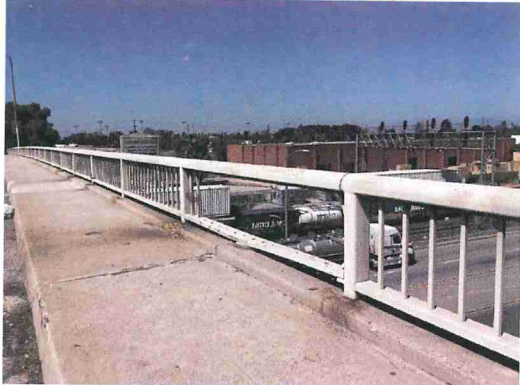
P3_Missing baluster in handrail _ Need repair

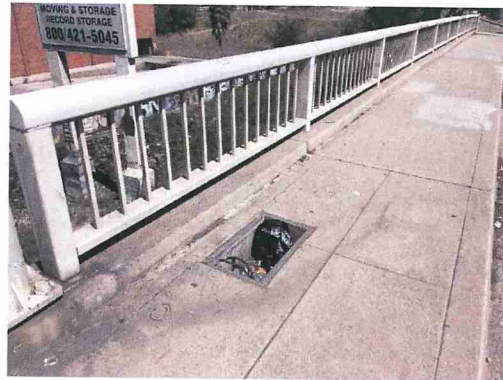
P4a_Missing utility box cover in sidewalk _ Need repair

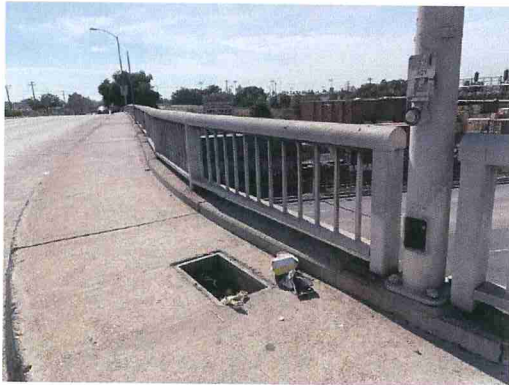
P4b_Missing utility boxes covers in light post and sidewalk (pic from August)

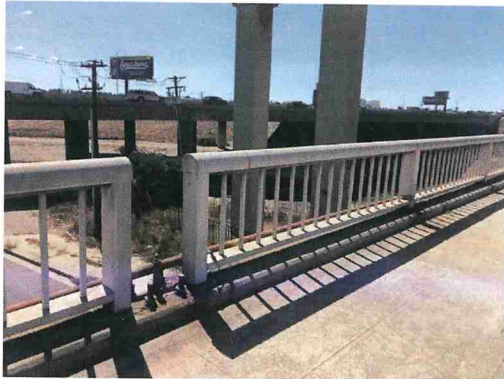
Gap between handrail after utility post was removed _ Need repair (Newfound)
