日本三菱重工(MHI)及荏原製作所(EBARA) 備品製作進度及經驗交流

服務機關:台灣電力公司龍門電廠

出國報告名稱:日本三菱重工(MHI)及荏原製作所(EBARA)備品製作進度及經驗交流

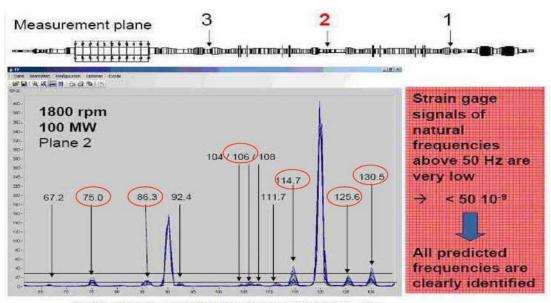
解析度之影響

67.2/75.0/86.3/92.4/104/106/108/111.7/114.7/125.6/130.5/...HZ FIG:1:

threshold value 為 0.03 µ m/m·在 65~135HZ 之間只能看到 114.7 及 130.5 HZ 兩個自然頻率・但若 改以 0.01 µ m/m(=10^8)為 threshold value・則可看到 75.0/86.3/106/114.7/125.6/130.5/...HZ・ threshold value 至少至 0.002 µ m/m(=2X10^9)。 11-01-11;09:55 ;MHI高砂受注G 原輸2G

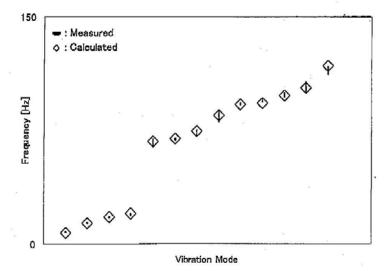
Figure.1 Measurement result of torsional vibration test with Magnetic Probe

Action Item	Answer
1	MHI will submit the measurement result of torsional test which was used both Magnetic Probe and	As a result of search, it found the measurement data is not stored.
	Telemetry.	The measurement in question was carried out more than 30 years ago. By the successful measurement result, we confirmed reliability of the measurement with electromagnetic probe, we are using the measurement method as our standard since then.
2	MHI will submit the past field measurement result in order to show that the electromagnetic probe method can detect all torsional natural frequencies.	Figure.1 shows the result of the field torsional test measured with electromagnetic probe at one 1200MW class nuclear power plant. The measurement was carried out during no load to rated load in 1986. The measured frequencies have some variation because each frequency was measured at each load and have measuring variation. The measured natural frequencies agree well with calculation, and all natural frequencies are detected by the measurement.

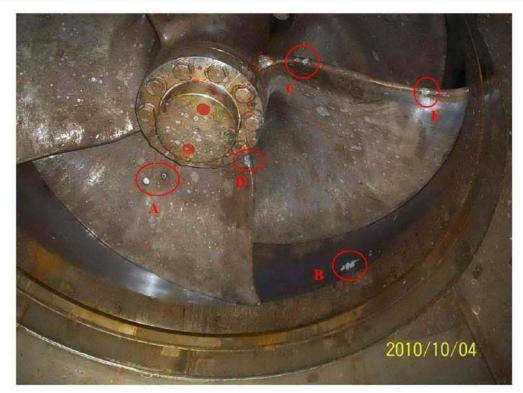
Photo 1

- (1) Impeller Casing 的內面和 Impeller 之間的摺觸面有摺動痕跡,故表面可看到呈現金屬光澤,但和 Impeller 無摺動的地方,其表面呈現污髒的茶褐色。
- (2) Impeller 之翼表面及翼之前端部也無流水痕跡現象且無金屬光澤,並有污髒的茶褐色和海洋生物 (例:貝類等)附著的痕跡等現象。
- (3) 觀察各腐蝕部之內部都有凹凸劇烈的鋸齒現象。

根據 貴公司所提供的照片判斷,此次所發生的腐蝕現象應是孔蝕所造成的。

所以,長時間停機的期間海洋生物附著後,海水轉變成 Stagnant,海洋生物因海水含氧不足後死亡·脫落而導致孔蝕的現象。

- (1) 根據 貴公司的照片判斷,其腐蝕範圍和深度皆屬輕微,泵的機能並無影響,故只需清除孔蝕部後可正常操作使用。
- (2) 敝公司提供給 貴公司的Installation, Operation and Maintenance Manual (Doc. No. R0100141-1170-0133) 資料中的P.24有記載,如何對應泵需長時間停機時的對策,並請遵照資料中的方式維護及操作。如此的話可將泵因海水的腐蝕減至最低。
