Tsunami Impacting Eastern Japan and Preparedness for Extraordinary Natural Disaster

Takehiko Fujita

Executive Director Port and Airport Research Institute, Japan

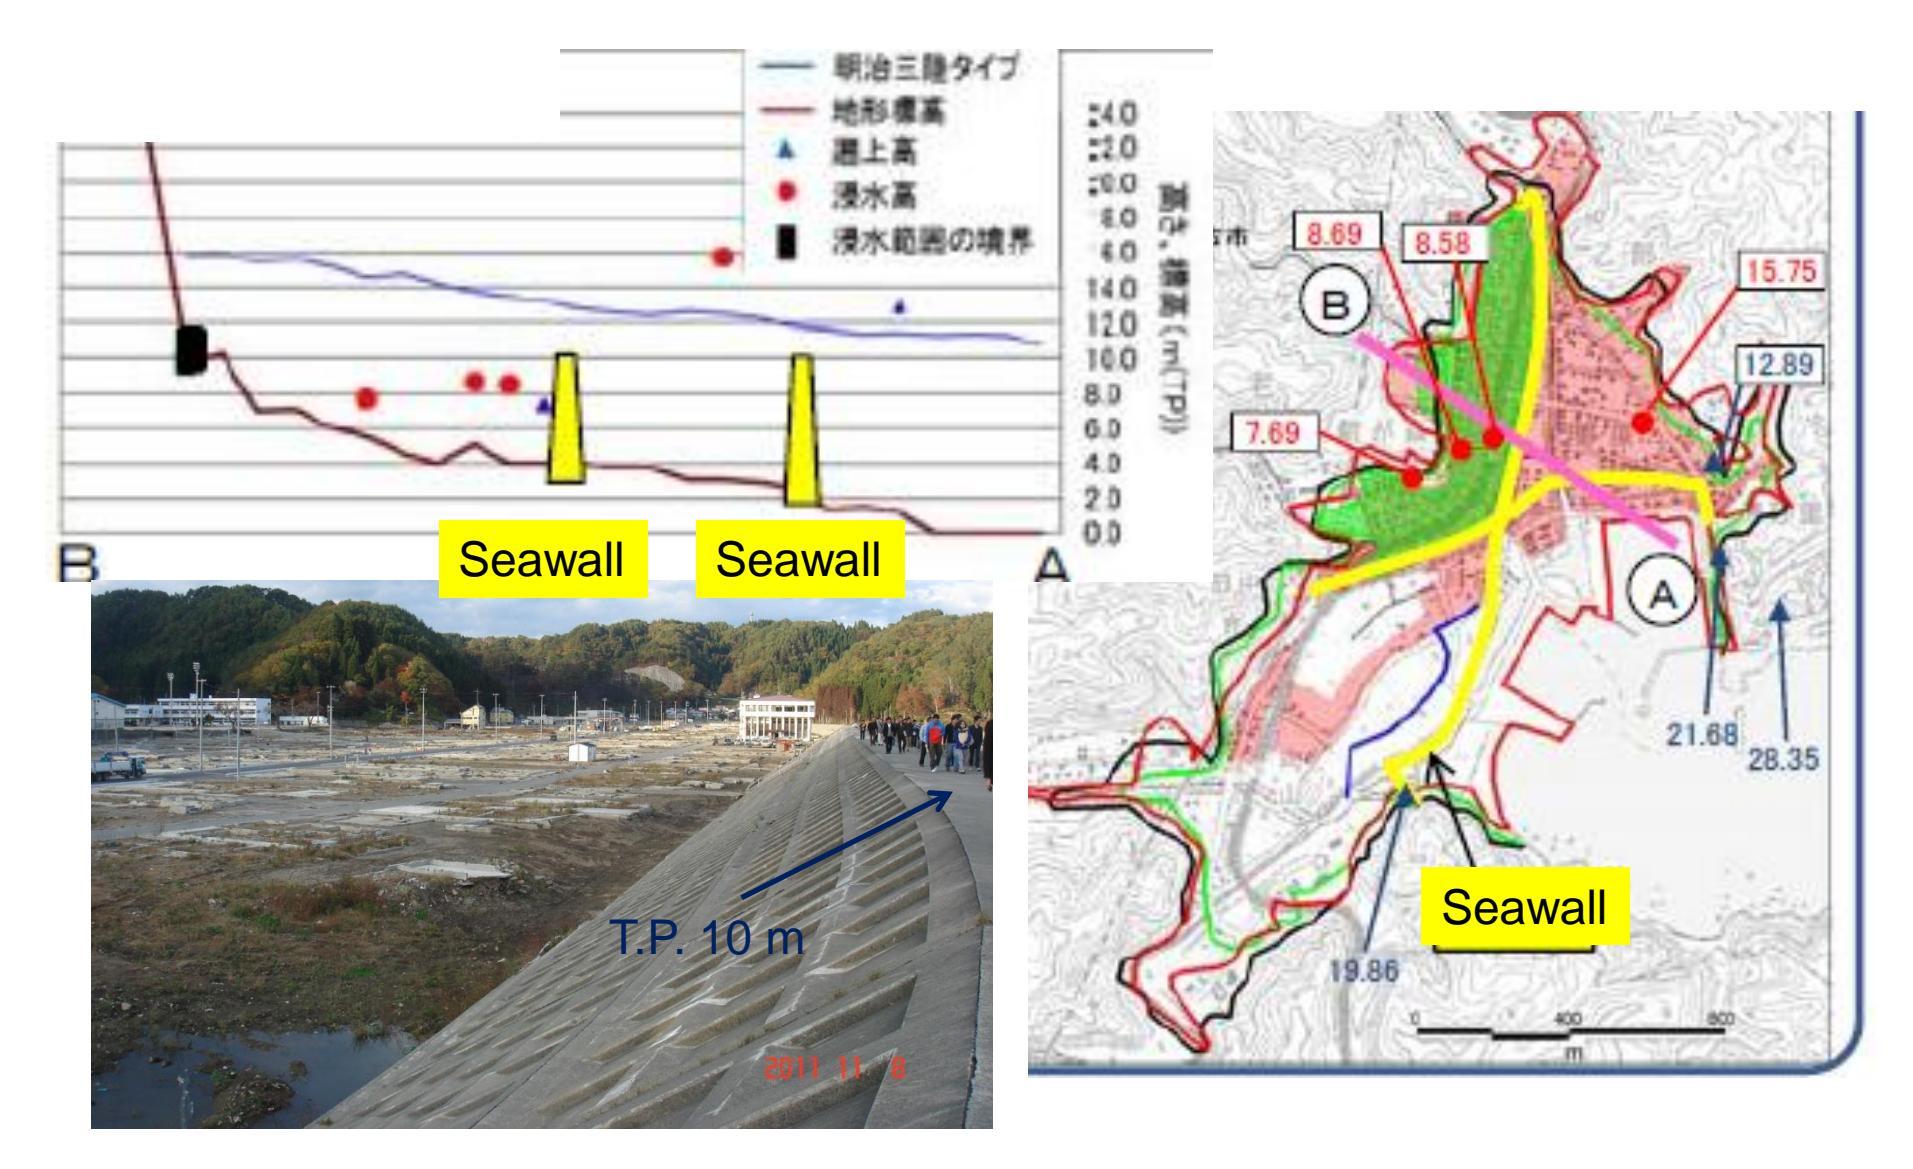
Severe damage at Taro, Iwate

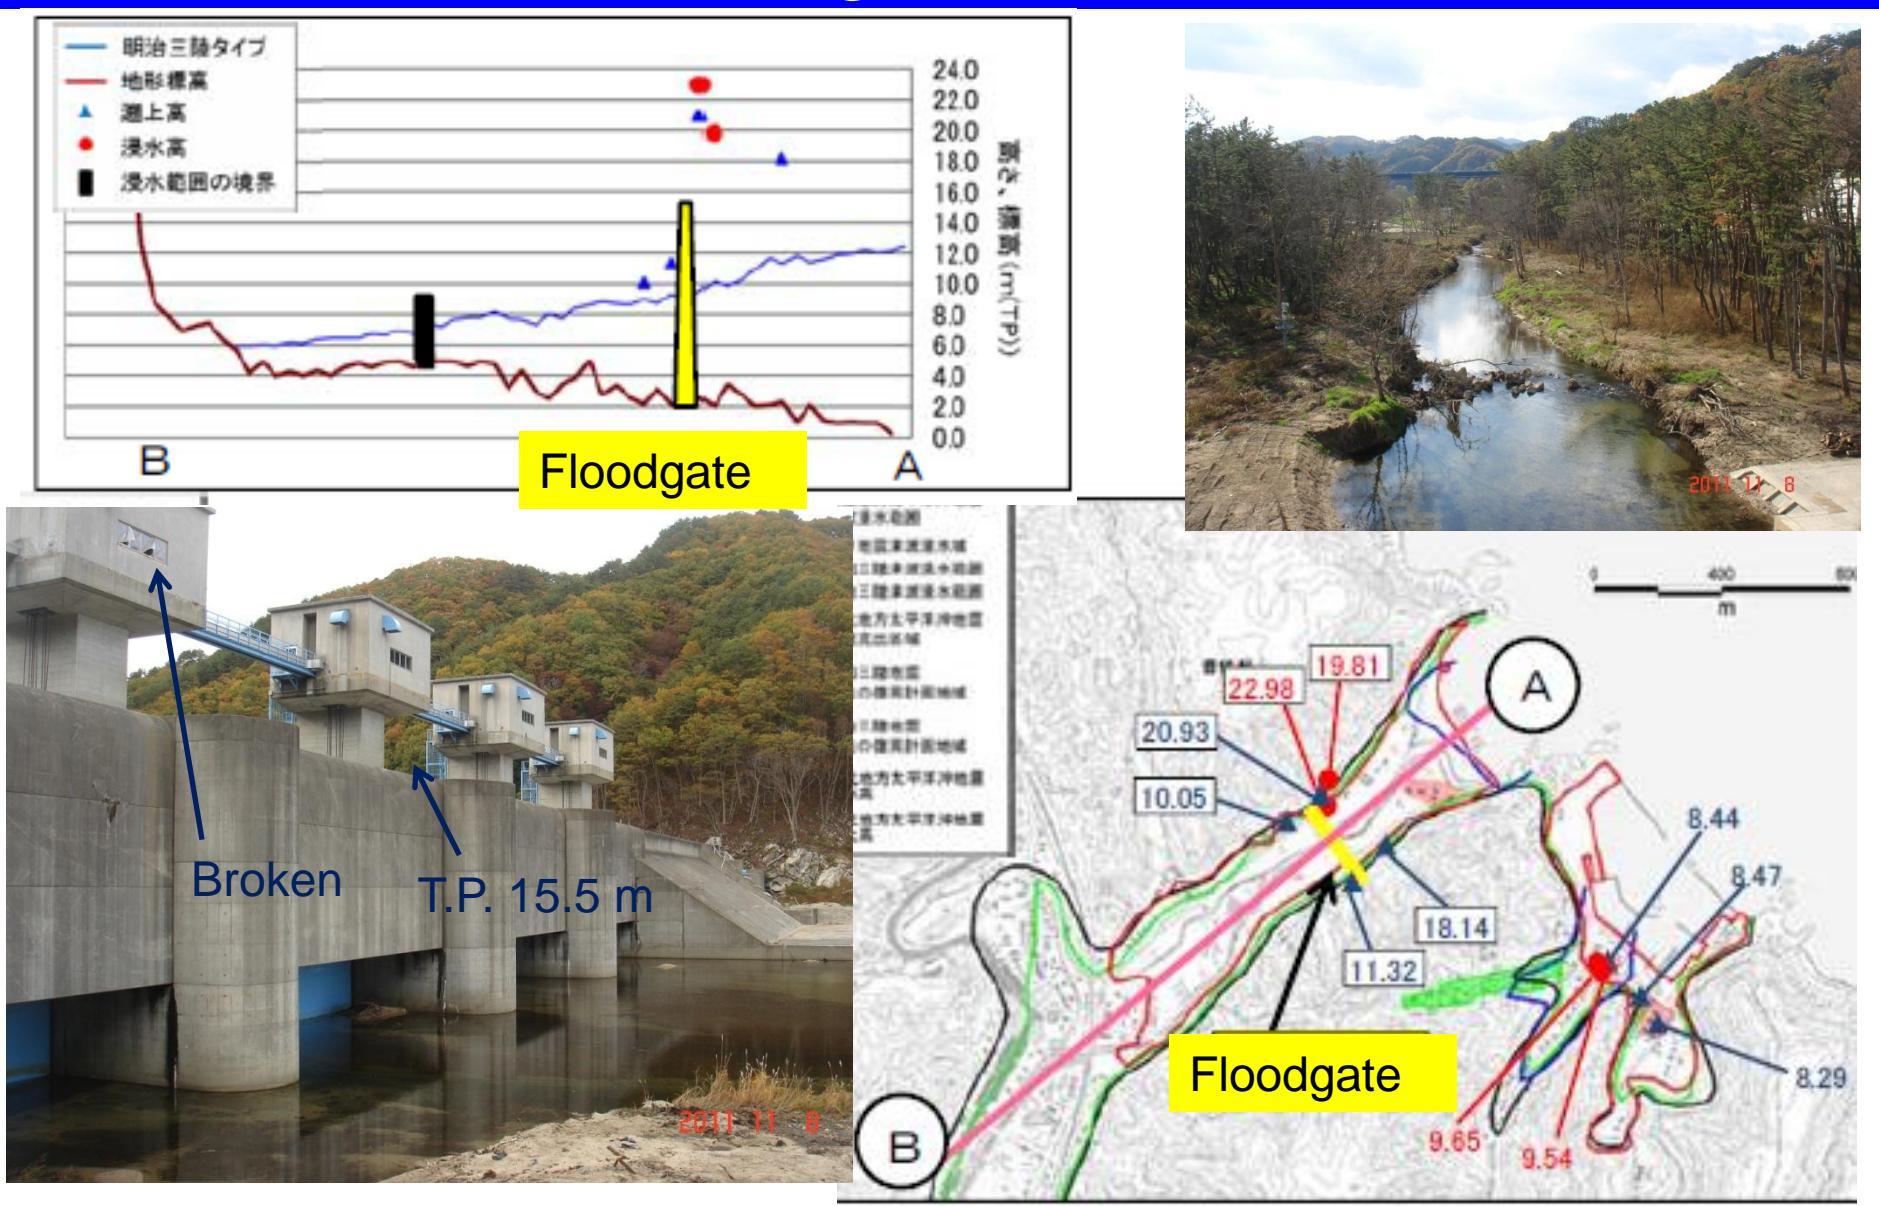
Minor damage at Fudai, Iwate

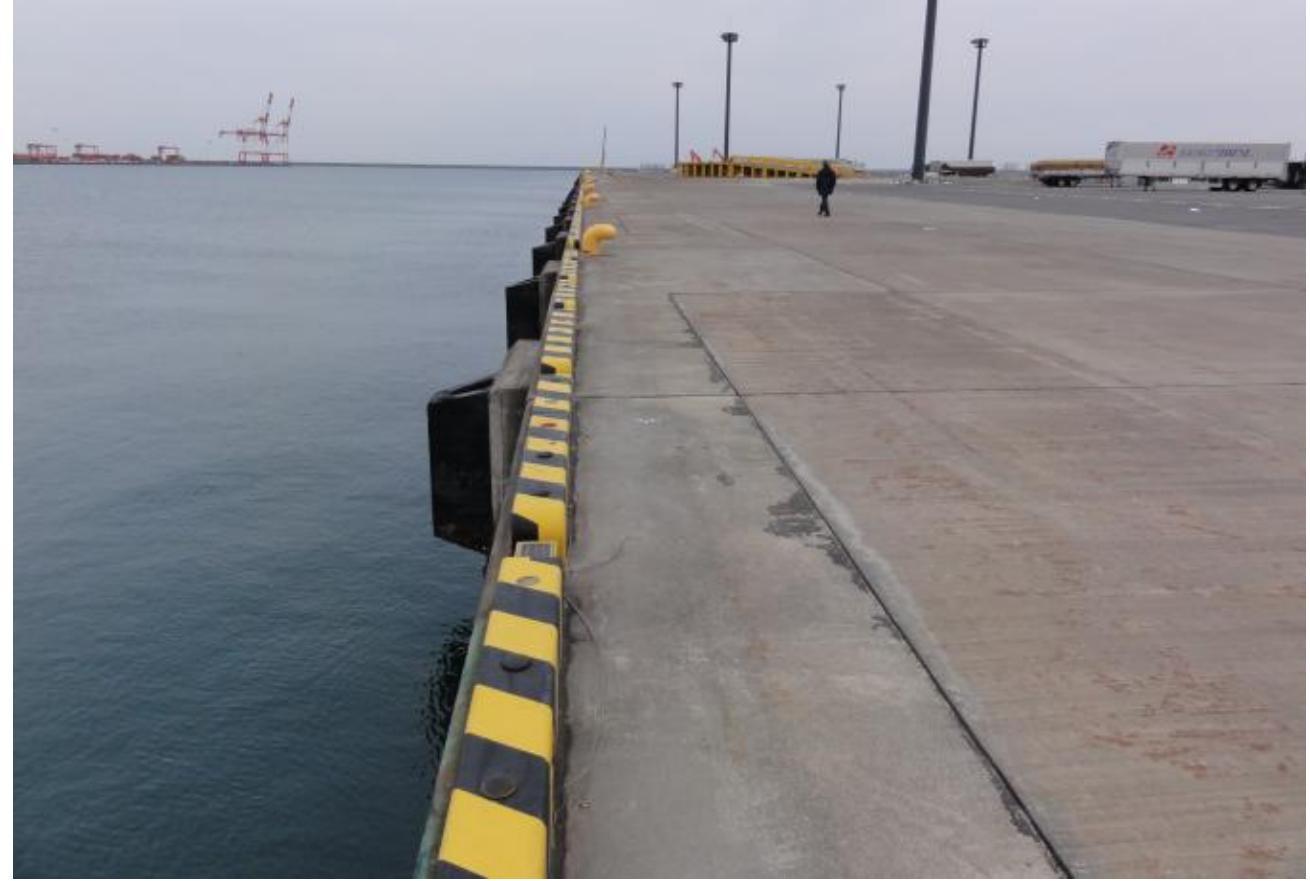
High earthquake-resistance quay wall Central Wharf, Hitachi-naka District, Ibaraki Port

- •Little lateral displacement of the quay wall.
- •Liquefaction evidence was not recognized since un-sieved crushed stone is filled as liquefaction countermeasure.
- •The high earthquake resistance quay wall showed good seismic performance. The quay went into service on March 15 after checking the burying of ²⁶ navigation channel by tsunami.

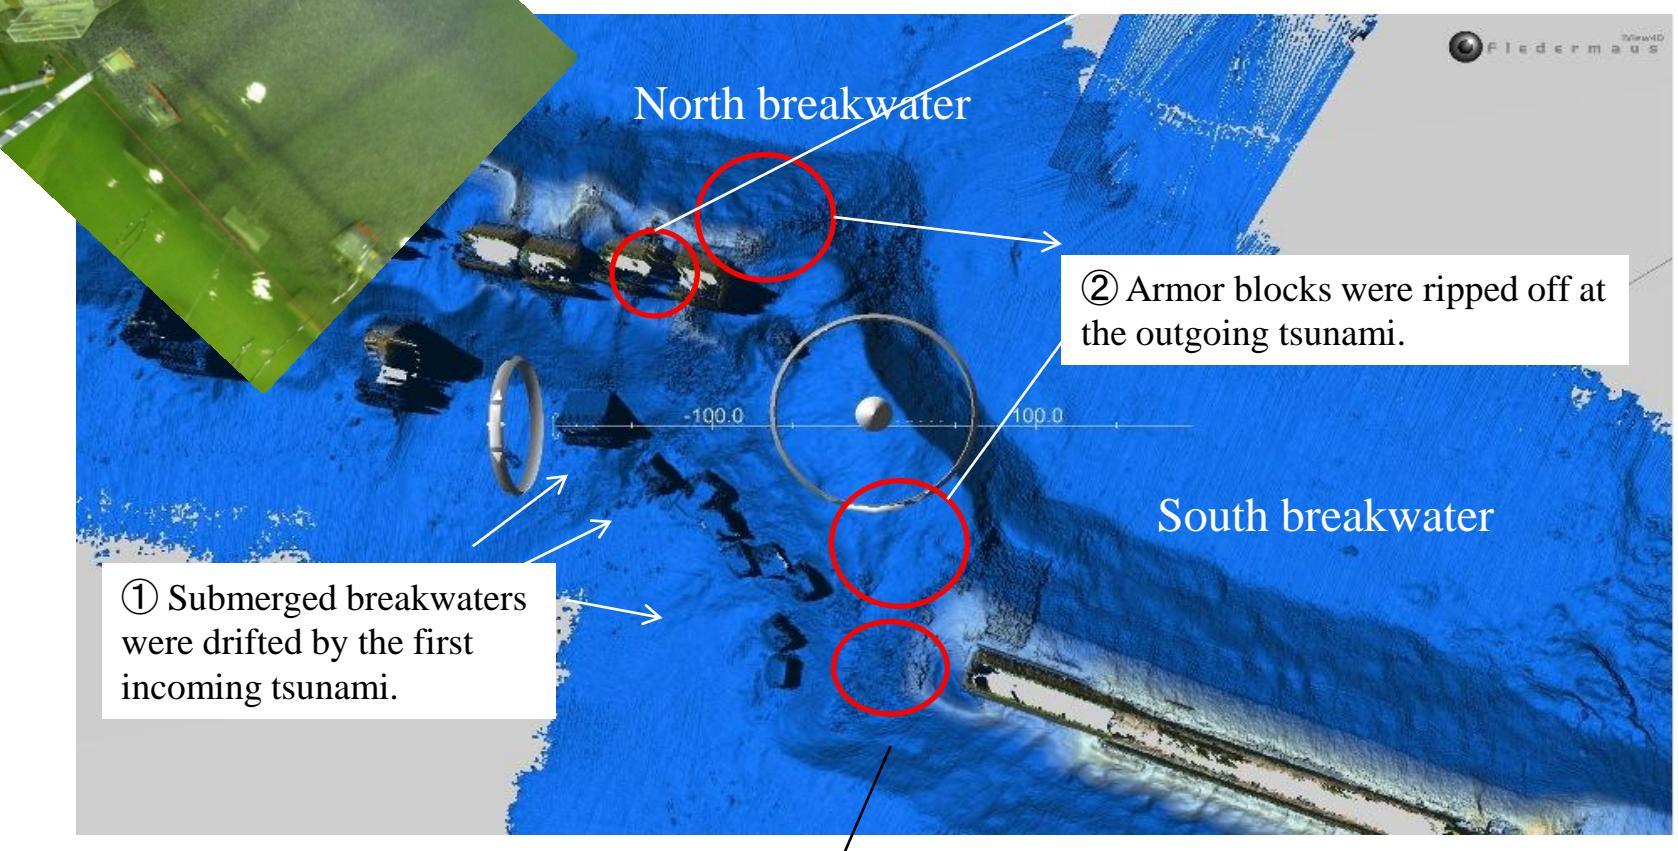
Failure mechanism of head breakwater at Kamaishi

③ The mound was scoured at the outgoing tsunami and the head breakwater was tilted.

Although the mound was scoured, the head breakwater was not tilted.

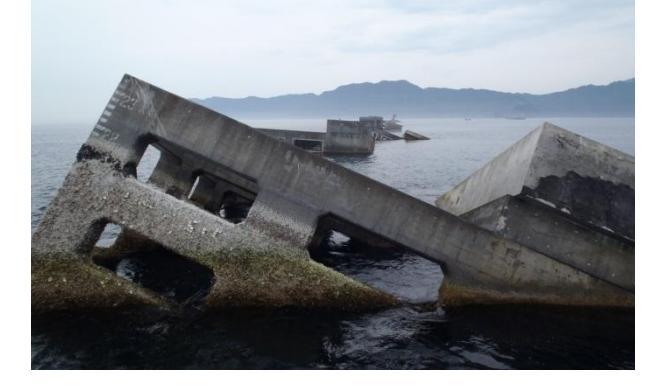
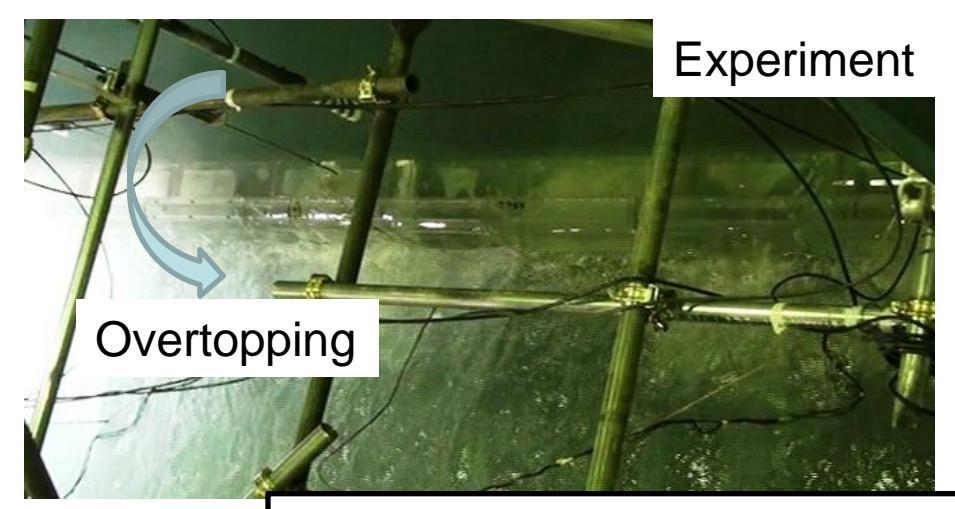
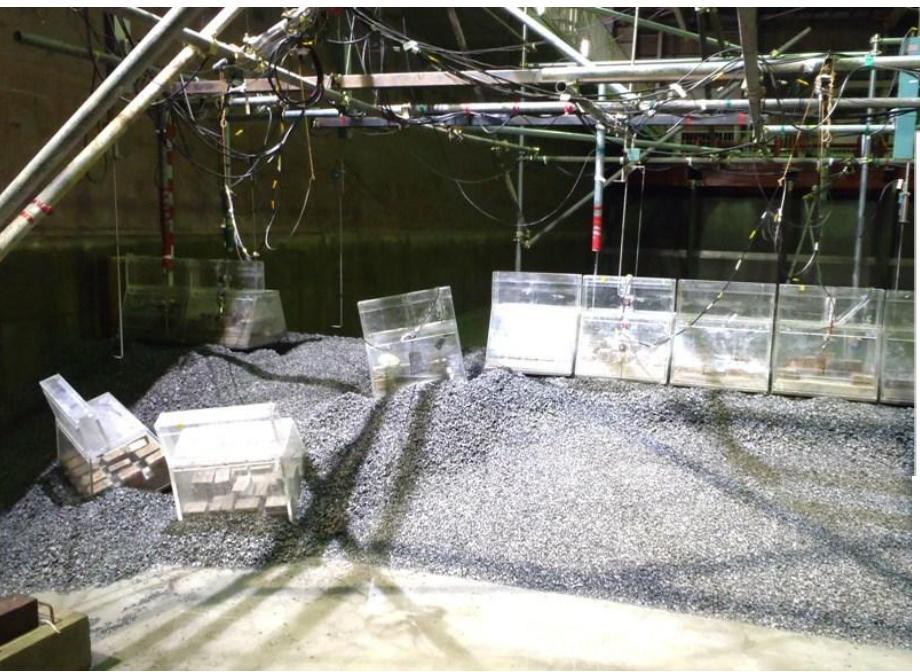
Damaged north breakwater

Two out of 17 caissons were slid and one was tilted.

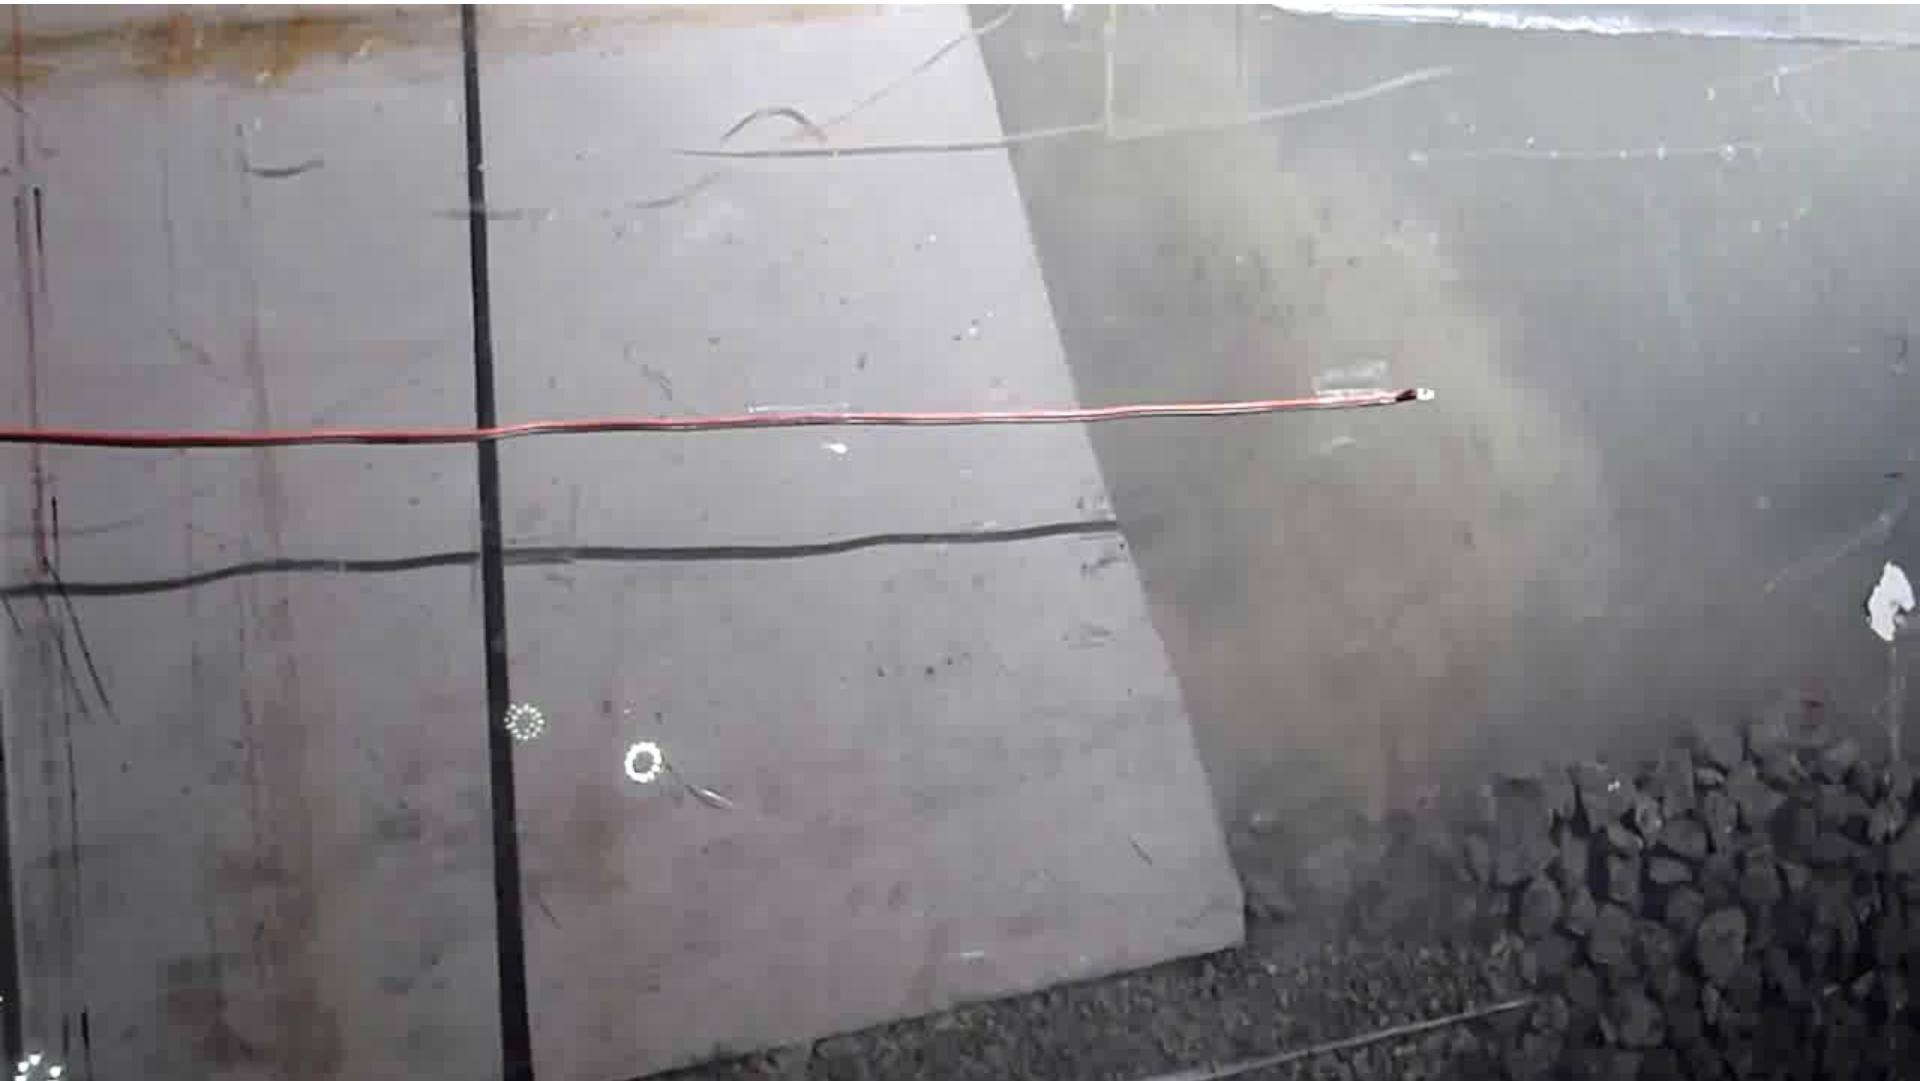
Influence of scour due to overflow tsunami

The quantification of the amount of a decrease of the sliding resistance force is a future task

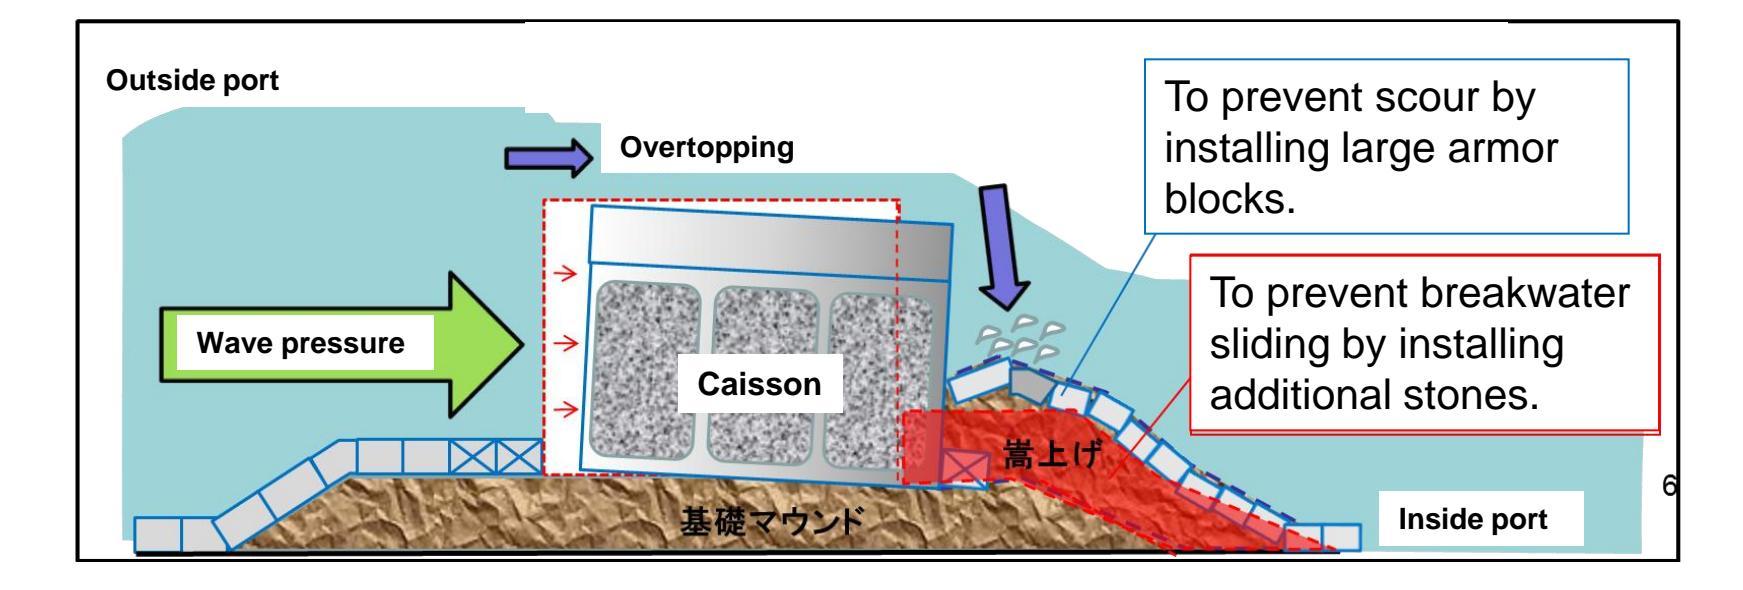
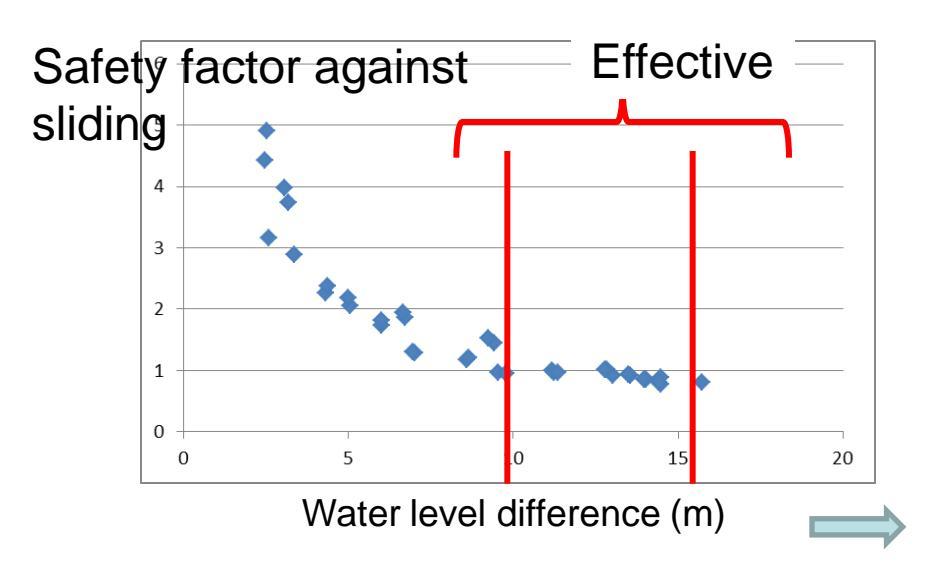
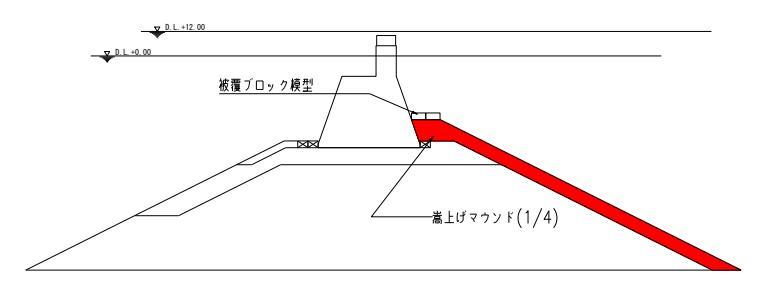
Tenacious breakwater

The problem is the scour caused by $_{\rm 38}$ overtopping behind the breakwater.

The thickness of additional stones is 1/4 the caisson height.
