行政院及所屬各機關出國報告

出席 2002 年國際腐蝕學會第七屆印度分會年會  
及第二屆亞太區域國際會議報告

服務機關：交通部公路總局

**Service Life Prediction of Prestressed Concrete Bridges  
Through On-Site Corrosion Monitoring**

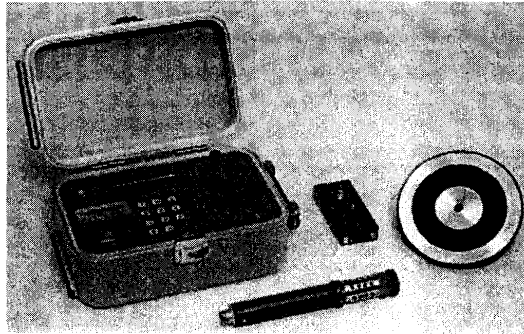
Fig. 2.1. Corrosion Rate Measuring Meter GECOR 6 [2,7]

- Corrosion Rate Meter
- Sensor 'A' (disk shaped)
- Sensor 'B' (rod shaped)

A calibration unit is also provided with the Sensor 'A'. Sensor 'A' is fitted with copper-copper sulphate electrodes, and stainless steel counter electrode (through which the external current is applied). The instrument measures corrosion rate (in micro-amps per sq. cm) and corrosion potential. Sensor 'B' is fitted with copper-copper sulphate electrode, stainless steel counter electrode and capacitance based relative humidity probe and solid state temperature probe. It measures concrete resistivity, relative humidity and ambient temperature. Based on the numerous laboratory and field investigations, corrosion activity has been correlated with the corrosion current [2,4,6,7] as given below.

Third type of measurement was the periodic monitoring of the corrosion rates. It was measured by the linear polarisation technique using the equipment, GECOR 6. This equipment is able to make a sensorised confinement of the electrical current applied to the steel reinforcement, which is assured by a guard ring as shown in Fig.2.
