## 赴澳洲學習電力系統運轉、維護模式報告

服務機關：台灣電力公司  
出 國 人 職 稱：十二等變電所所長  
姓 名：白雲年  
出國地區：澳洲  
出國期間：91.12.1~91.12.10  
報告日期：92.1.10

# 赴澳洲學習電力系統運轉、維護模式報告

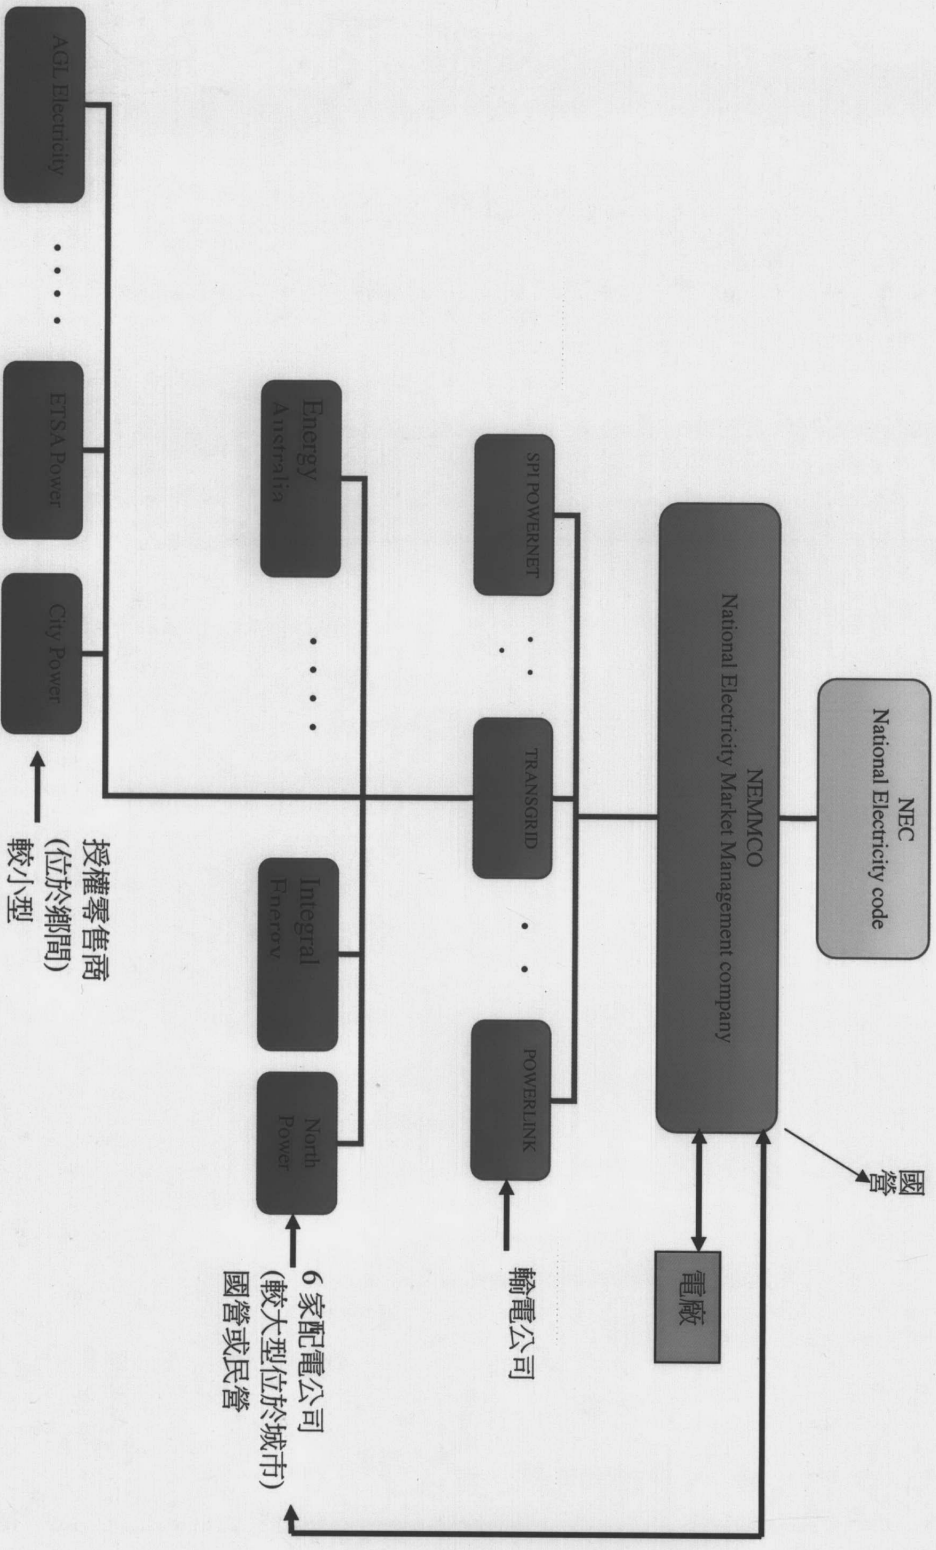
## 六、澳洲電力系統管理架構圖

澳洲電力系統是依據國家電業法(National Electricity Code)作最高指導原則，下設國營國家電力市場管理公司，掌管電力市場運作，其中包含發電、輸電、配電系統，電價結構管控，電力發展指標訂立等業務。輸電公司負責將電廠電力輸送至配電公司，其中財務管理運作變成一相當重要業務，如自配電公司收費及付費給電廠，輸電利益計算等。配電公司數量很多如 **Powerlink** 有主要配電公司 7 家，另外在偏遠地區亦有授權零售商 20 家，負責小區域售電業務。

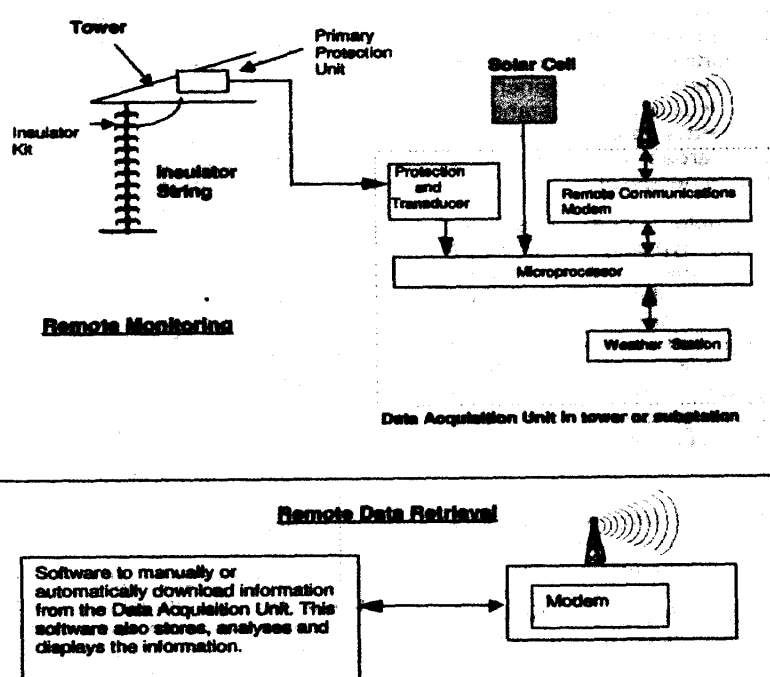
### Overview of the LCM Pollution Monitoring System for Overhead Line Insulation

檢出礙子污染造成放電電流脈衝配合雨量計、溼度計判斷污染程度作為礙子清洗判斷參考。(請參考結構圖及簡單原理)此項污染偵測系統在澳洲高鹽害地區輸電線路已採用多套，Powerlink 公司研發此系統成功後，亦銷售至其他東南亞國家及中國大陸。

線上型礙子污染偵測系統工作原理概述：

在高污染地區輸電鐵塔或變電所，於送電礙子串最靠近接地端部位多一只礙子，該礙子中心鐵棒裝設一只電流感測元件(類似比流器原理)，截取礙子表面污

染物放電電流脈衝，此脈衝電流經第一段保護迴路(類似放電間隙)送至轉換器及第二段保護迴路(突波吸收器)，此轉換器內部裝設高頻濾波器(high pass filter)，電路僅取用高頻放電訊號，並轉換成數位訊號送至微處理機分析，得到結果採用大哥大通訊迴路傳送到維護人員辦公室供分析。為判別造成放電脈衝是真正由污染物造成或由濕氣、下雨引起，在設備現場亦裝有溼度感測元件及雨量計，此兩種裝置亦分別提供電氣訊息送至微處理機。(判斷污染方法請參考下列檢圖說明)

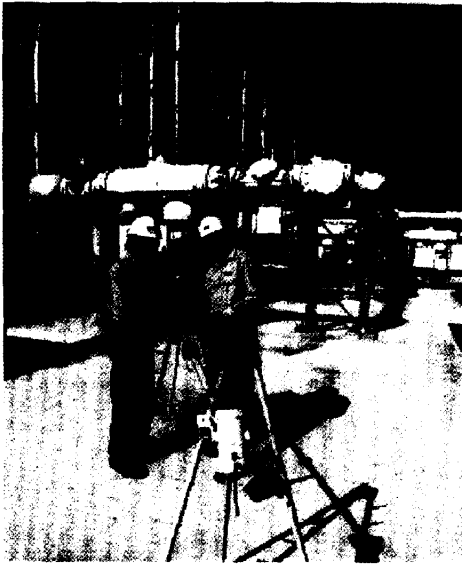
數位攝影系統安裝中

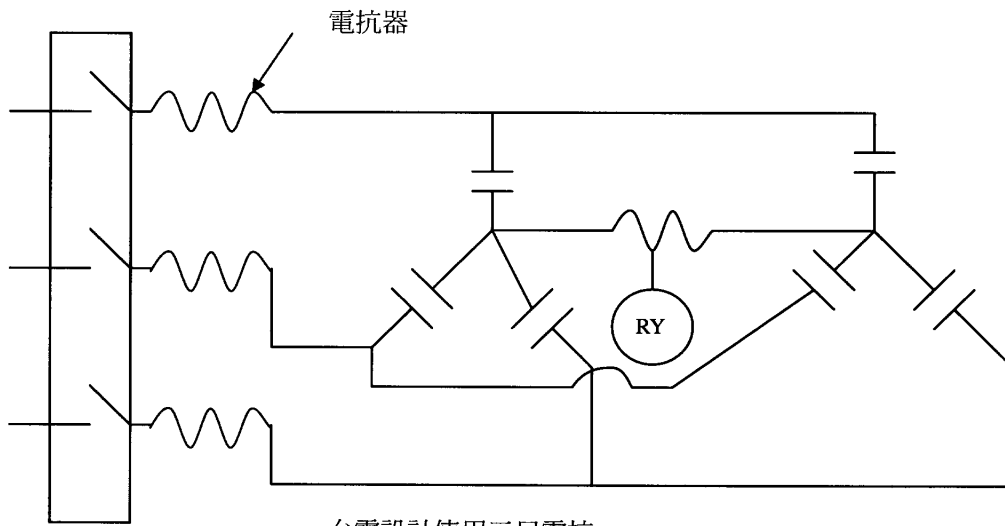
台電設計使用三只電抗

台電 161KV 系統過去安裝多組電容器組，加壓後毛病不斷，除了電容器品質有問題外設計上也有檢討空間，依 TransGrid 公司之經驗安裝在 330KV 系統電容器組極少有故障案例。經深入了解其結構是有不同(另參考下圖)，台電也可以用

澳洲模式做為設計參考。

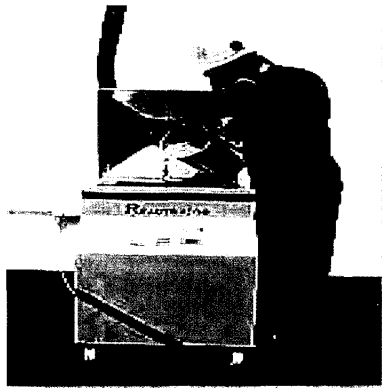
The Brownell 1005 reactivator being filled with cobalt chloride impregnated silica gel.

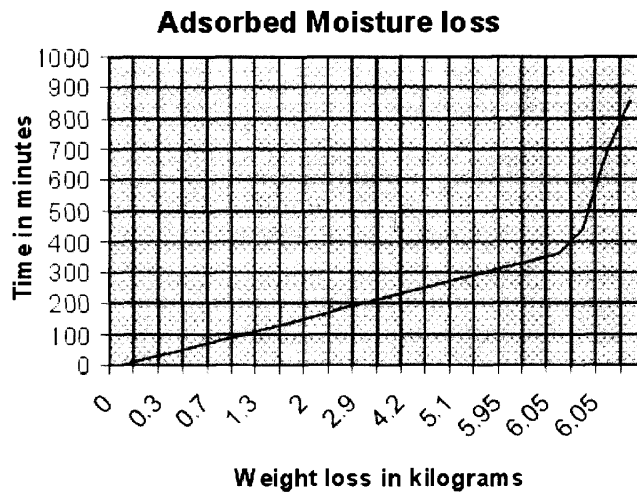
Graph indicating the rate of moisture loss during reactivation from the Brownell 1005 desiccant reactivator.

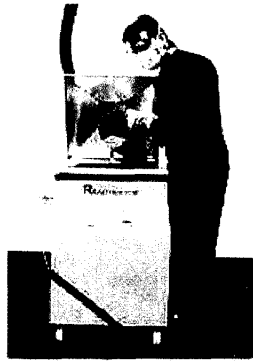
**The Brownell 1005 reactivator being filled with Envirogel.**
