BEA
Bureau d'Enquêtes et d'Analyses
pour la sécurité de l'aviation civile

**Finding Nuggets:
Cooperation vital in efforts to recover buried data**

Issues with retrieval of data from Honeywell SSCVR

Applying combined data sets for performance analysis

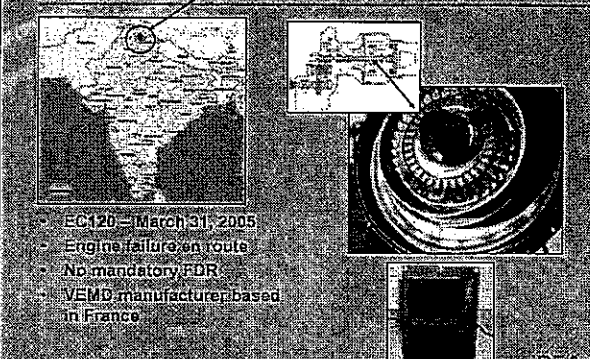
Case 1 : EC120 accident

- EC120 – March 31, 2005
- Engine failure en route
- No mandatory EDR
- VEMO manufacturer based in France

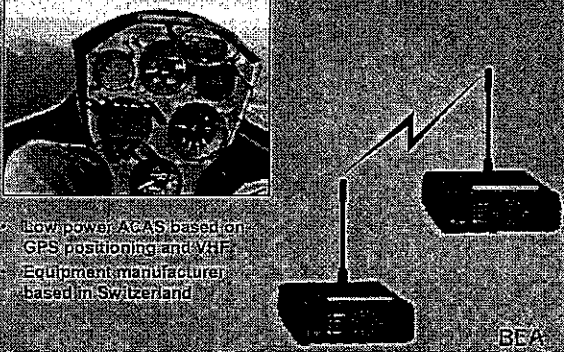
Case 2 - Glider accident

low power ACAS based on GPS positioning and VHF
Equipment manufacturer based in Switzerland

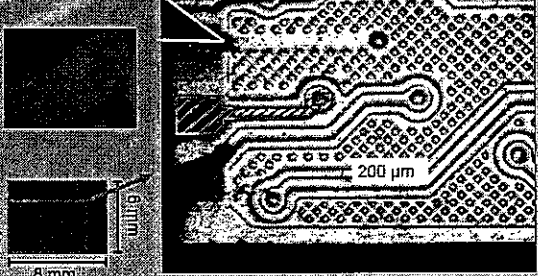
Flash memory chip readout with probes

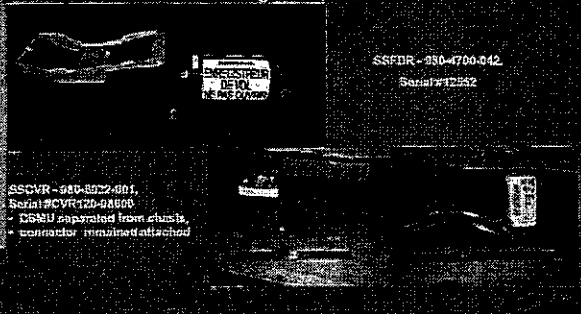
GOL Airlines, 29 Sep 2006
Boeing 737-800, PR-GTD

SSFDR - 950-4700-042
Serial#12552

SSCVR - 980-8522-001
Serial#CVR120-08600
• CSMU separated from chassis, connector minimized attached

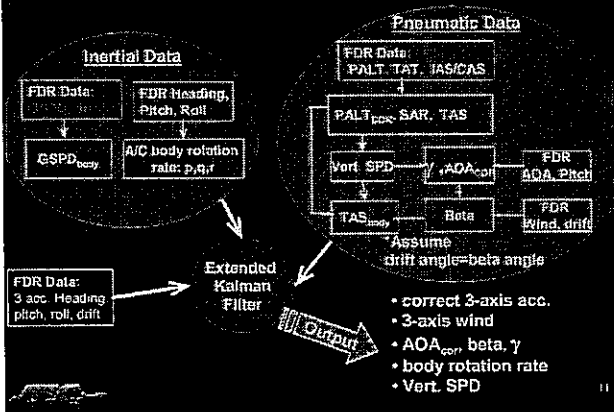
FDQES: GSPD Module

- Incorrect FDR data will affected the performance analysis, reasons:
 - Sensors calibration
 - Data recording resolution
 - Incorrect signal source into FDAU
 - Wrong data location/bits
- Using Kinematics and optimization method to processing FDR data (FDQES)
 - ensuring the flight data consistency
 - Obtain performance related flight data
 - FDQES is based on estimation theory of the Extended Kalman Filter (EKF)

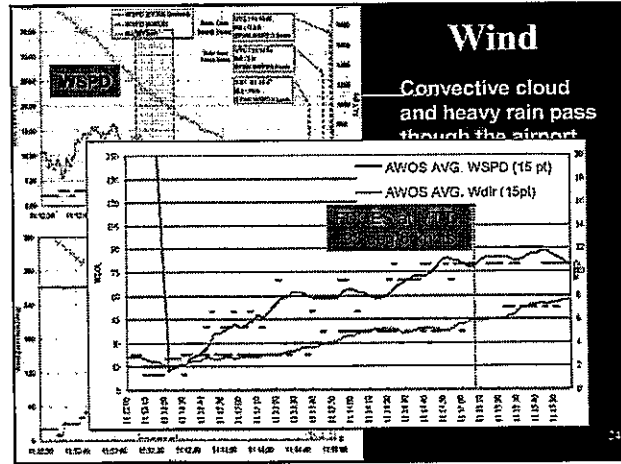
- ### FDQES in the FLT066
- ▣ Limited FDR data, it did not recording
 - ▣ Ground speed, drift, wind, lat/long position. . .
 - ▣ Airport Surveillance Radar track is available
 - ▣ Scanning rate 4.62 sec, below 200 ft no data (blind area)
 - ▣ Other useful factual data
 - ▣ Ground tracks, surface wind, two previous flight data
 - ▣ Performance problems
 - ▣ Evaluate the ILS path , touched down pt.
 - ▣ Calculate the wind
- 21
