出國報告（出國類別：進修）

參加美國國家運輸安全委員會  
航空器失事調查基礎訓練報告書

服務機關：飛航安全調查委員會

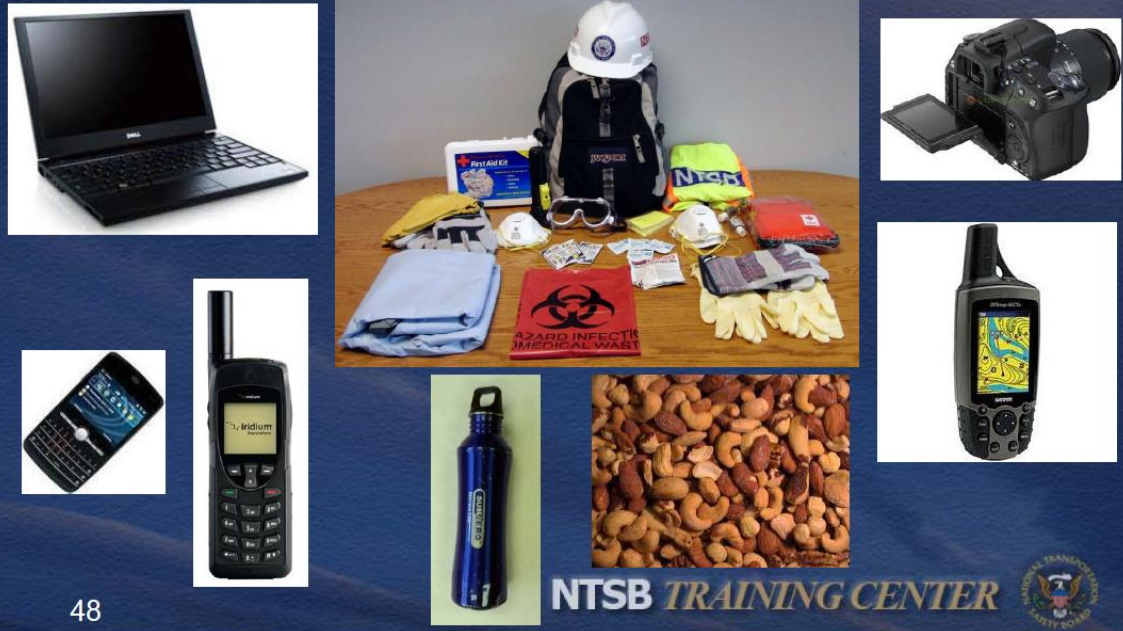
機動小組成員的裝備（Go-bag；圖 3-1）應包括必要之個人裝備和調查所需要之蒐證工具。此外，NTSB 徽章或是具有法律效力之證明文件應攜帶著以備必要時便於執行調查作用。為前往事故現場執行調查任務，除使用汽車及一般航班外，NTSB 人員亦獲得授權得搭乘 FAA 專機或使用商用航班之駕駛艙觀察席（Jump seat）以增加機動性，但僅限於出發前往現場之單程行程。

圖 3-1：機動小組成員的裝備。

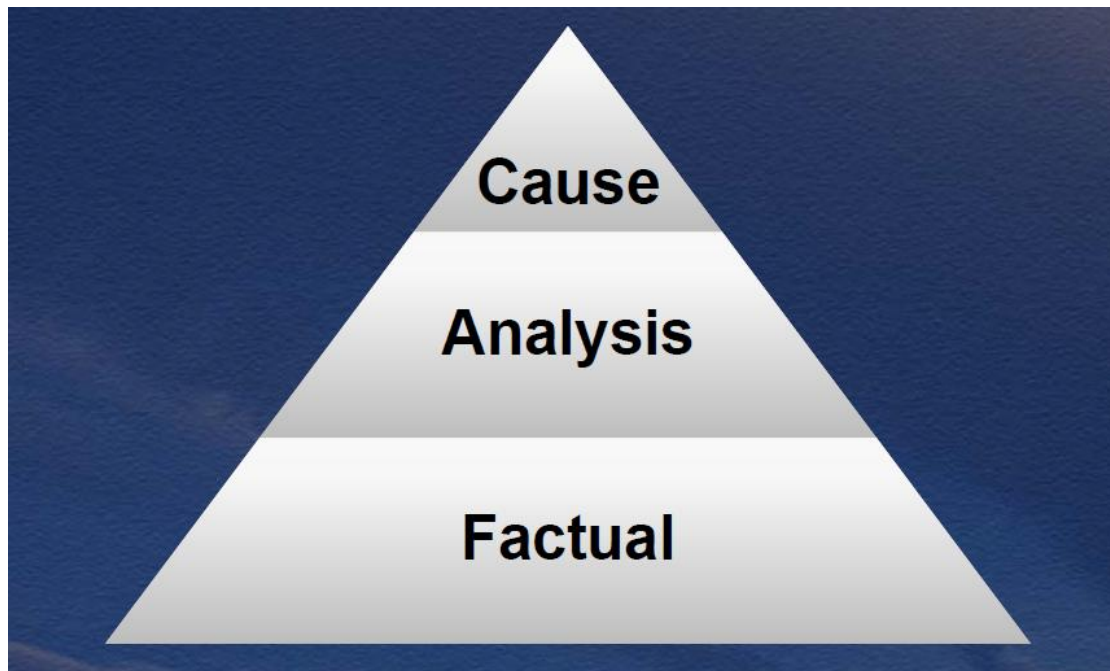
圖 3-4：飛航事故調查的架構－蒐集事實、推理分析、找出肇因。

ICAO 第 13 號附約中揭櫫飛航事故調查的目的在避免類似的事故再度發生。當事故調查團隊從事實資料所建構的基礎發掘起，經分析推理模型的運作歸納找出肇因(圖 3-4)後，最終的工作是能夠提出改善的建議，講師 J. Marcus 說這也是 NTSB 完成調查工作後最重要的成果。身為民航監理機關的 FAA，因其身負制定適航規範，航務操作程序、政策、訓練的審核，所以會是大多數的改善建議的受文對象。講師在課中亦提到，在民用航空現實的考量，尤其是成本的顧忌下，有些飛安改善建議是得經歷近十年才能完成建議書中的要求。以下節將述的 TWA800 事故為例，當 NTSB 調查發現該型機油箱和一些電線的佈線設計有需要改進的地方並在調查報告中提出改善建議，但 FAA 最終是在兼顧成本的考量下，逐步的制定改善的時限。

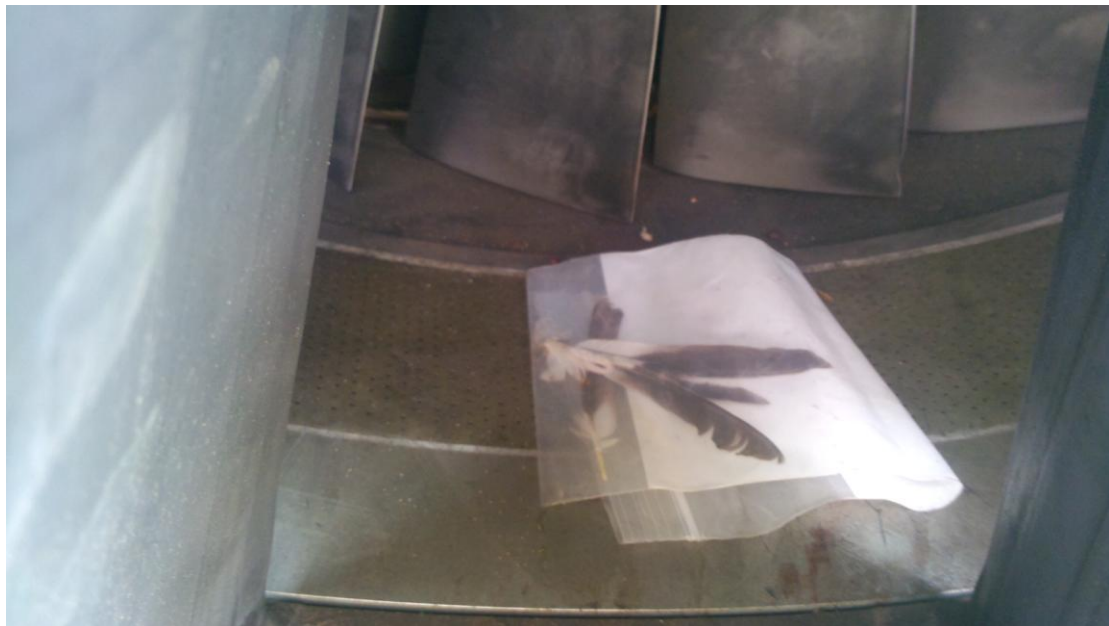
圖 3-6：事故調查實習中於發動機中的禽類羽毛。

和標準 (Standard)。用反覆循序的思惟，系統的完成現場調查工作。本人被分入發動機小組成員，現場的兩具發動機，一為渦輪風扇型、另一為活塞式螺旋槳型。現場調查中於發動機中發現禽類的羽毛(圖 3-6)，暗示著遭遇鳥擊狀況；彎曲的螺旋槳則顯示撞地時槳葉仍在旋轉(圖 3-7)。

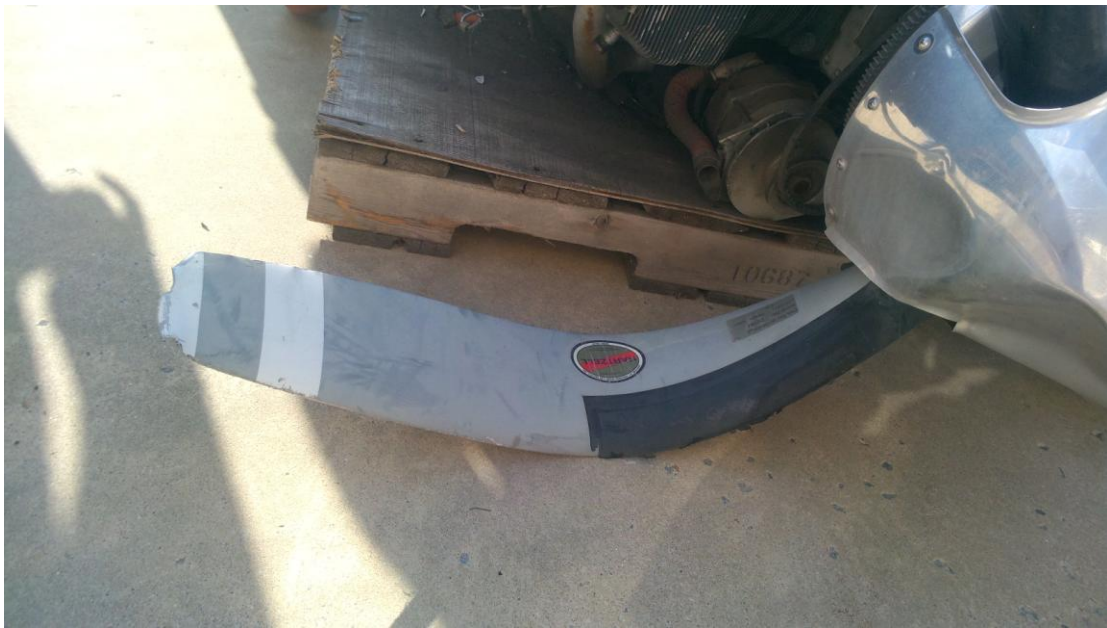
圖 3-7：螺旋槳受損彎曲的活塞式引擎。

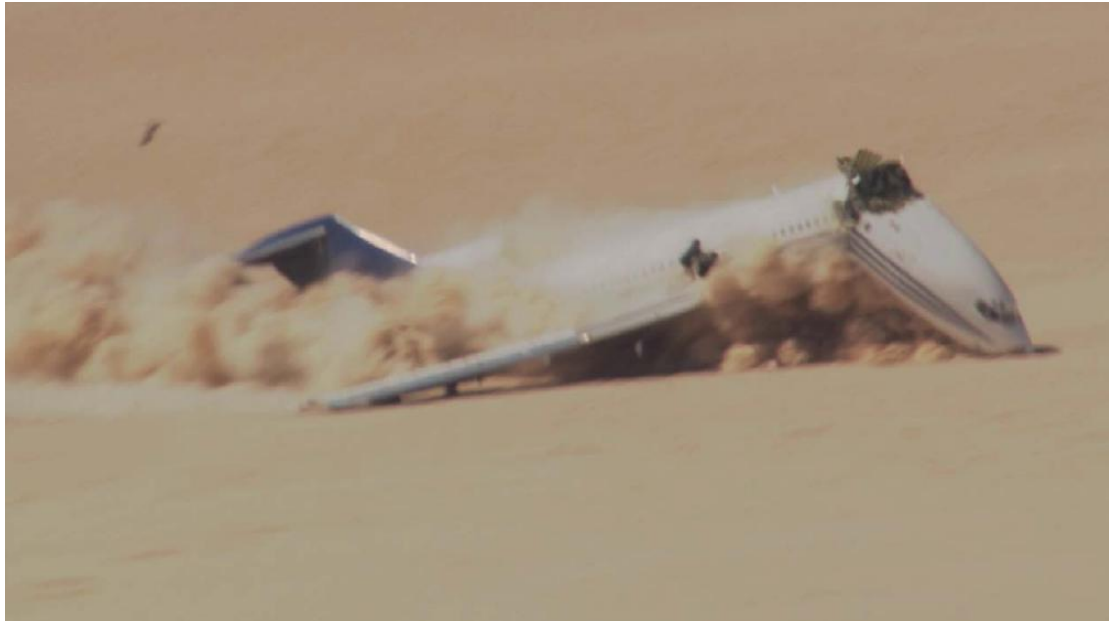
本次訓練課程中，新增一門由 T. Barth 博士講授其所參與的一項關於生還因素的研究計畫－將裝載實驗用假人的一架波音 B727 客機操控使之著陸墜毀於沙漠中(圖 3-8)，以探討航機設計下人員生還的可能性。此一主題所涉入的生還因素，主要有生還空間和身體負荷兩部份！進行這項實驗的目的，在於希望能夠在掌握各種變因的條件下，了解客艙設計、配置及諸如現行安全帶的使

圖 3-8：藉由遙控操控的方式，使一架在撞地前機上已無人員的波音 B727 航機進行生還因素實驗。

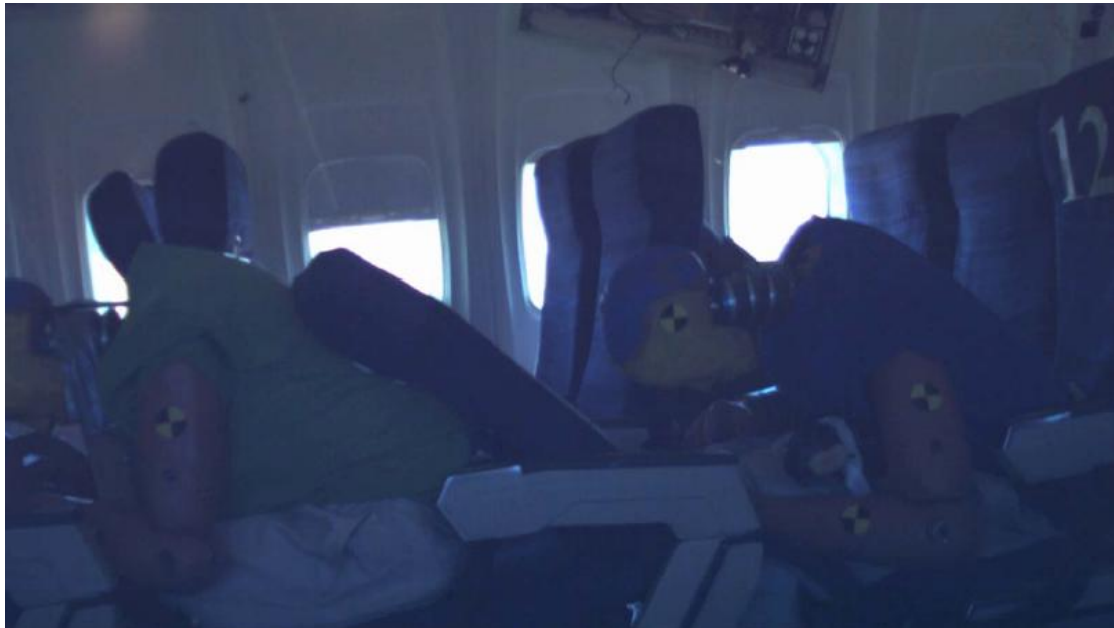
圖 3-9：由實驗機內部預架好的攝影機監控航機觸地時客艙的景況

此實驗的進行方式是將實驗機的客艙座椅上放置繫好和未繫安全帶的人偶，並佈滿許多的攝影機和加速儀等研究裝備以進行不同角度的客艙監控，接著由一名飛行員將航機建立落地姿態後跳傘離機，改以跟隨於機旁直升機上的人員以遙控的方式持續操控實驗機著陸於沙漠上，當航機觸地時，客艙內的攝影機錄下客艙毀損的過程（圖 3-9），加速儀記錄了瞬間最大加速度的出現時間、強度和方向（圖 3-10），以了解機載乘客所面臨各面向的風險和此客艙設

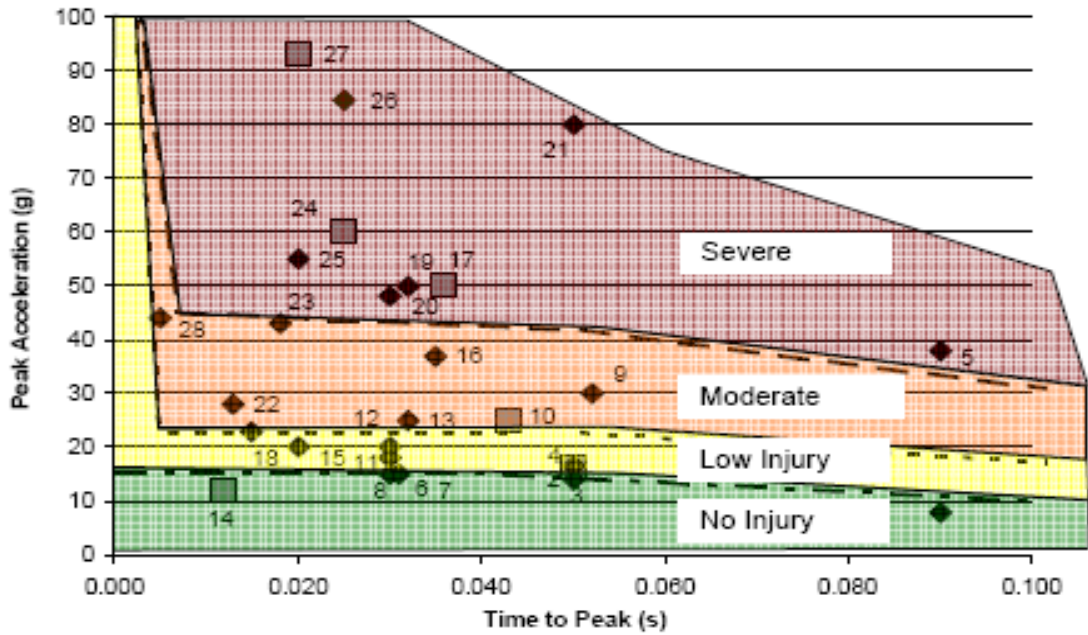
圖 3-10：實驗機觸地（時間定為 0）起各偵測點所記錄瞬間最大加速度值和對應發生時間分布。

根據此一實驗的撞擊條件所得到的結果研判，依照目前的設計規範，此狀況下乘客的死亡、嚴重受傷、和普通受傷的比例各約 1/3。而後續的分析處理目前仍在繼續的進行，以對於如座椅和安全帶的議題能提供更多的建議。
