出國報告（出國類別：會議）

參加 2015 法國巴黎非破壞檢測及評估國際研討會並發表論文

Study of Electro Magnetic Acoustic Transducer to detect flaw in pipeline

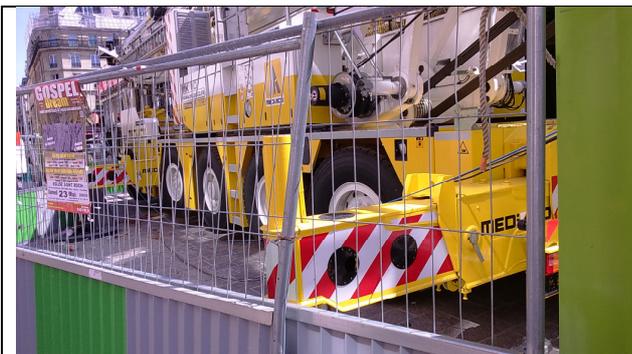
圖 7 移動式起重機路邊停放時，以圍籬作適當人員隔離及防護

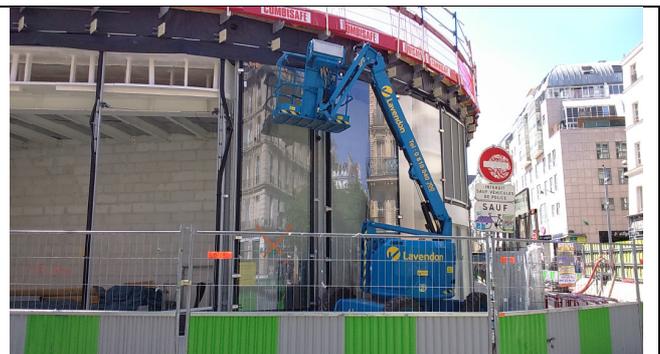
圖 8 高空工作車路邊停放時，也作好適當人員隔離及防護

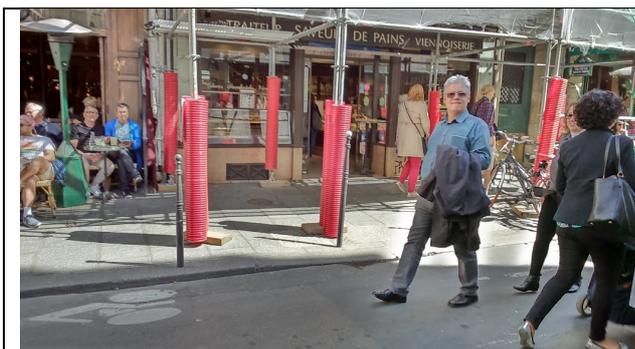
圖 9 人行道上的施工架，在與人體有接觸之虞的高度，包套塑膠軟墊

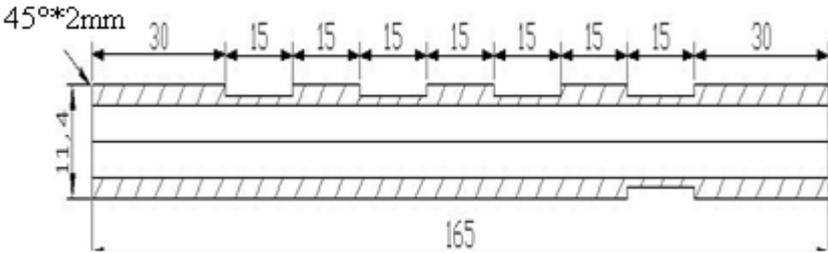
Figure 1 testing tube with defect length 15cm

In this study, we prepared four steel pipe (ASTM A106), tube diameter is 114 mm, wall thickness is 6.5 mm, circumference is 360 mm. Defects was made by milling machine, tube defects depth are 1/2T and 1/4T respectively, T is wall thickness. There are five defect length is 15cm, tube defects depth of 1/2T, shown in Figure 1. The defect length is 4 cm, shown in Figure 2. Defect circumferential angle are 90°、180°、270° and 360° respectively, shown in Figure 3. The tube defect depth is 1/2T.

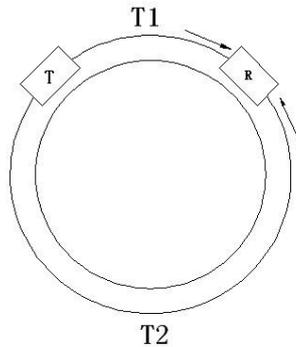
Figure 4 EMAT wave delivery route

In this study, we used EMAT Scans software 'Do Runs mode' to show the defect signal, the 'Do Runs mode' apply the phase, amplitude scan recording pattern, shown in Figure 4. The excitation coil T1 and T2 with two kinds of Lamb wave transmission to the receiving coil, T1 is around the tube top, T2 is around the tube from bottom to top.

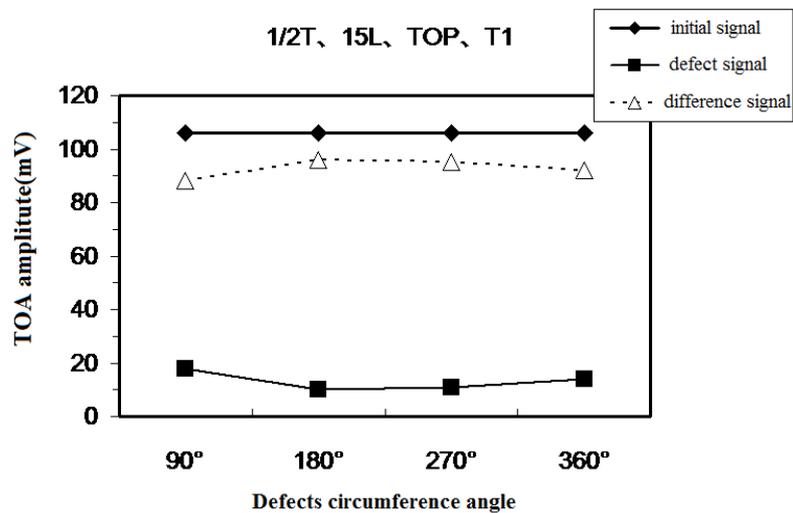
Figure 5 T1 signal amplitude of defect depth 1/2T, length 15cm

Table 1 and Table 2 is data sheet of $1/2T$ and $1/4T$ defect depth, 15cm defect length respectively, T1 measure defects from the tube top. Figure 5 shows the T1 signal amplitude of $1/2T$ defect depth, defect length is 15 cm. Figure 7 shown the T1 signal amplitude of defect

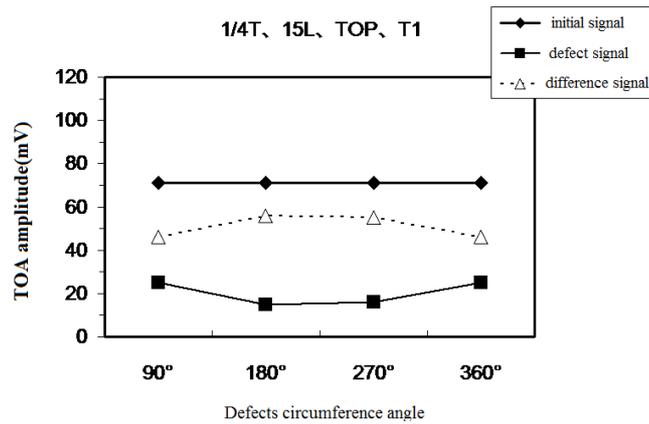
Figure 6 T1 signal amplitude of defect depth 1/4T, defect length 15cm

From Figure 6 and Figure 7, we found that at 90° and 180° defect angle, the amplitude of the defect signal decline, but at 270° and 360° defect angle, the amplitude of the defect signal rise may be affect by wave propagation velocity changes. Figure 8 shows the signal amplitude difference of 1/2T defect depth is greater than 1/4 T, it can be confident, that the signal

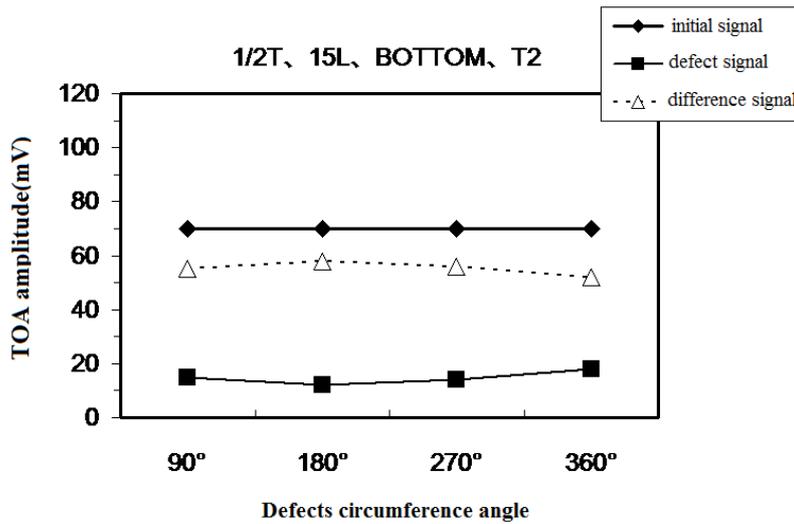
Figure 8 T2 signal amplitude of defect depth 1/2T, length 15cm

Table 3 and Table 4 is data sheet of 1/2T and 1/4T, T2 measure defects from the tube bottom. Figure 9 shows the T2 signal amplitude 1/2T defect depth, defect length 15 cm. Figure 10 shows the T2 signal amplitude of 1/4T defect depth, defect length 15 cm.

From Figures 8 and 9, we found that at 90° and 180° defect angle, the amplitude of the defect signal decline, but at 270° and 360° defect angle, the amplitude of the defect signal rise may be affected by wave propagation velocity changes. Figure 11 shows the signal amplitude difference of 1/2T defect depth is very close to 1/4 T, but at 360° circumferential, 1/2T amplitude signal slightly higher than 1/4T defect depth. It can be confident, that the signal amplitude is affected by defect depth by T2 mode.

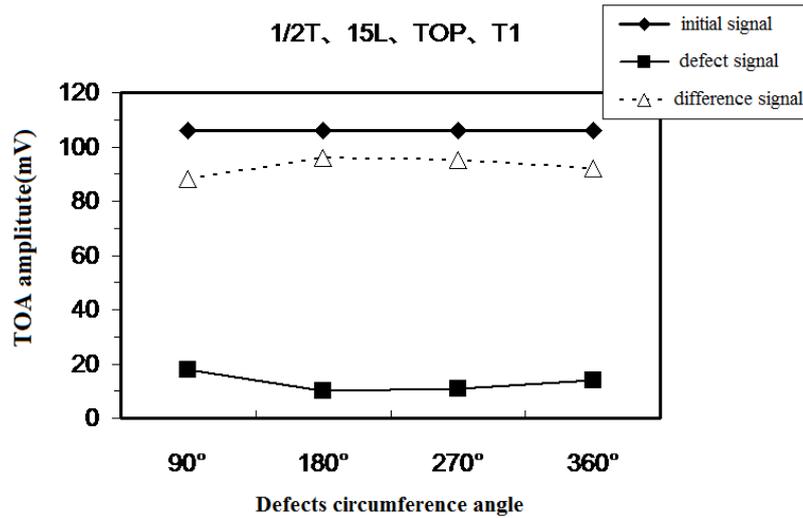
Figure 5 T1 signal amplitude of defect depth 1/2T, length 15cm

Table 1 and Table 5 is data sheet of 15 cm and 4 cm defect length, 1/2T defect depth respectively, T1 measurements for defects in the tube top. Figure 5 shows the T1 signal amplitude of 1/2T, defect length 15 cm. Figure 11 shown the T1 signal amplitude of defect depth 1/2T, defect length 4 cm.

From Figure 5 and Figure 11, we found that the amplitude at 180°, 270°, 360° defect angle is very close. Figure 11 shows defect signal amplitude of 90° than the 180°, 270°, 360°. Figure 12 shows that the signal amplitude difference between without defect and 15 defect length, greater than 4 cm defect length. It can be confident, that the signal amplitude affect by defect length by T1 mode..

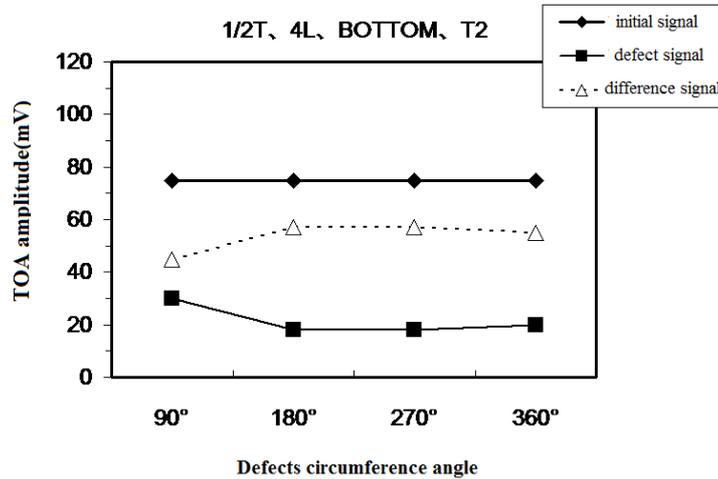
Figure 13 T2 signal amplitude of defect depth 1/2T, defect length 4cm

Table 3 and Table 6 is data sheet of 15 cm and 4 cm, T2 measurements defects from tube bottom. Figure 8 shows the T2 signal amplitude 1/2T defect depth, defect length 15 cm. Figure 13 shows the T2 signal amplitude of 1/2T defect depth, defect length 4 cm.

From Figure 13, we found that signal amplitude of 4cm defect length at 90° defect angle is higher than 180°, 270°, 360° angle, the defect length of 4 cm, 180°, 270°, 360° the defect signal amplitude is very close. Figure 14 defects angle of 90°, 15 cm signal amplitude difference higher than 4 cm, but the amplitude of the other three angles are very close to the difference signal. It can be confident, that the signal amplitude affect by defect length.

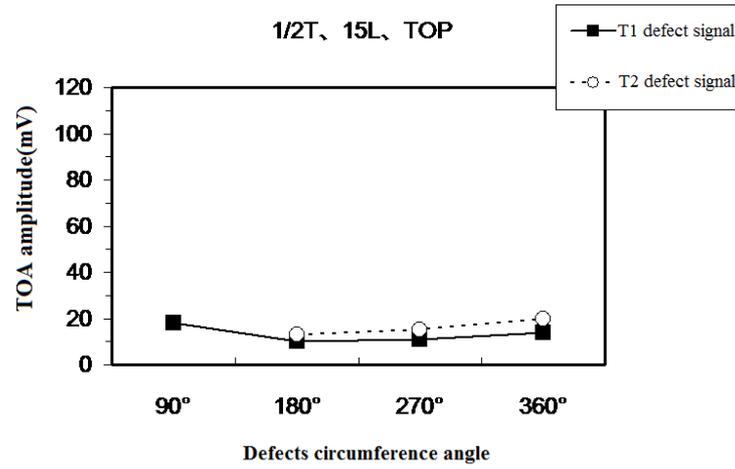
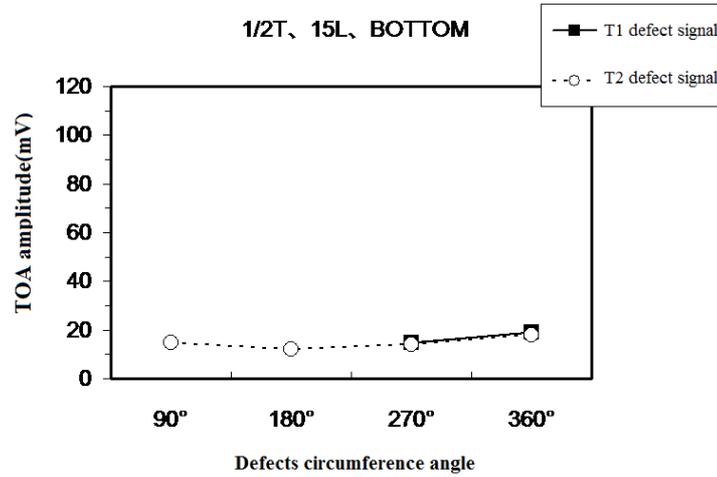
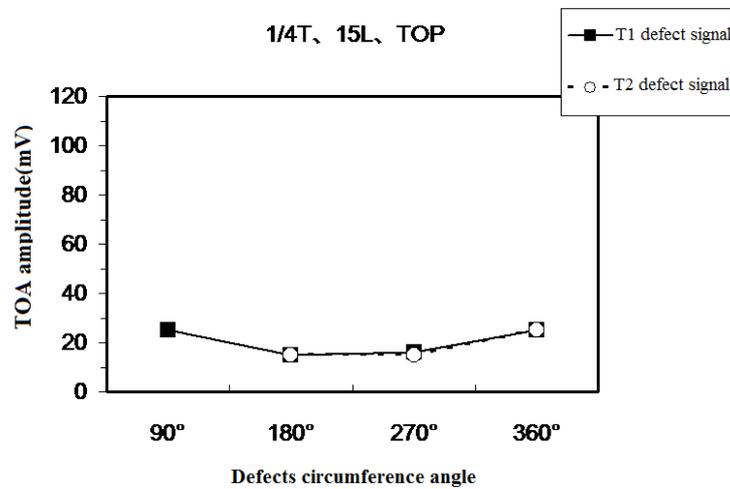
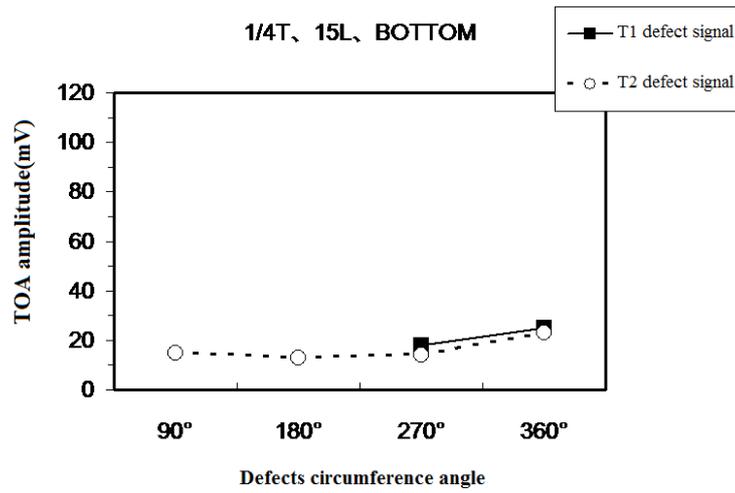
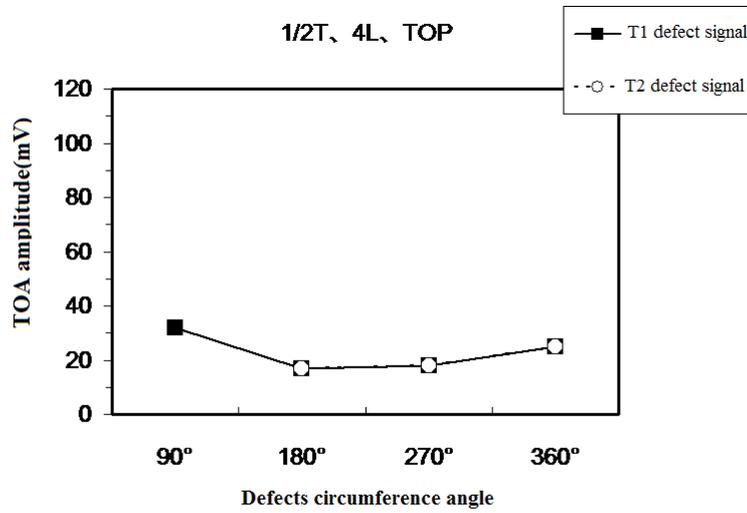
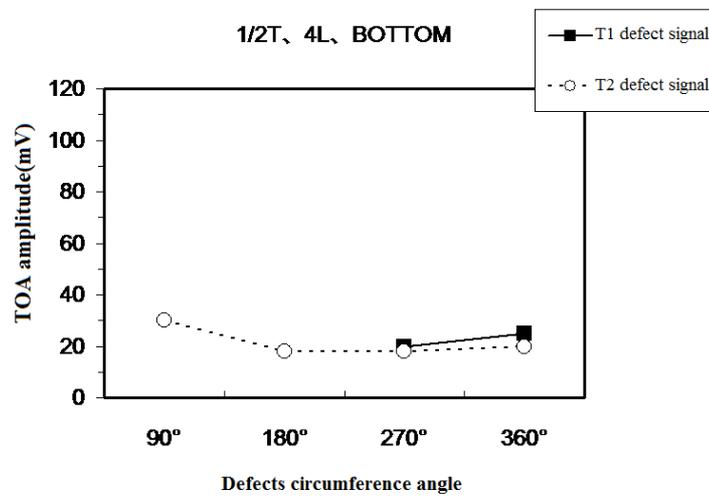
Table 7 and Table 8 is data sheet of the defect depth 1/2T, defect length 15cm. Table 9 and Table 10 for defect depth 1/4T, defect length 15cm. Tables 11 and Tables 12 for the defect depth 1/2T, defect length 4cm, top and bottom measure defect amplitude signal data shown in Figure 15 to Figure 20.

Because the EMAT sensor scanned to the defect-free place, so that the Tables 7 to 11 cannot be show part angle. Because T1 and T2 distance is very close, so resulting in T1 and T2 defects signal amplitude is similar in Figure 16 to Figure 20.
