關島 CABRAS 電廠#1 機
汽機大修 PART II 報告

服務機關：台灣電力公司電力修護處

關島 CABRAS 電廠 #1 機汽機大修 PART II 報告

TURBINE CONTROL SYSTEM INSPECT REPORT For Guam Power Authority Cabras Power Station Unit 1

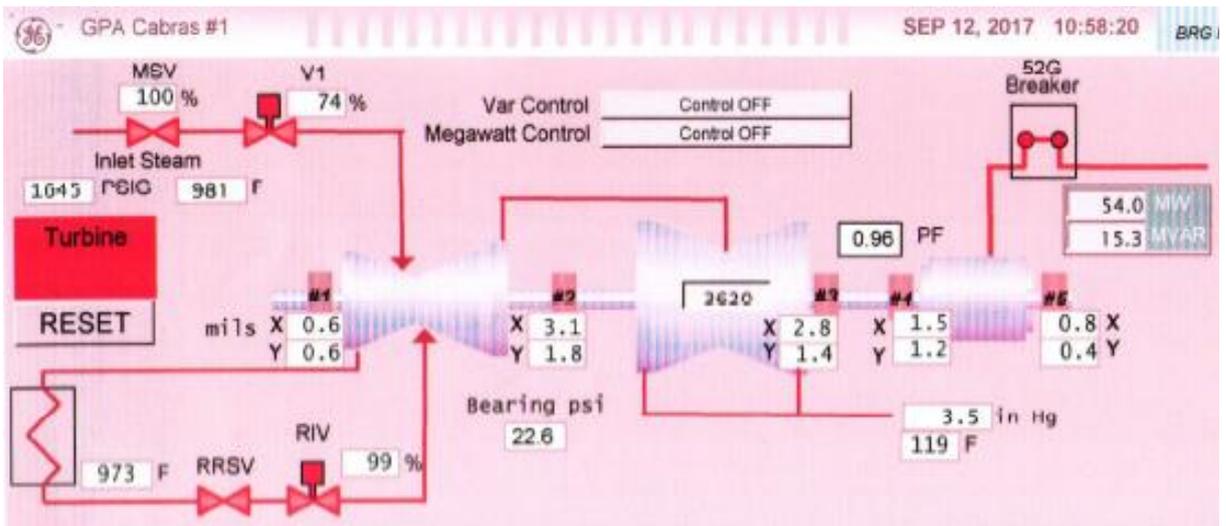
(1) 2017/09/09 於 240°~250°處增加 336 克(6 塊)配重塊。

穩定升載後，各軸承之振動數值如下圖所示：

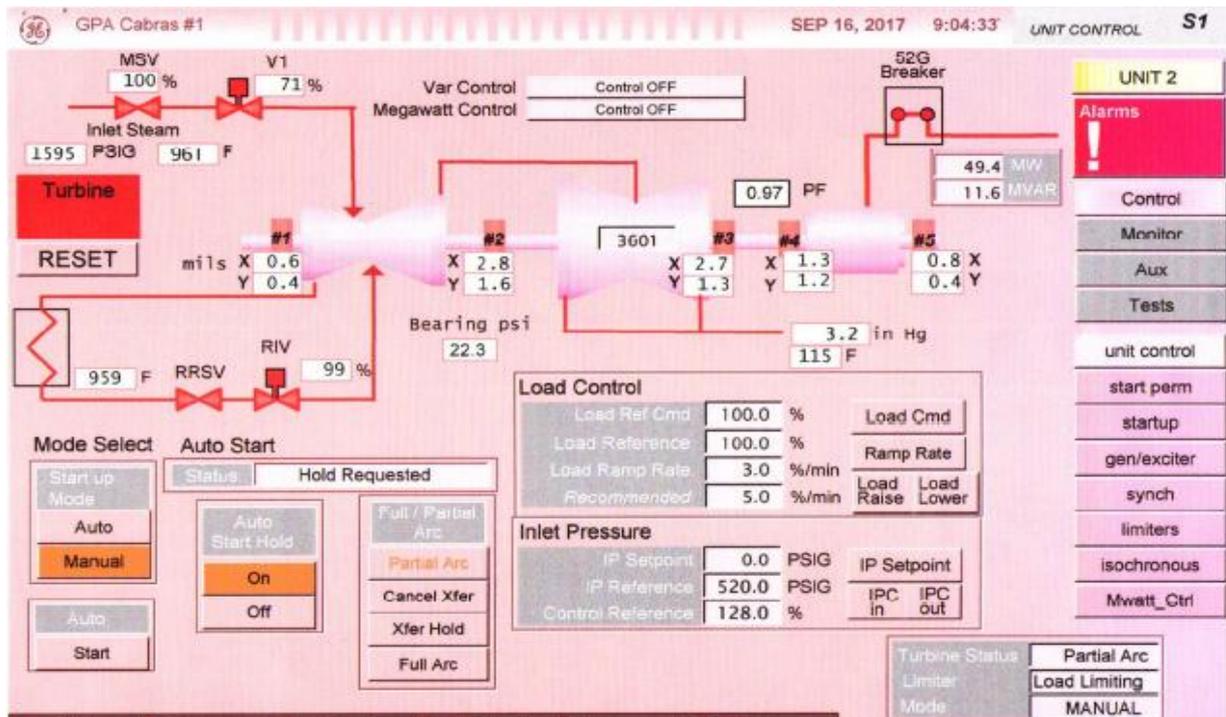
2017/09/14 於 230°處減少 56 克(1 塊)配重塊。

穩定升載後，各軸承之振動數值如下圖所示：

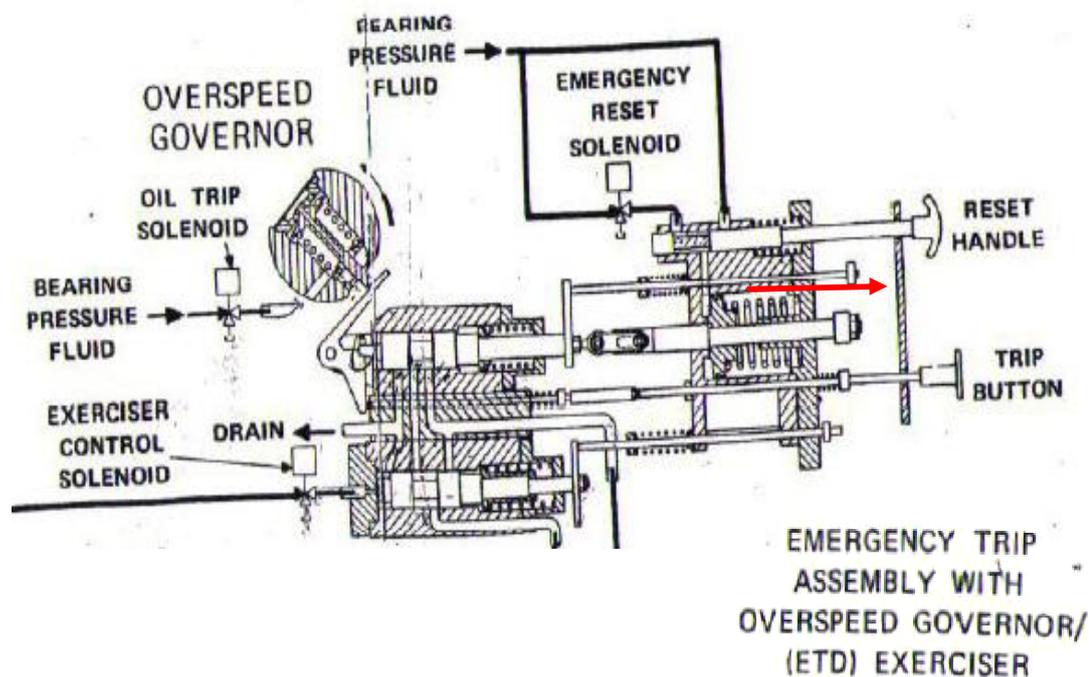
- (2) 軸位顯示因待測面之差異性，turning gear 時即約有 8 mils 之變化，導致汽機運轉時，顯示之數值偏高，趨近警報值，台中電廠王課長明山於 Mark V 系統裡做補償修正後即顯示正常。
- (3) 汽機頭 OVERSPEED GOVERNOR/(ETD)EXERCISER 復歸手把(Reset Handle)機構附件，因內部活塞阻滯致行程不足，無法自然觸發 reset limit switch，需靠外力幫助才能定位(如下圖紅線標示)，已建議廠方於下次大修時更新該機構或請值班人員每次復歸時至現場手動操作。

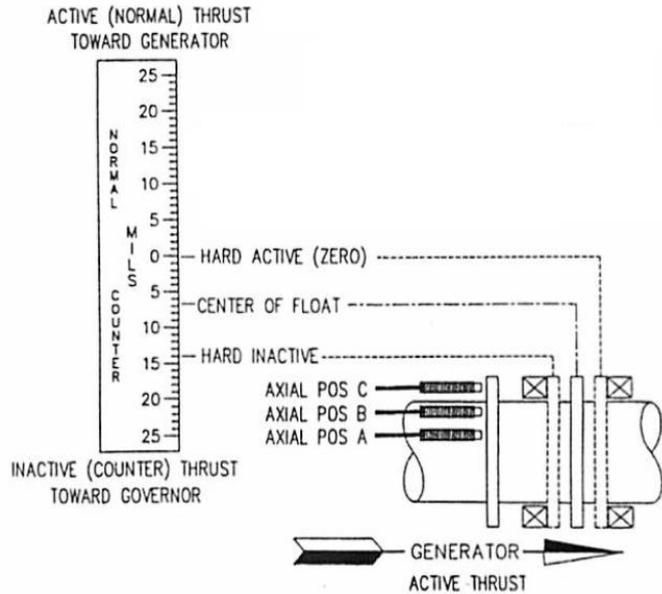
Control Constants were modified as following:

- K39AAA 15.0mils changed to 7.0mils
- K39AAT 20.0mils changed to 12.0mils
- K39AIA -15.0mils changed to -23.0mils
- K39AIT -20.0mils changed to -28.0mils

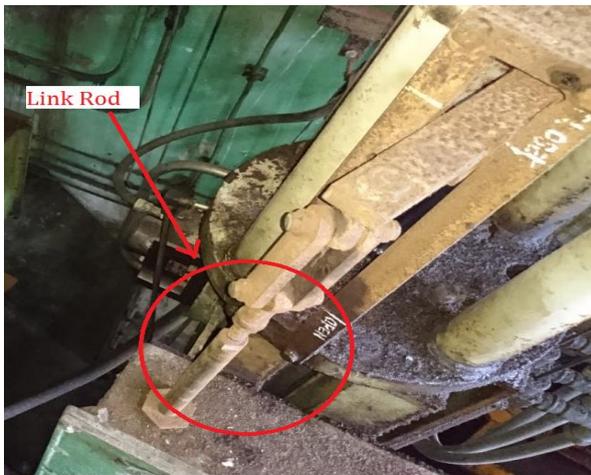
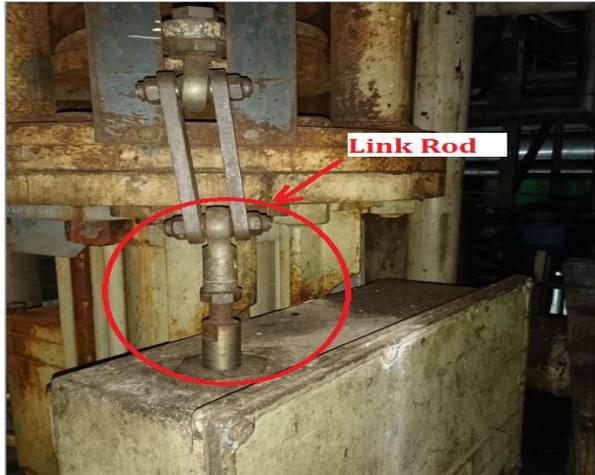
4. Test and adjust the MSV / RSV / RIV limit switches

The MSV / RSV / RIV close limit switches, labeled CSB-1 / CSB-2 / CSB-3, which used for the unit safety protection. When the MSV fully closed and either RSV nor RIV fully closed, it will trip both boiler and generator. The close limit switch must be verified and adjust carefully when the link rod, connect valve to switch box(refer to the figure), was disconnected and connected for the valve maintenance. The Mark V valve calibration function used to force valve open and close to verify the safety protection.

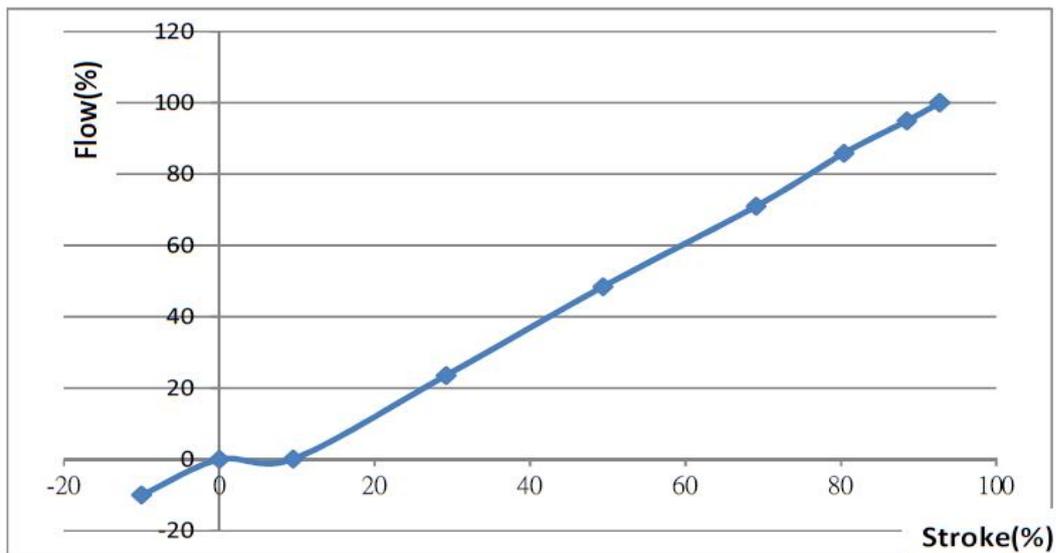
5. V1 Valve Calibration

Mark V Control Constant

Index	KV1U_TRO	KV1L_FLO
0	-10	-10
1	0	0
2	9.5	0.1
3	29.2	23.56
4	49.4	48.46
5	69.1	71.02
6	80.4	85.87
7	88.5	94.94
8	92.71	100
9	92.71	100

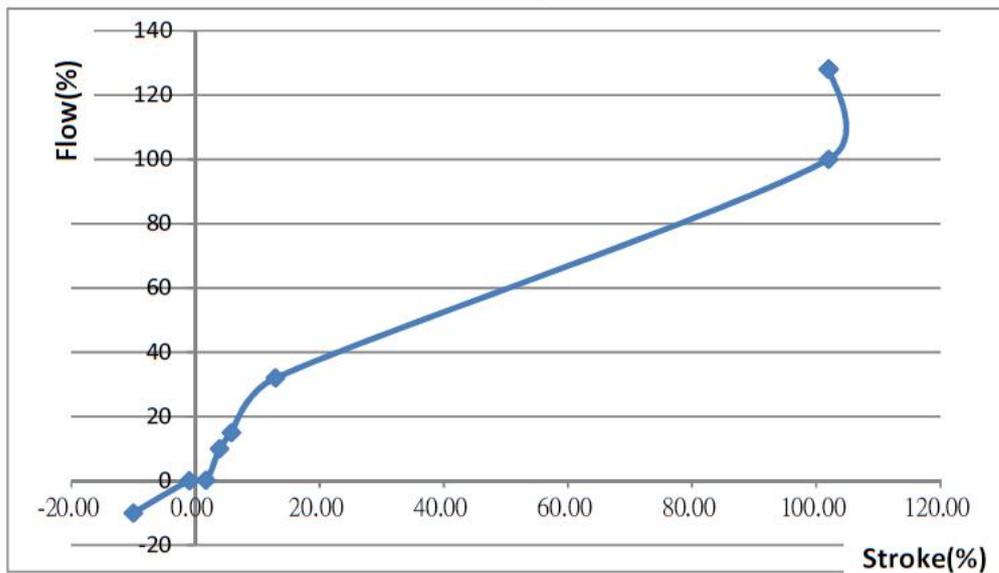
6. MSV Valve Calibration

Mark V Control Constant

Index	KMSV_TRO	KMSV_FLO
0	-10.00	-10
1	-1.00	0
2	1.70	0.2
3	3.90	10
4	5.80	15
5	12.90	32
6	102.00	100
7	102.00	128
8	102.00	128
9	102.00	128

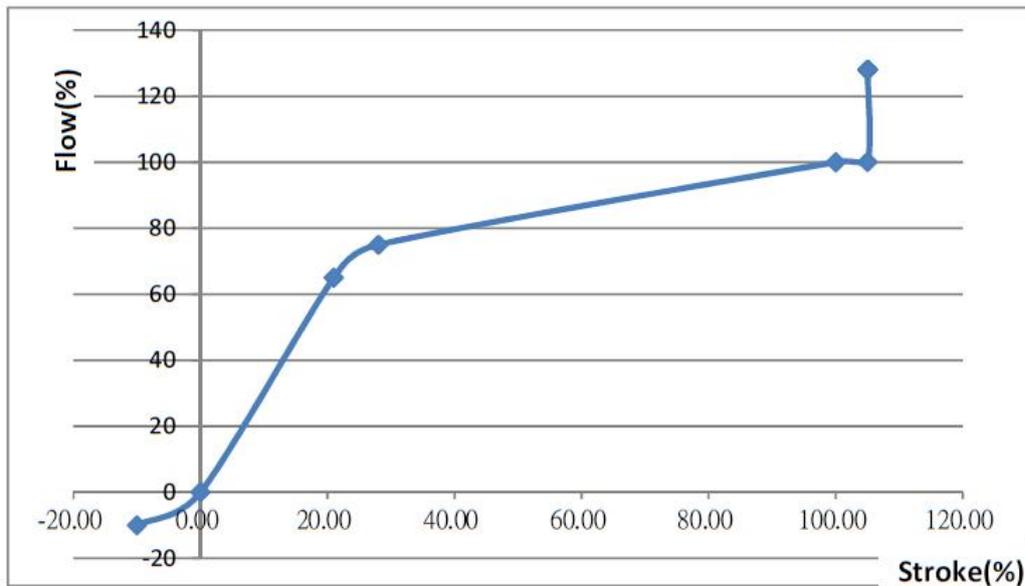
7. RIV Valve Calibration

Mark V Control Constant

Index	KMSV_TRO	KMSV_FLO
0	-10.00	-10
1	0.00	0
2	21.00	65
3	28.00	75
4	100.00	100
5	105.00	100.1
6	105.00	128
7	105.00	128
8	105.00	128
9	105.00	128

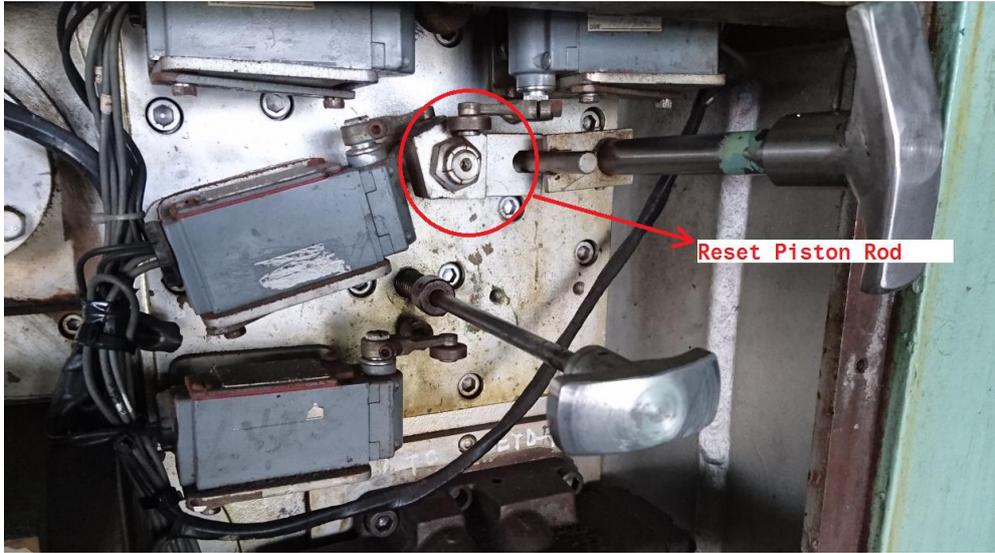
(2) When the unit finished the mechanical overspeed test, the turbine cannot be reset. It is still not working to pull the manual reset handle in the front standard. The turbine tripped once and again when the manual reset handle return to original position. It seems that the reset mechanism has problem. The reset piston stocked and could not hold the trip trigger at reset position. Finally, the reset piston rod (refer to the following figure)was pulled manually ,and then the turbine reset successfully. On the next outage opportunity, the turbine trip and reset mechanism should be disassembled, inspected and washing the sludge out.

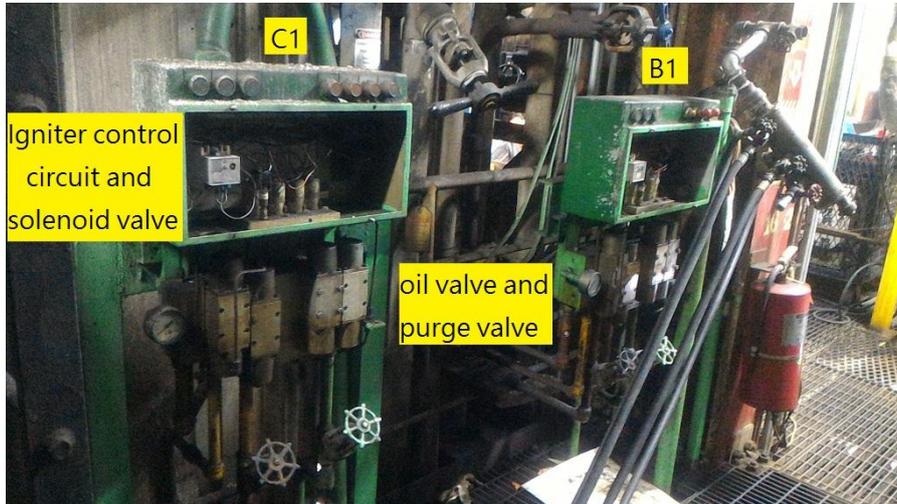
FIGURE 1. OLD IGNITER LOCAL CONTROL PACKAGE (B1 & C1)

The oil valve and purge valve of the Igniter system is too old to find repair kits, and hard to prevent valve leakage. But the new oil valve and purge valve did not have this weakness. Using the pneumatic actuator to drive oil and purge valve could have quick response and the limit switch of the actuator could feedback right position to the control system.

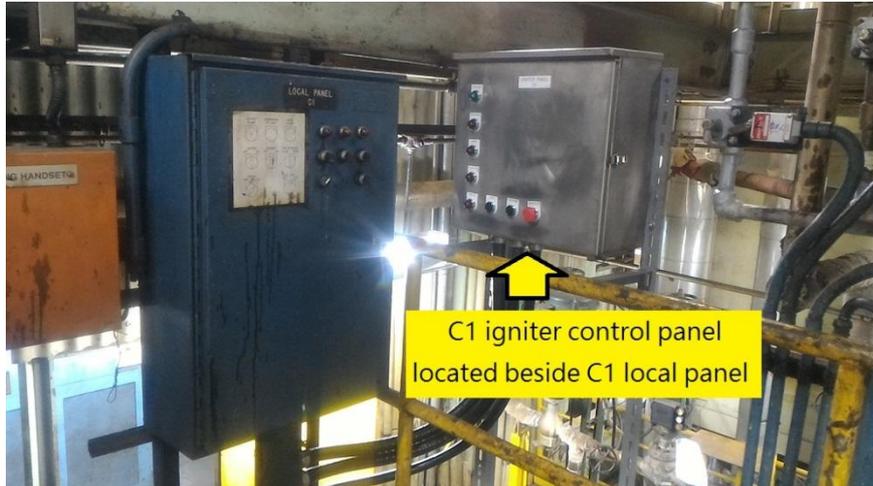
FIGURE 6. C1 IGNITER CONTROL PANEL

We relocate the igniter control panel for real use and nearby the Igniter which control by the control panel. Igniter control panel of B1 & B2 are located at the same place, but C1 & C2 are located nearby C1 & C2 burners. (figure 6 & 7)

New Igniter control wiring schematic is quite simple and easy to maintain.

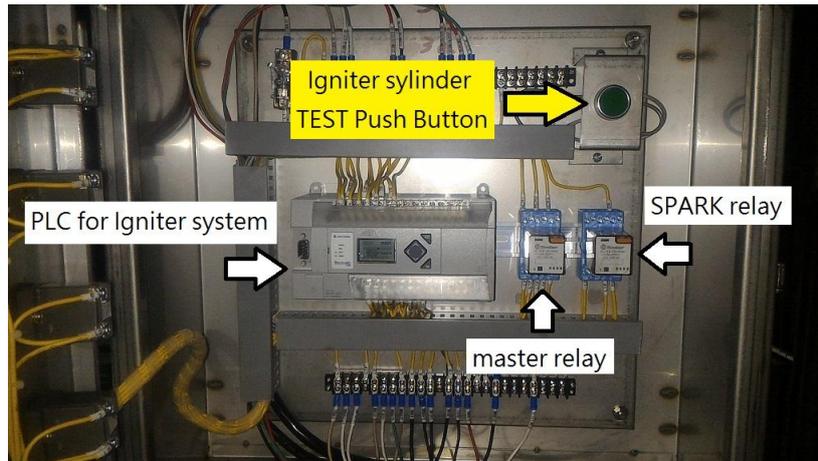
FIGURE 8. PLC INSIDE IGNITER CONTROL PANEL

There is a Allen-Brandley Micro logix 1400 PLC in the igniter control panel(Figure 8), all control sequence had programmed into ladder logic and download to the PLC.

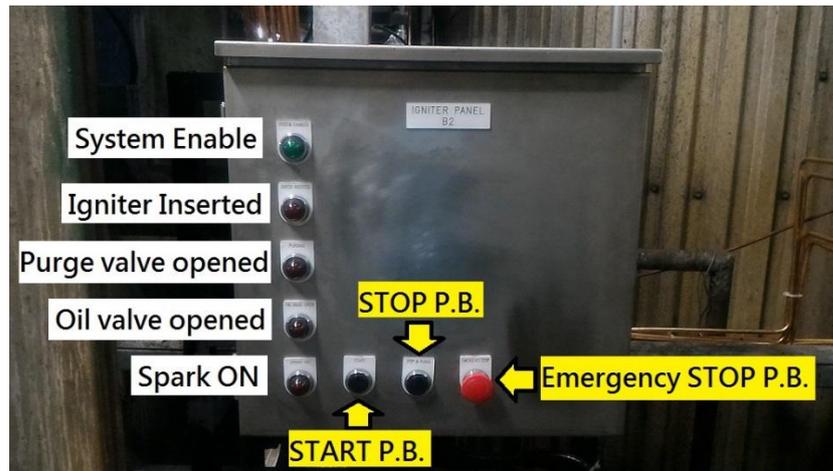
FIGURE 9. INDICATOR LIGHT AND PUSH BOTTOM OF IGNITER CONTROL PANEL

New igniter control panels have START, STOP and Emergency STOP push buttons on the panel that could let operators operate the Igniter in the field, and have 5 indicator light to show the status of the Igniter system. These indicator lights will help operators more understanding the sequence of the Igniter system. (Figure 9) The following description are the functions of the indicator lights and push buttons.

EMERGENCY STOP P.B.: press to STOP igniter and FORCE retract igniter immediately, maintained type N.C. contact.

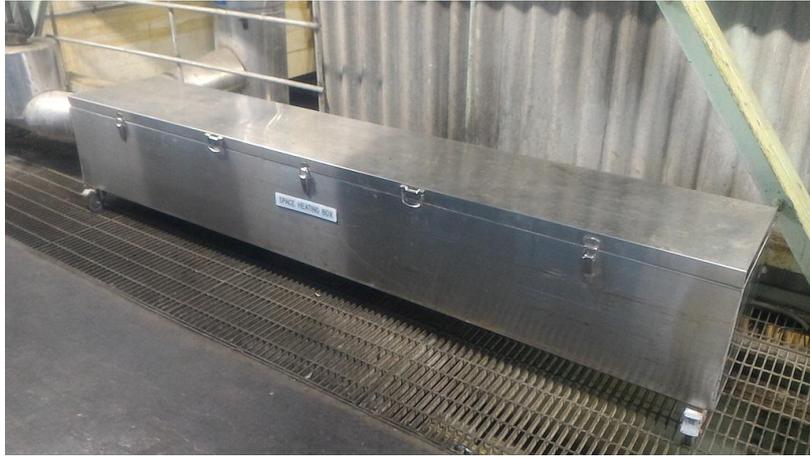
FIGURE 10. HEATING BOX

This project has to install a space heating box for protecting Igniter probe tips from moisture at long time outage. For the experience, when the unit is in outage period, the temperature will cool and make moisture inside the igniter probe rods and tips. If we did not remove the moisture, the igniter probe tip can't get good spark to light off the igniter. Put the igniter probe tips into a heating box to keep it stay dry and prevent moisture.

Igniter probe Supply power is 220VAC and temperature setting range is from 20°C ~80°C (68°F ~ 176°F).The box is shown in Figure 10.

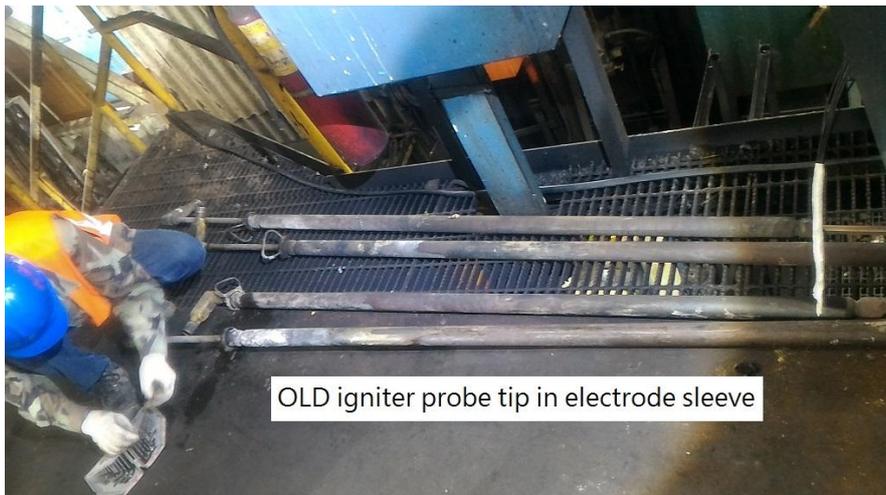
FIGURE 11. OLD IGNITER PROBE TIP IN ELECTRODE SLEEVE

The OLD igniter Probe tips and power unit did not provide strong SPARK to light off the Igniter, and electric leakage on the connector and shell that could cause light off failure of the igniter.

This project is to remove the existing Igniter probe package and replace new one. The new igniter probe package includes igniter probe tips and power unit. Both of them should be replaced for a new one.

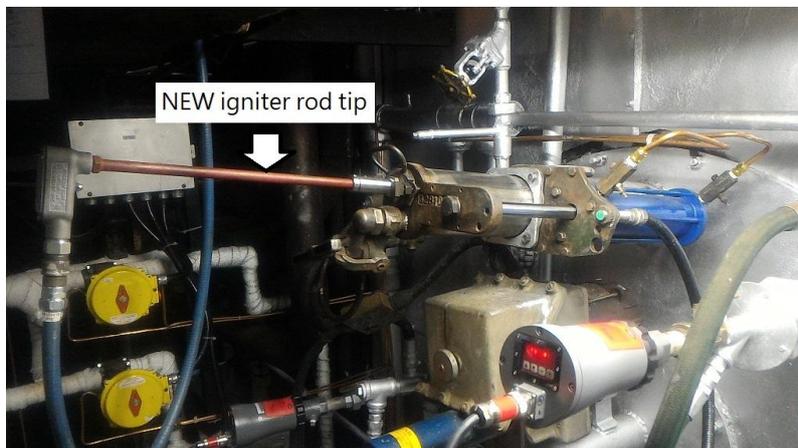
FIGURE 13. NEW IGNITER ROD TIP IN B1

New Igniter probe tips and power units are provided from Porney called “High Energy Spark Igniter (HESI)”. The length of spark rod tip is 96 inch, connecting cable is 20 feet.

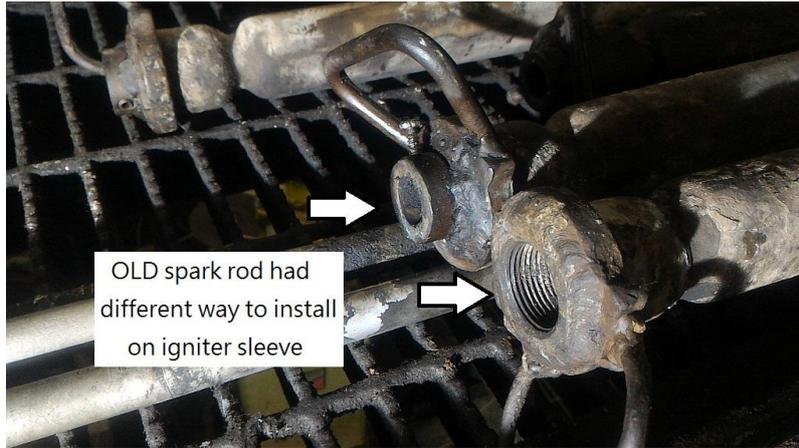
FIGURE 15. IGNITER SLEEVE FOR SPARK ROD (BEFORE)

The OLD spark rod had different way to install on igniter sleeve and all can't adjust the depth insert to the boiler. That may cause the spark is not in the right position to light off the igniter, and make the igniter hard to light off.

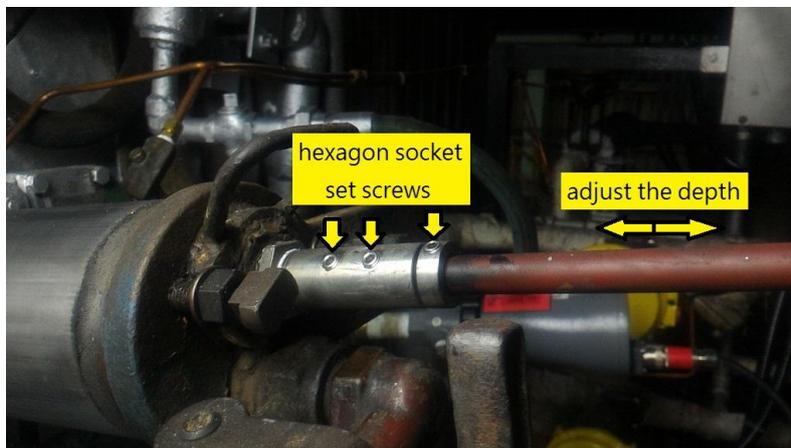
FIGURE 16. IGNITER SLEEVE FOR SPARK ROD (AFTER)

The original design of the depth of igniter rod tip is 8 inch, and we adjust the depth of the spark rod tip match the original design.

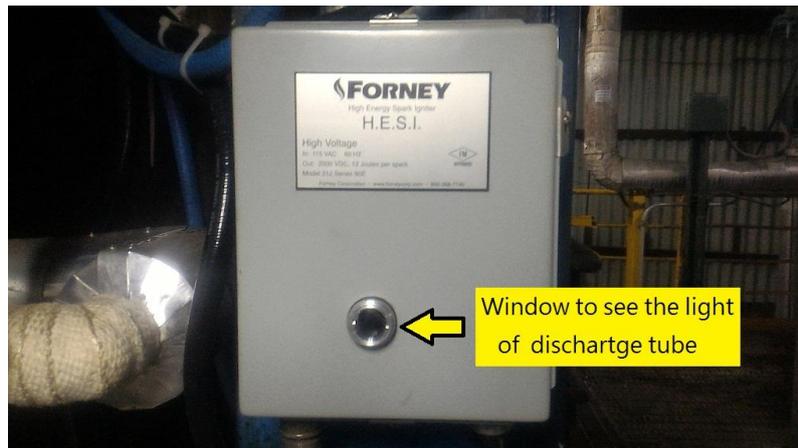
FIGURE 18. WINDOW OF IGNITER POWER UNIT

When the spark rod tip is inserted to the boiler and start spark, no one knows does it work or not. The only way to know is listen to the sound of the spark when it ignition, but it is hard to listen to the sound in the field. The new igniter power unit provide a window to see the light of the discharge tube when it ignition. That is easy to know the spark rod tip is working or not.

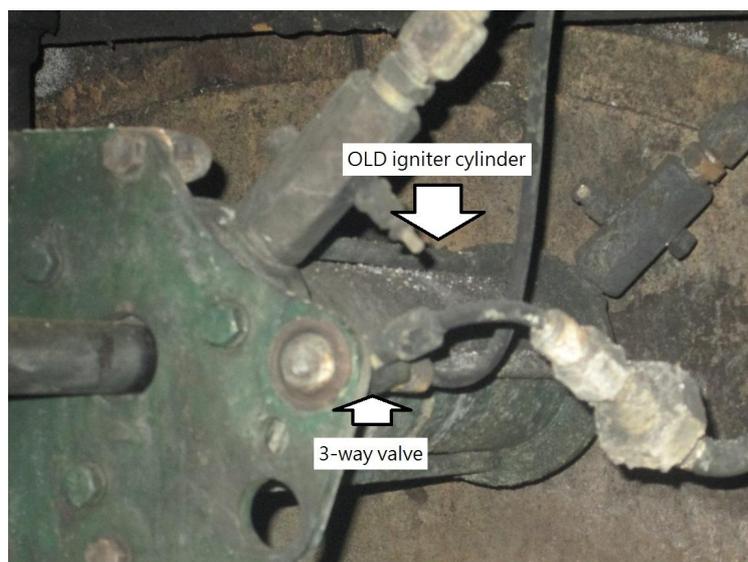
FIGURE 19. OLD IGNITER CYLINDER

Old pneumatic igniter cylinder is a very old and no piston seal type of cylinder. New igniter cylinder has seal between piston and cylinder to prevent air leakage and keep the cylinder working well.

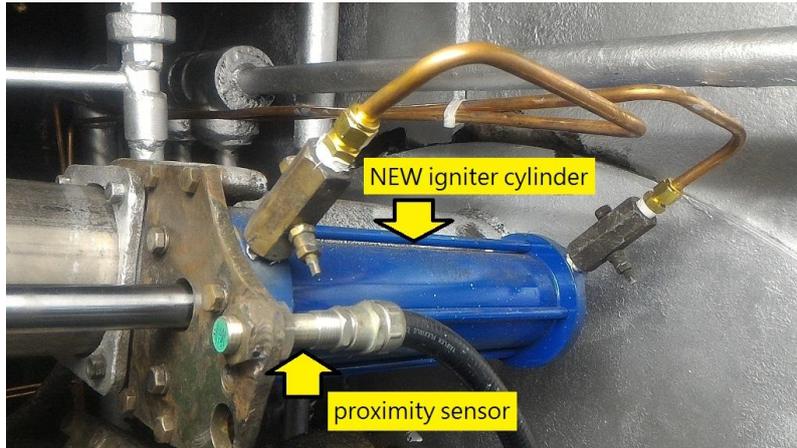
FIGURE 20. NEW IGNITER CYLINDER

Here also replace the old 3-way valve to proximity sensor. The function of the 3-way valve is let igniter control system know the igniter gun is really extend to the fully extended position. The proximity sensor has the same function as the 3-way valve in the new PLC control system.

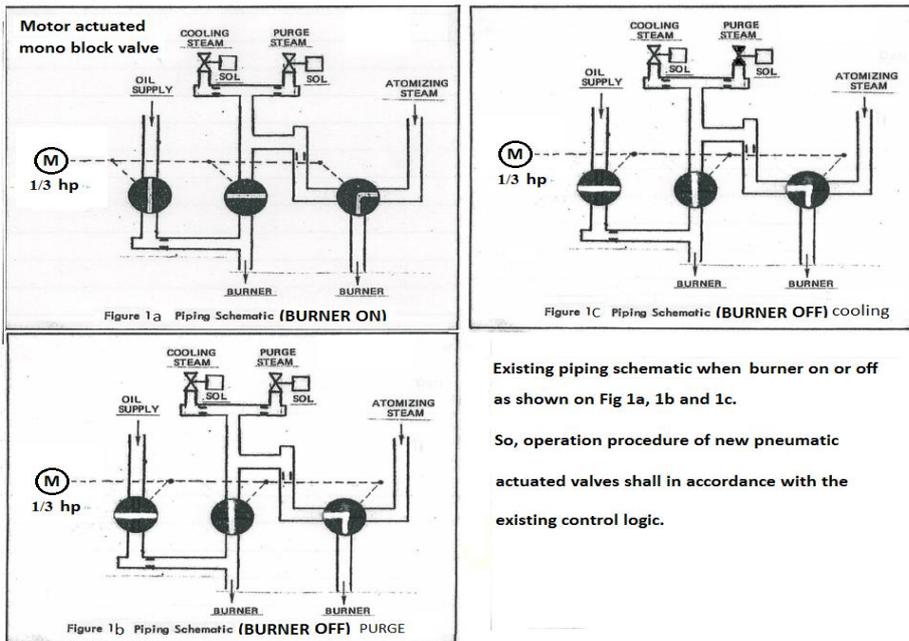
FIGURE 21. CONNECTION & VALVE POSITION DRAWING OF MONO BLOCK VALVE

The existing Main Burner Mono Block Valve is the key equipment for supplying fuel and atomizing media to main burner. Mono Block Valve composed of 1 motor, 1 limit switch, 2 2-way valve and 1 3-way valve. The pipe connection and valve position drawing shows in figure 21 & 22.

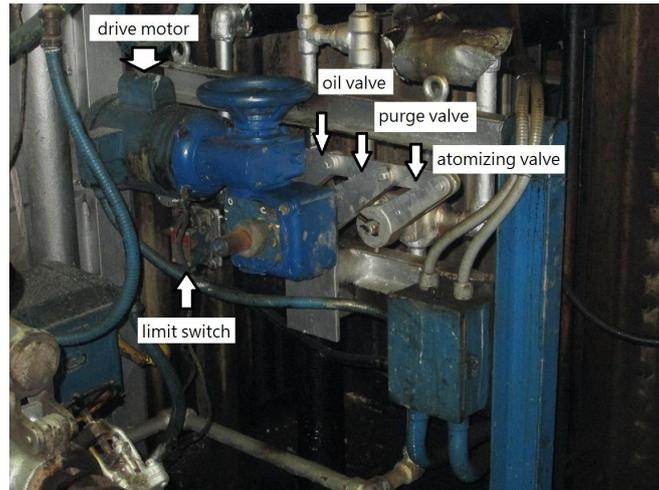
FIGURE 22. MONO BLOCK VALVE

Mono block valve is use a 1/3 motor to drive oil, purge and atomizing valves at the same time , and the motor stop command is come from the limit switch when the drive arm touch the limit switch. All the three valves have the same stroke, if one valve did not match the right position, that valve will leakage. If the limit switch did not adjust well, the motor will over travel and stop due to the motor overload. That will cause the main burner light off failure.

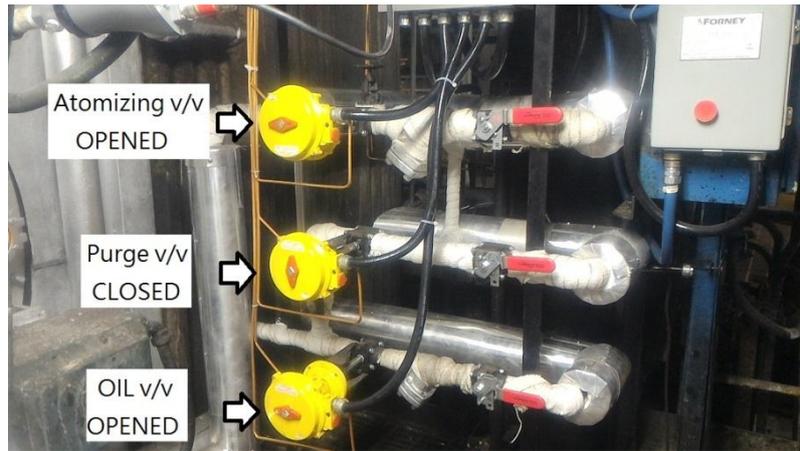
FIGURE 23. NEW PNUMATIC ACTUATED VALVE IN OPERATION

- A. Fast action and response of the valve.
- B. Control the valve one by one to prevent leakage.
- C. Two limit switches for open and close position can get the position accurately.
- D. Simple and easy to maintain.

The pneumatic actuated valve needs a solenoid valve to change the direction of the air inlet path to the actuator and drive the valve open or close. There are two solenoid valve panels located beside the burner front, each panel has 12 solenoid valves for 2 burners (B1&C1 or B2&C2). Those solenoid valves are driving the following valves.

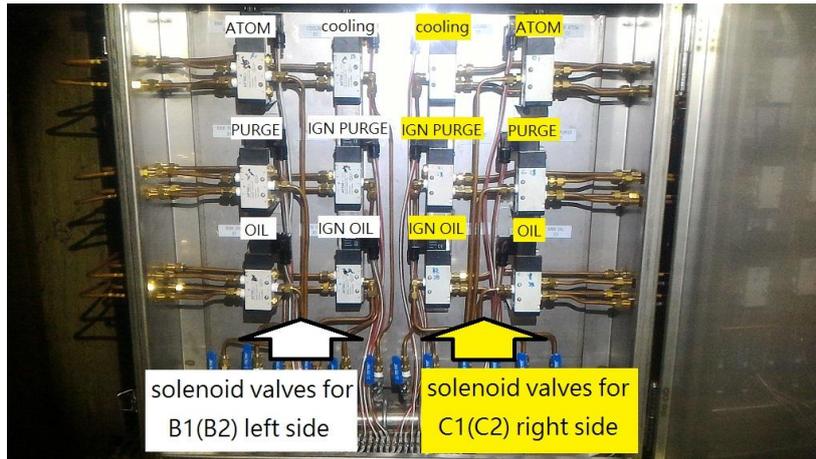
FIGURE 24. SOLENOID VALVE PANEL LAYOUT

The location of the solenoid valves are match valves in burner front physically. Both solenoid valve panel have same layout for the solenoid and have tags beside the solenoid valve to know which it drive. (Figure 24)

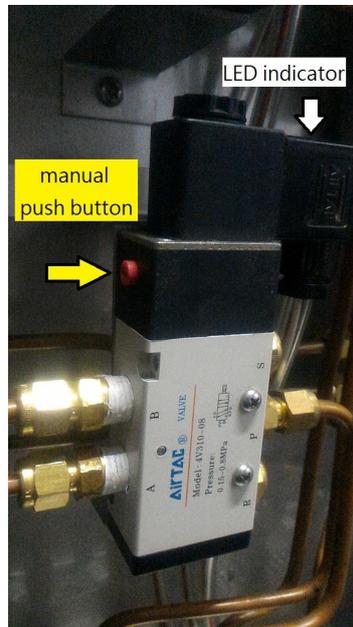
FIGURE 25. SOLENOID VALVE

Every solenoid valve has 1 LED indicator to indicate when the coil energized. There is a RED manual push button on the solenoid valve, when pressed the manual push button that will force the solenoid valve into energize function immediately and drive the pneumatic driven valve open. (Figure 25)

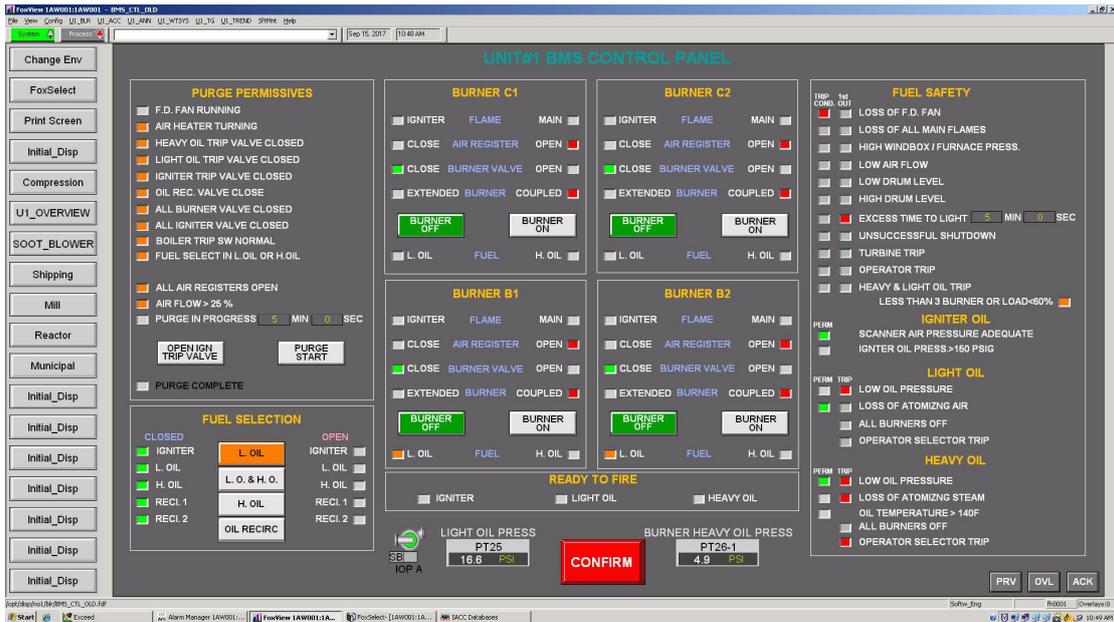
FIGURE 26.CONTROL GRAPHIC BEFORE MODIFICATION

There are more controlled signals feedback from burner front before renovate mono block valve to be pneumatic actuated. The advantage is operator can get more information from burner front and handle all well. Here are the control graphics before and after modification.(figure 26 & 27).

We only have 8 signals from burner front before, that are Igniter & main FLAME signals, air register OPEN or CLOSE position signals, Impeller EXTEND position signal & burner COUPLED signal. Right now we have 14 signals from burner front, the new added signals are:

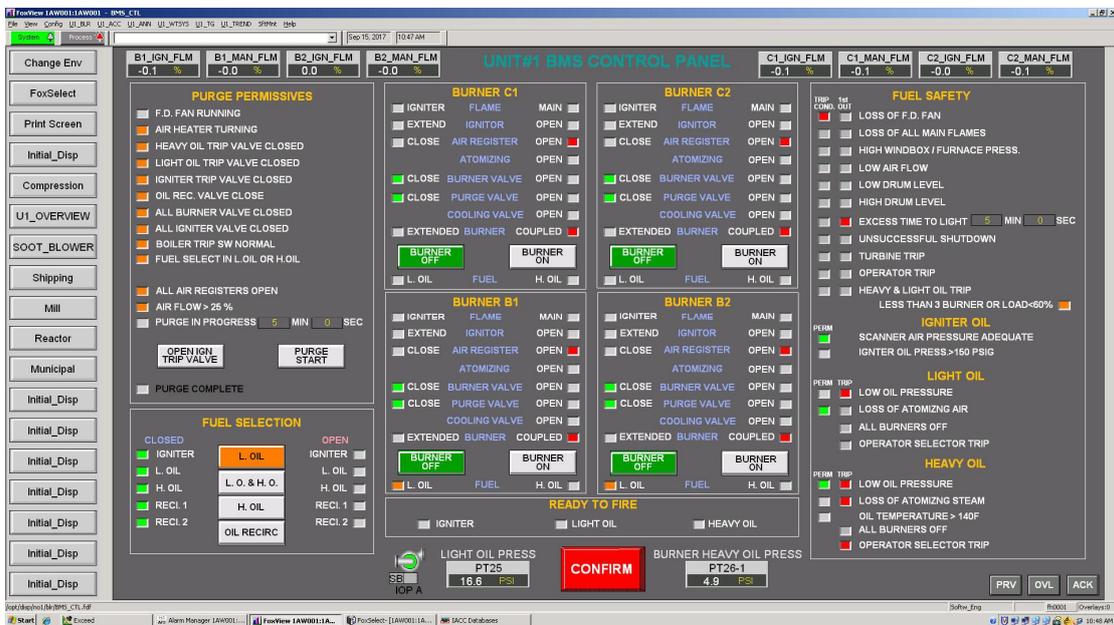
FIGURE 27.CONTROL GRAPHIC AFTER MODIFICATION

Those signals provide all information of burner front to the operator to handle the burner.

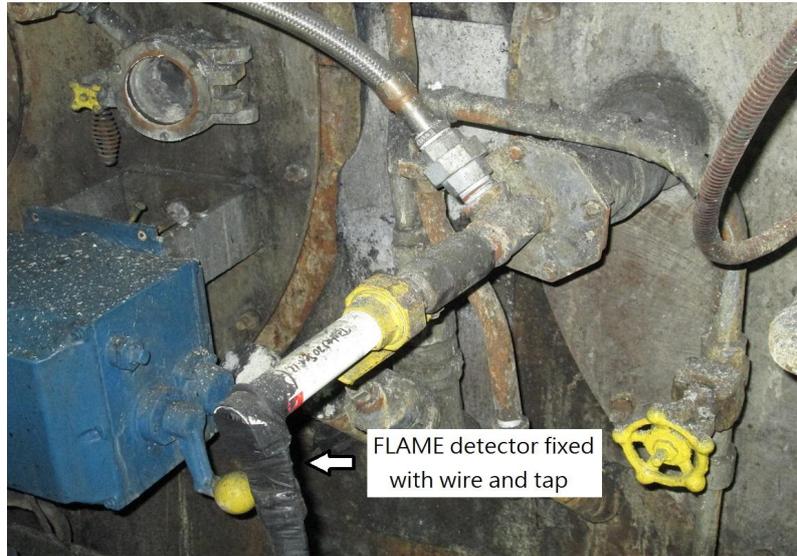
FIGURE 28.FLAME DETECTOR BEFORE MODIFICATION

There are 8 flame detectors in burner front to detect the flame of 4 igniters and 4 main burners. The old igniter and main flame detectors are old, out of phase and hard to find spare parts to maintain. Most flame detectors in burner front are in poor condition.

The old flame detectors are amplifier type, flame detector in burner front to detector the flame of the burner and send signal to the amplifier module in the electric room, the amplifier module analyze the signal and determine the

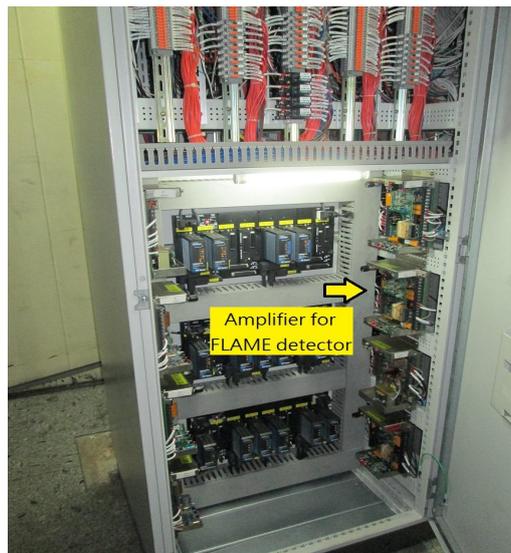
FIGURE 30.AMPLIFIER FOR FALEM DETECTOR

flame is ON or OFF, if the flame detector detect the flame, the amplifier module send a **FLAME ON** signal to **BMS**(Burner Management System).

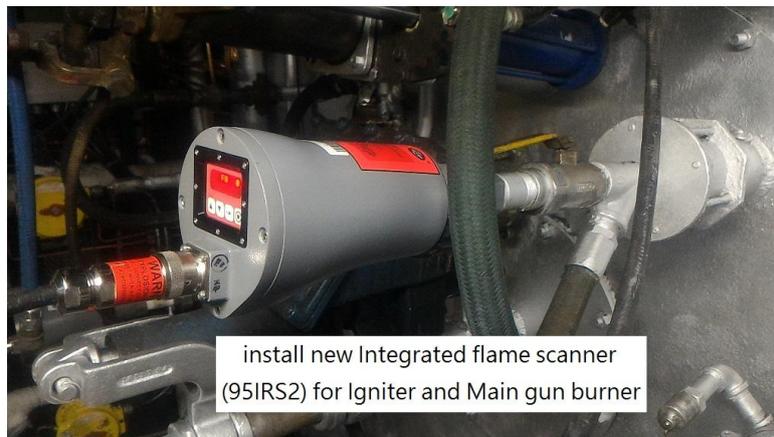
This project needs to replace the old flame detectors with NEW intelligent integrated flame detectors with internal flame relay model. The new intelligent integrated flame detectors are made by FIREYE type is 95IRS2. 95IRS2 have 21 choices of flame flicker frequency, adjustable sensor gain, adjustable flame relay ON/OFF thresholds, 4-20mA analog signal strength output, fault relay and 4 selectable programmable files to store setting. And we could remote communication via Fireye software in laptop. All settings could be set via keypad on the 95IRS2 scanner.

The NEW 95IRS2 flame detector in burner front shows in figure 21

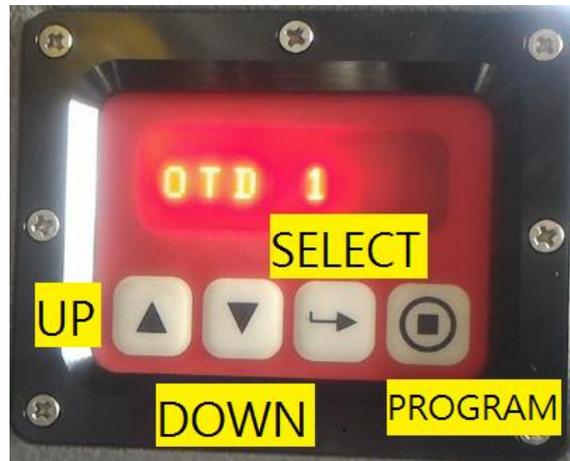
FIGURE 32.DISPLAY AND PUSH BUTTON ON 95IRS2

We can use the push button on the flame detector to change the settings, the display and push button shows in figure 31.

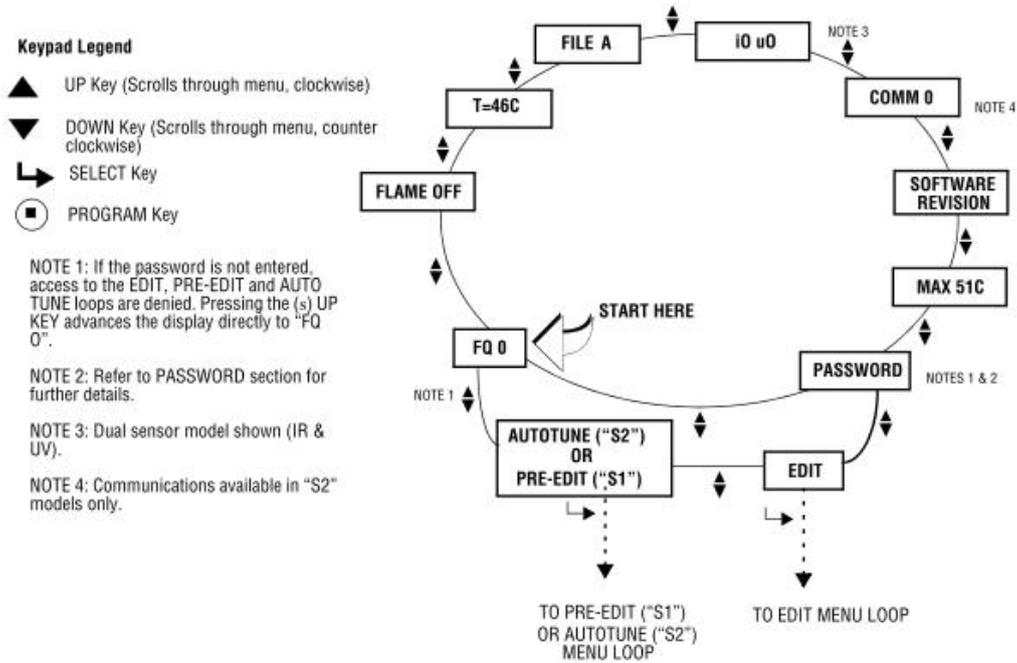
FIGURE 33.STATUS MENU OF 95IRS2

TEXT DISPLAYED	DESCRIPTION	POSSIBLE VALUES
FQ 0	Flame Quality (scanner output)	0-100
FLAME OFF	Flame Relay status	ON, OFF
T= 46C	Present Scanner temperature	+32°F to 212°F (0°C to 100°C)
File A	Scanner file in operation	A,B,C,D
i 0 u 0	Signal strength, IR and UV (dual sensor models)	0-999
COMM 0	Communication address ("S2" models only)	0-127
FIREYE INSIGHT 95XXXX VX.X	Scanner part number and software revision	
MAX XXX°C (XXX°F)	Scanner Temperature, exposure (stored) maximum	-40° F to 185°F (-40°C to 85° C)
PASSWORD	A Password is required to enter the EDIT, PRE-EDIT or AutoTune menus. See PASSWORD section.	0000-9999

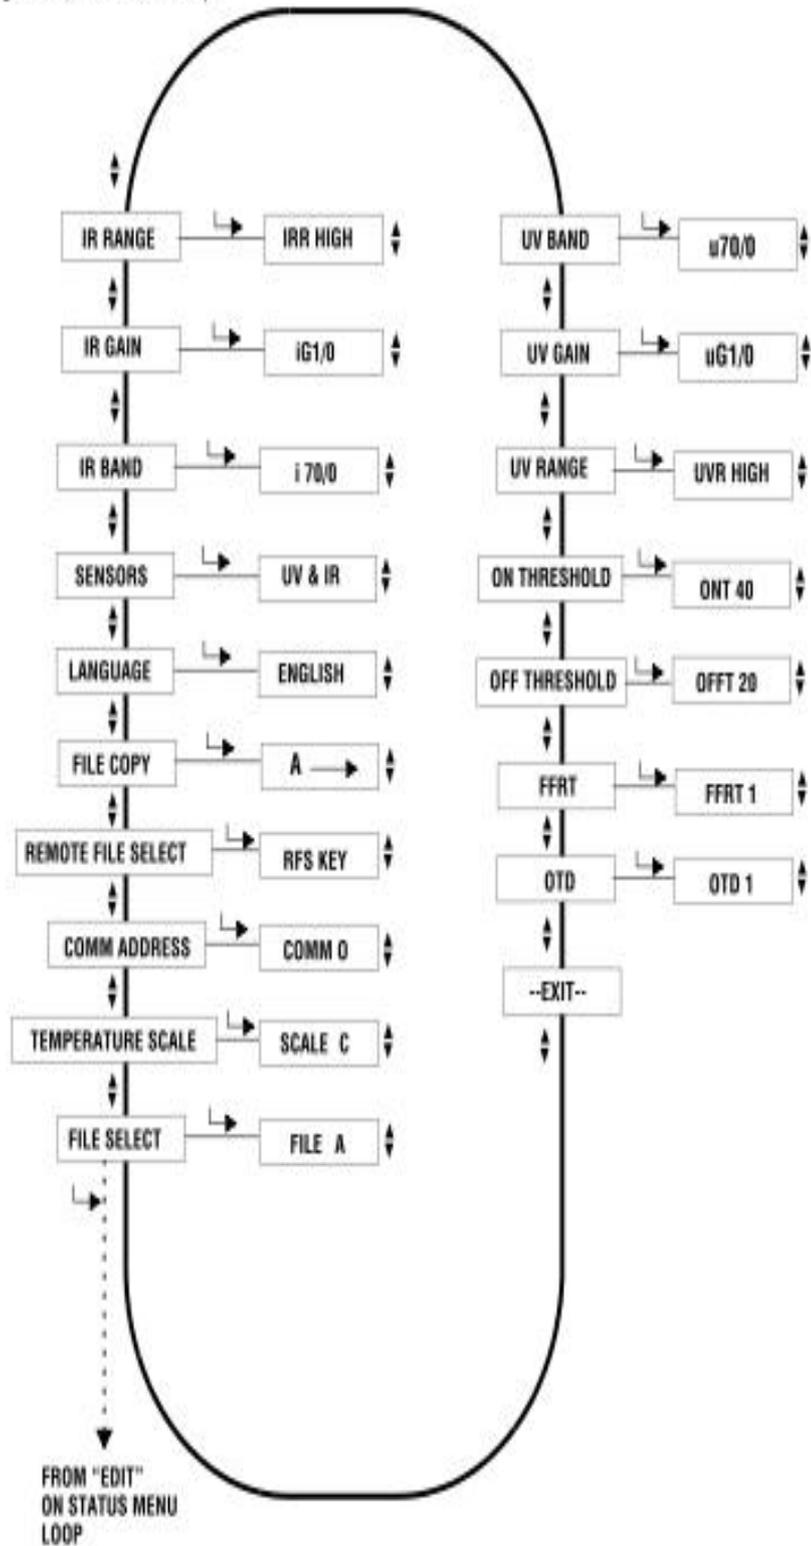
FIGURE 35.EDIT MENU OF 95IRS2

TEXT DISPLAYED	DEPRESS 'SELECT' KEY, TEXT DISPLAYED	POSSIBLE VALUES (UP/DOWN KEYS)
File Select	FILE A	"S1" models: A,B "S2" models: A,B, C, D
Temperature Scale	Scale C	C, F
Comm address ("S2" only)	COMM 0	0-127
Remote File Select	RFS KEY	"S1" models: KEY, LINE "S2" models: KEY, LINE, COMM* *(Comm not available in "E" models)
File Copy	A-> (See File Copy Section)	
Language	English	English
Sensors (Dual Sensor Models Only)	UV + IR	UV + IR, IR Only, UV Only
IR Band	i70/ 0 (IR Frequency selected/Signal strength)	"S1" Models: 23, 70, 117 "S2" Models: 23, 31, 39, 46, 54, 62, 70, 78, 85, 93, 101, 109, 117, 125, 132, 140, 148, 156, 164, 171, 179 Hz
IR Gain	iG1 / 0 (IR Gain selected/ Signal strength)	1 - 31
IR Range	IRR HIGH	HIGH, LOW
UV Band	u70/ 0 (UV Frequency selected/Signal strength)	"S1" Models: 23, 70, 117 "S2" Models: 23, 31, 39, 46, 54, 62, 70, 78, 85, 93, 101, 109, 117, 125, 132, 140, 148, 156, 164, 171, 179 Hz

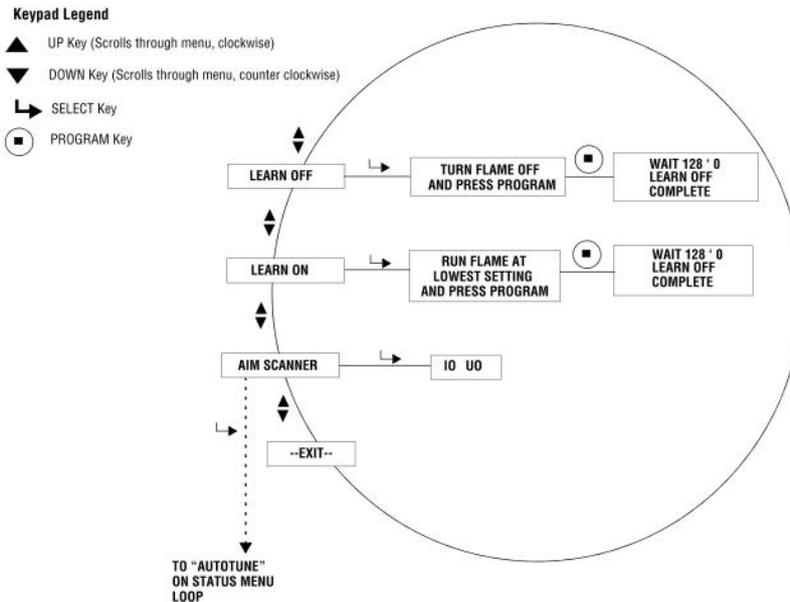
FIGURE 37.AUTOTUNE MENU OF 95IRS2

AUTOTUNE MENU: From the AutoTune menu, the user views the flame signal intensity and physically aims the scanner for optimum signal. The user then commands the InSight scanner to analyze the flame ON and OFF (background radiation) conditions, and automatically select the optimum

TEXT DISPLAYED	DEPRESS "SELECT" KEY TEXT DISPLAYED	DEPRESS "PROGRAM" KEY TEXT DISPLAYED
Aim Scanner	I 0 U 0 (Possible Values 0-60)	
Learn On	Run Flame at Lowest setting and press PROGRAM	WAIT 128 - 0 (Counts down to 0 within 20 seconds, then displays "Learn ON complete")
LearnOff (only displayed if Learn ON had been performed)	Turn Flame OFF and press PROGRAM	WAIT 128 - 0 (Counts down to 0 within 20 seconds, then displays "Learn OFF complete")
--Exit--	AutoTune (Returns you to STATUS loop)

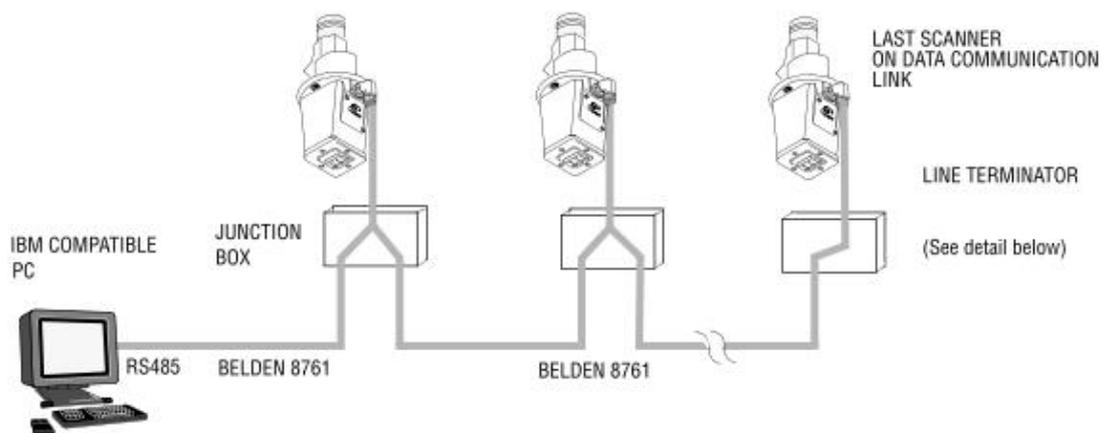
FIGURE 40 COMMUNICATION WIRING OF 95IRS2 FLAME DETECTORS

The communication wiring of flame detectors is shown in figure 40. Most new IBM compatible PC did not have RS485 port, there is a RS485 to USB converter used for communicating with 95IRS2 flame detectors.

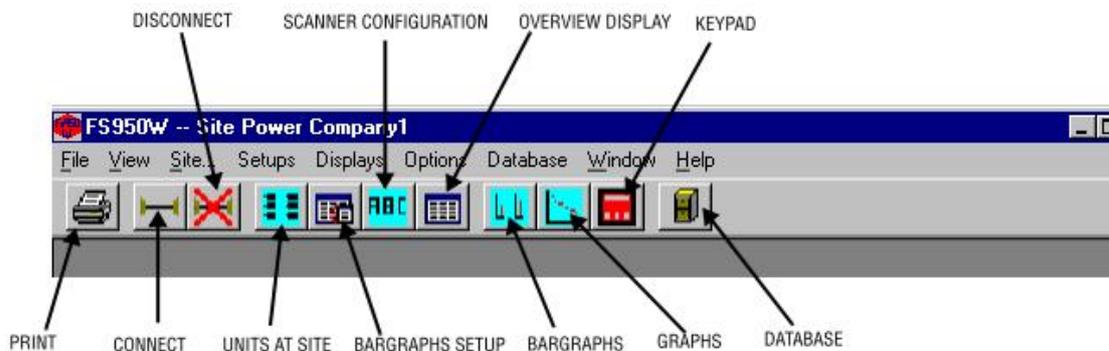
FIGURE 41 THE FUNCTION OF THE TOOLBAR

The “CABRAS UNIT” database had created in FS950W, and there are 8 flame detectors in the database. We shall click the “CONNECT” pushbutton on the toolbar to connect the flame detectors in the burner front, the function of the toolbar shows in figure 41. The useful tools are “SCANNER CONFIGURATION”, GRAPHS” and “KEYPAD”.

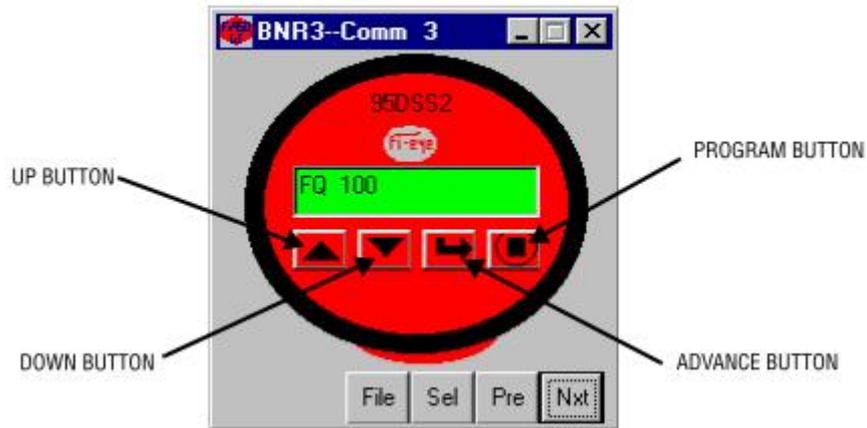
FIGURE 42 THE KEYPAD SCREEN

KEYPAD: The “Keypad” Screen (figure 42) duplicates the action of the detector keypad display in the field. User can set all setting in front the laptop and don’t need go to the burner front.
