4000 噸級巡防艦主機廠試 出國報告

服務機關：海洋委員會海巡署艦隊分署

本次為海洋委員會海巡署艦隊分署 4000 噸級巡防艦 4 艘統包採購案 (契約案號：B107240) 首艘艦主機工廠測試 (Factory Acceptance Tests , FAT)，於德國 MTU 主機工廠(福吉沙芬 Friedrichshafen) 進行。

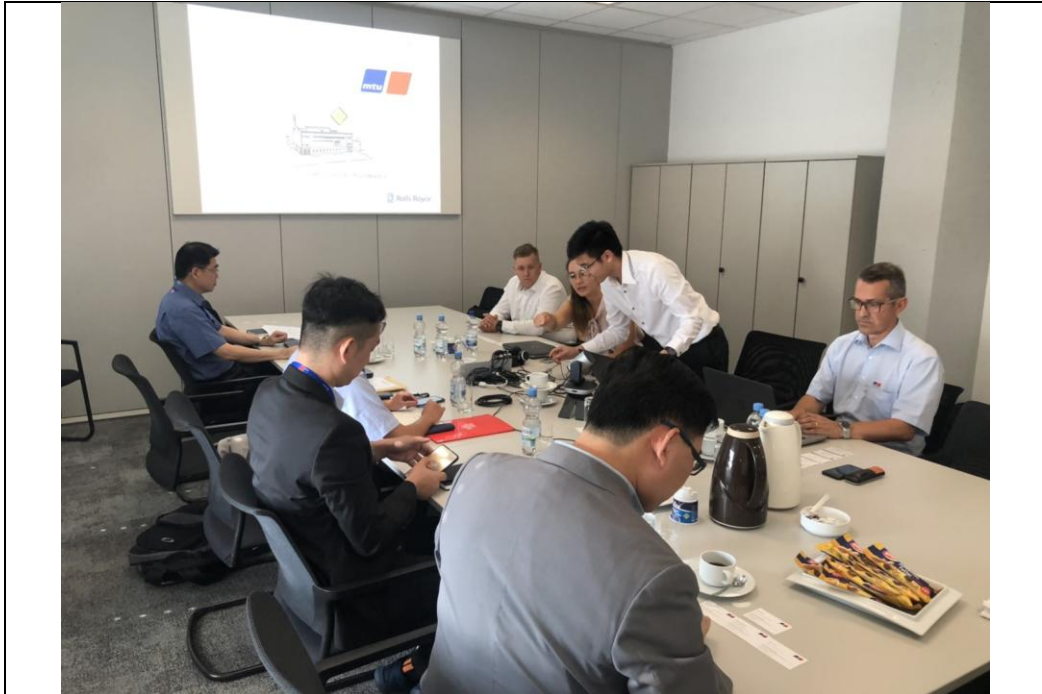
測試前會議

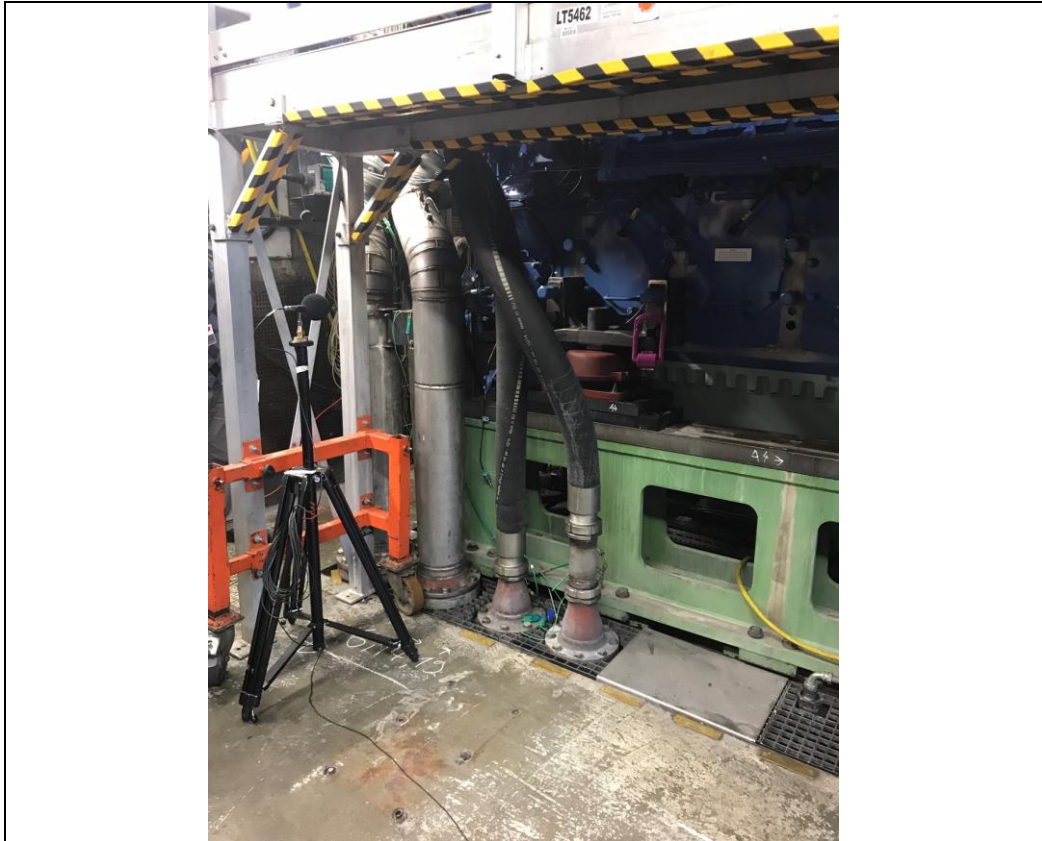
噪音測量

因受限於測試模台高度限制，本次廠試時未安裝進氣消音器，然於全負載運轉時噪音測試分析為 108.5 分貝，已低於規範要求之 110 分貝，未來安裝於艦上時將再加裝進氣消音器，於噪音抑制上將更優於規範要求。

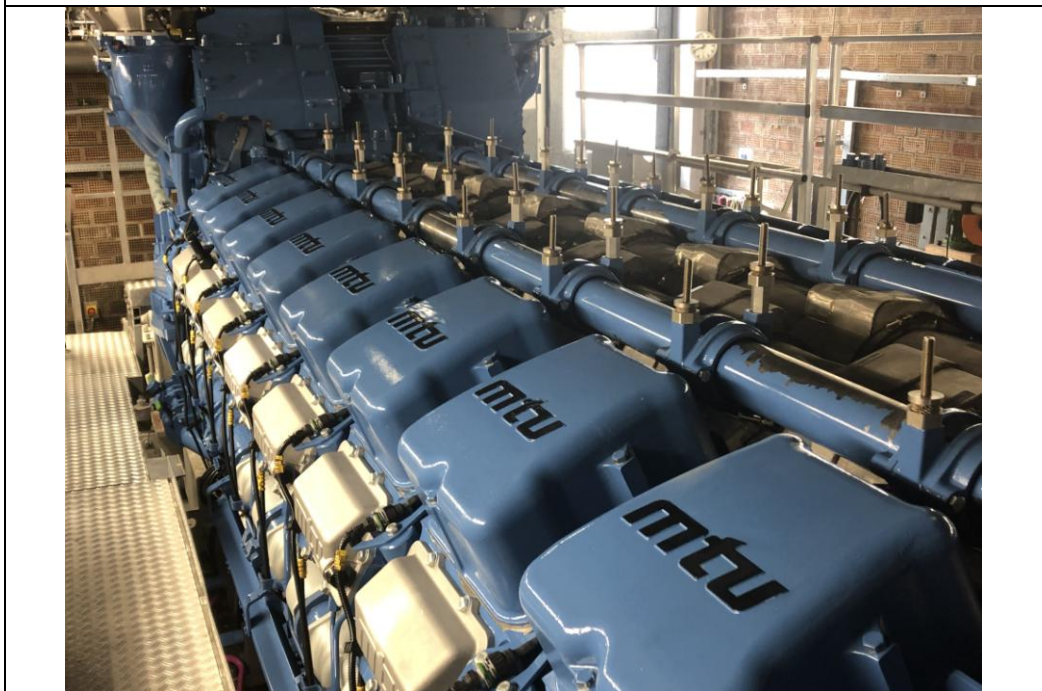
主機運轉測試

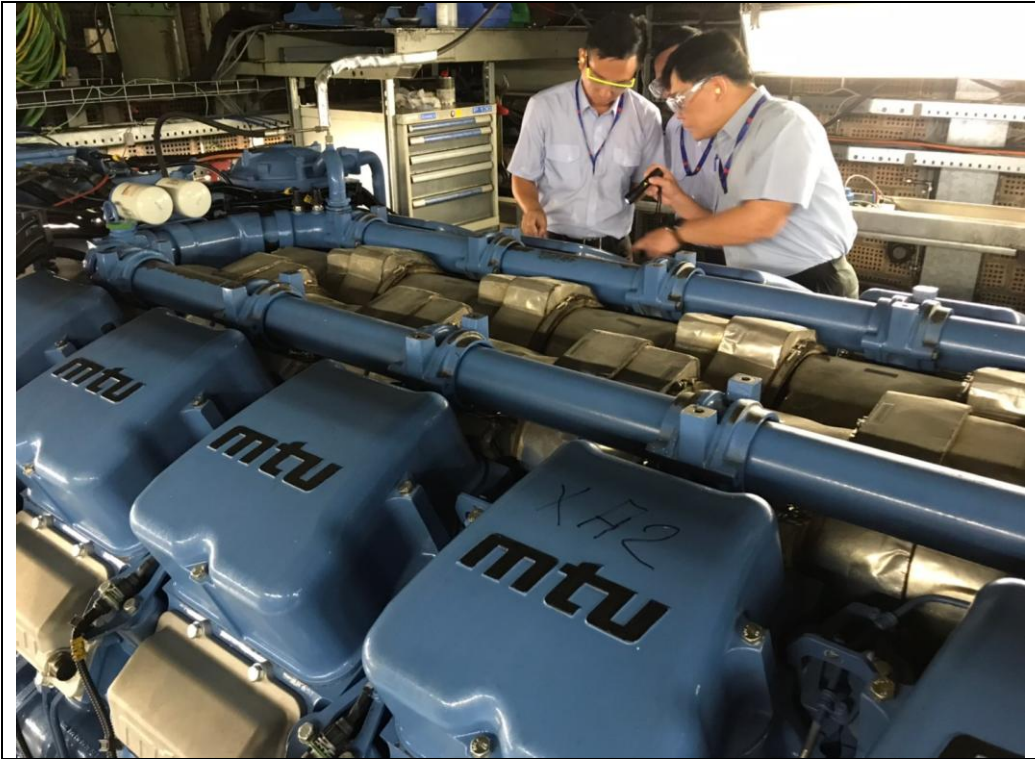
主機全負載時檢查是否有洩漏狀況

本次廠試除於全負載(9,100kw)運轉 2 小時測試外，更以 110%負載(10,010kw)運轉達 30 分鐘測試，且於全負載運轉期間多次檢視機件

均無任何洩漏狀況(如滑油、燃油等)，全般運轉測試完成後亦拆卸滑油過濾器檢驗，並經分析所濾殘渣中不含任何金屬成分，確保主機無不當磨耗，顯見設計餘裕充足，品質優異無虞。

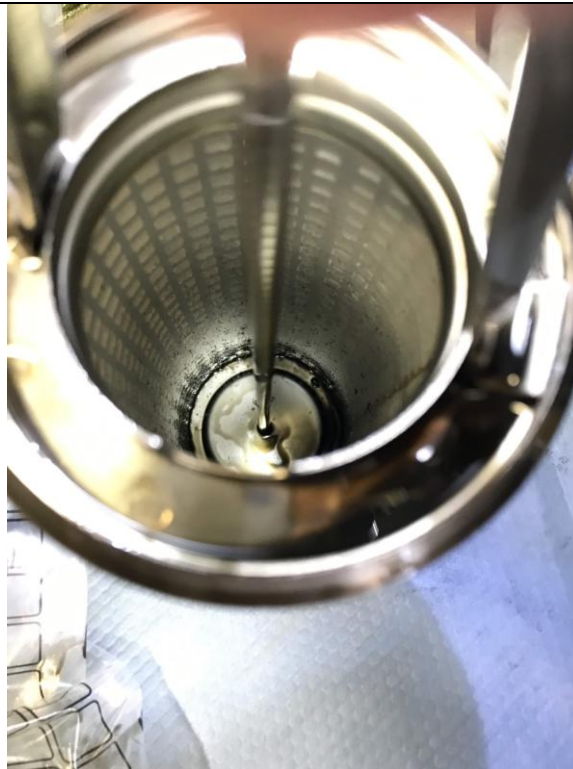
檢查滑油濾芯，以確定機件無異常磨耗情形

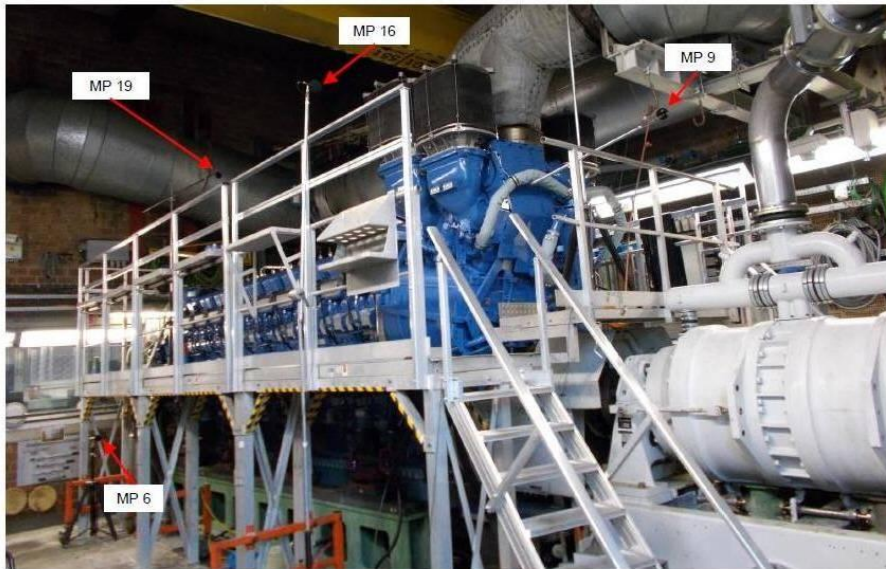
Installation of the 20V 8000 M71L in test cell 130 with indication of microphone positions

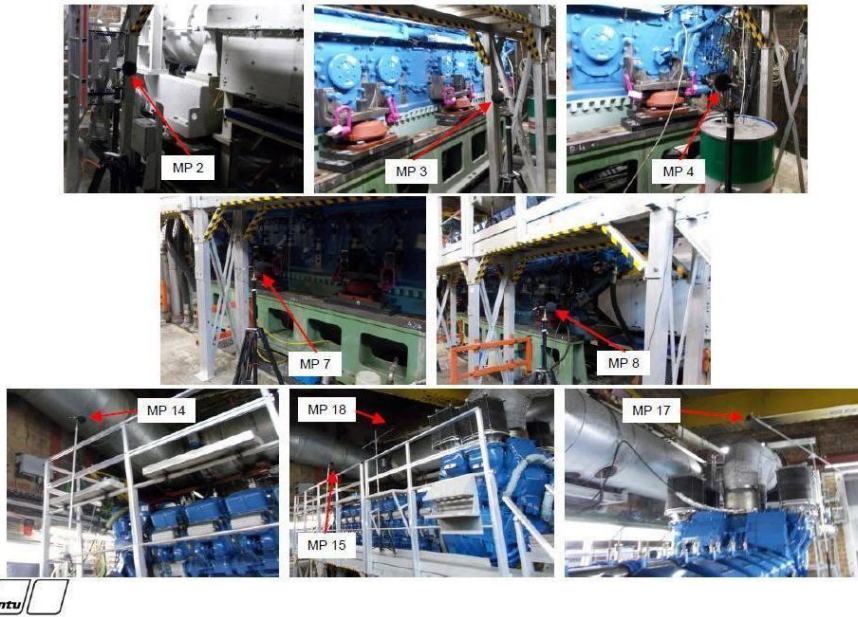
噪音測試報告紀錄-5

Airborne Noise Analysis - ISO 6798
 280 0000 M71L - eng. no. 569100319
 Taiwan Coast Guard - CPU - A1294675
 25.07.19 - MTU test cell 130
 9100 kW @ 1150 rpm - room levels

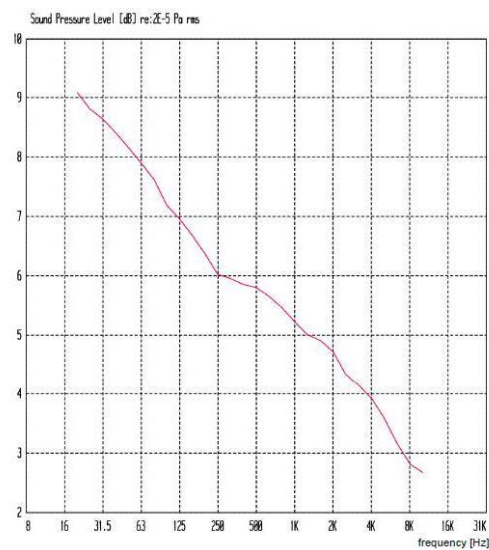
Airborne Noise Analysis - ISO 6798
 201 8888 N7/L - eng. no. 569188319
 Taiwan Coast Guard - CPU - A1284675
 25.87.19 - MTU test cell 138

! K2 - free field correction Lin: 28.8 La: 16.3

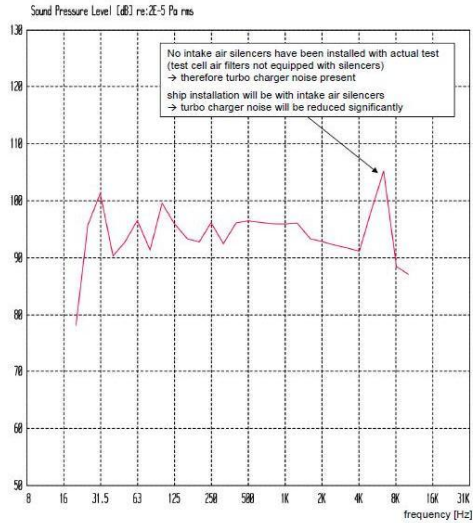
Airborne Noise Analysis - ISO 6798
 280 0800 MTU - eng. no. 569180319
 Taiwan Coast Guard - OPV - A1284675
 25.07.19 - MTU test cell 130
 9100 kW @ 1150 rpm - energy mean free-field levels

1 energy mean free-field levels Lin: 110.9 Lo: 100.5

Please note that with the actual noise test no intake air silencers have been installed as the test cell's air filters are not equipped with silencers; therefore the turbo charger noise peak at 6.3 kHz is dominating the spectrum (fig. 7). As the ship installation will be equipped with intake air silencers this peak will be reduced significantly. Fig. 8 shows that the actual measurement is similar to type approval measurements without silencers; therefore it is expected that with installed intake air silencers the result will be similar to type approval data with intake air silencers (dvg. no. 734 270e).

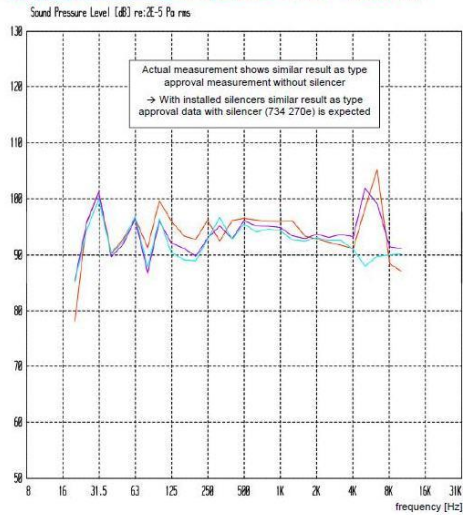
Airborne Noise Analysis - ISO 6798
 280 0800 MTU - eng. no. 569180319
 Taiwan Coast Guard - OPV - A1284675
 25.07.19 - MTU test cell 130
 9100 kW @ 1150 rpm - energy mean free-field levels

1 energy mean free-field levels - eng. no. 569180319 Lin: 110.9 Lo: 100.5
 2 energy mean free-field levels without silencers - type approval data Lin: 103.7 Lo: 107.4
 3 energy mean free-field levels with silencers - type approval data - 734 270e Lin: 100.8 Lo: 104.3

The overall A-weighted sound pressure level in 1 m distance to the engine is then expected to be at ca. 105 dB(A).

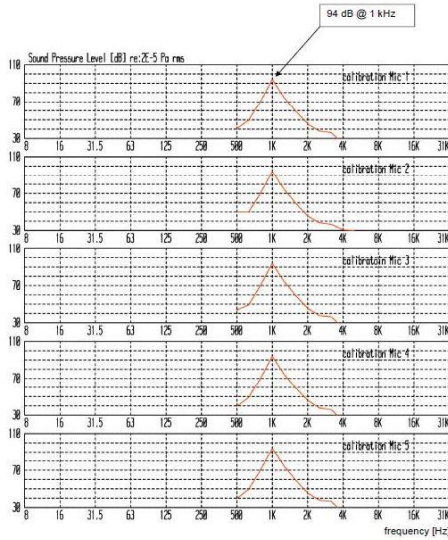
Airborne Noise Analysis - ISO 6798
 201 8888 MTU - eng. no. 569108319
 Taiwan Coast Guard - (PV) - A1204675
 25.07.19 - MTU Test cell 130
 calibration signals

Calibration signals and calibration certificates are given in figs. 9 to 12.
