Tsunami Impacting Eastern Japan and Preparedness for Extraordinary Natural Disaster

Takehiko Fujita

Executive Director Port and Airport Research Institute, Japan

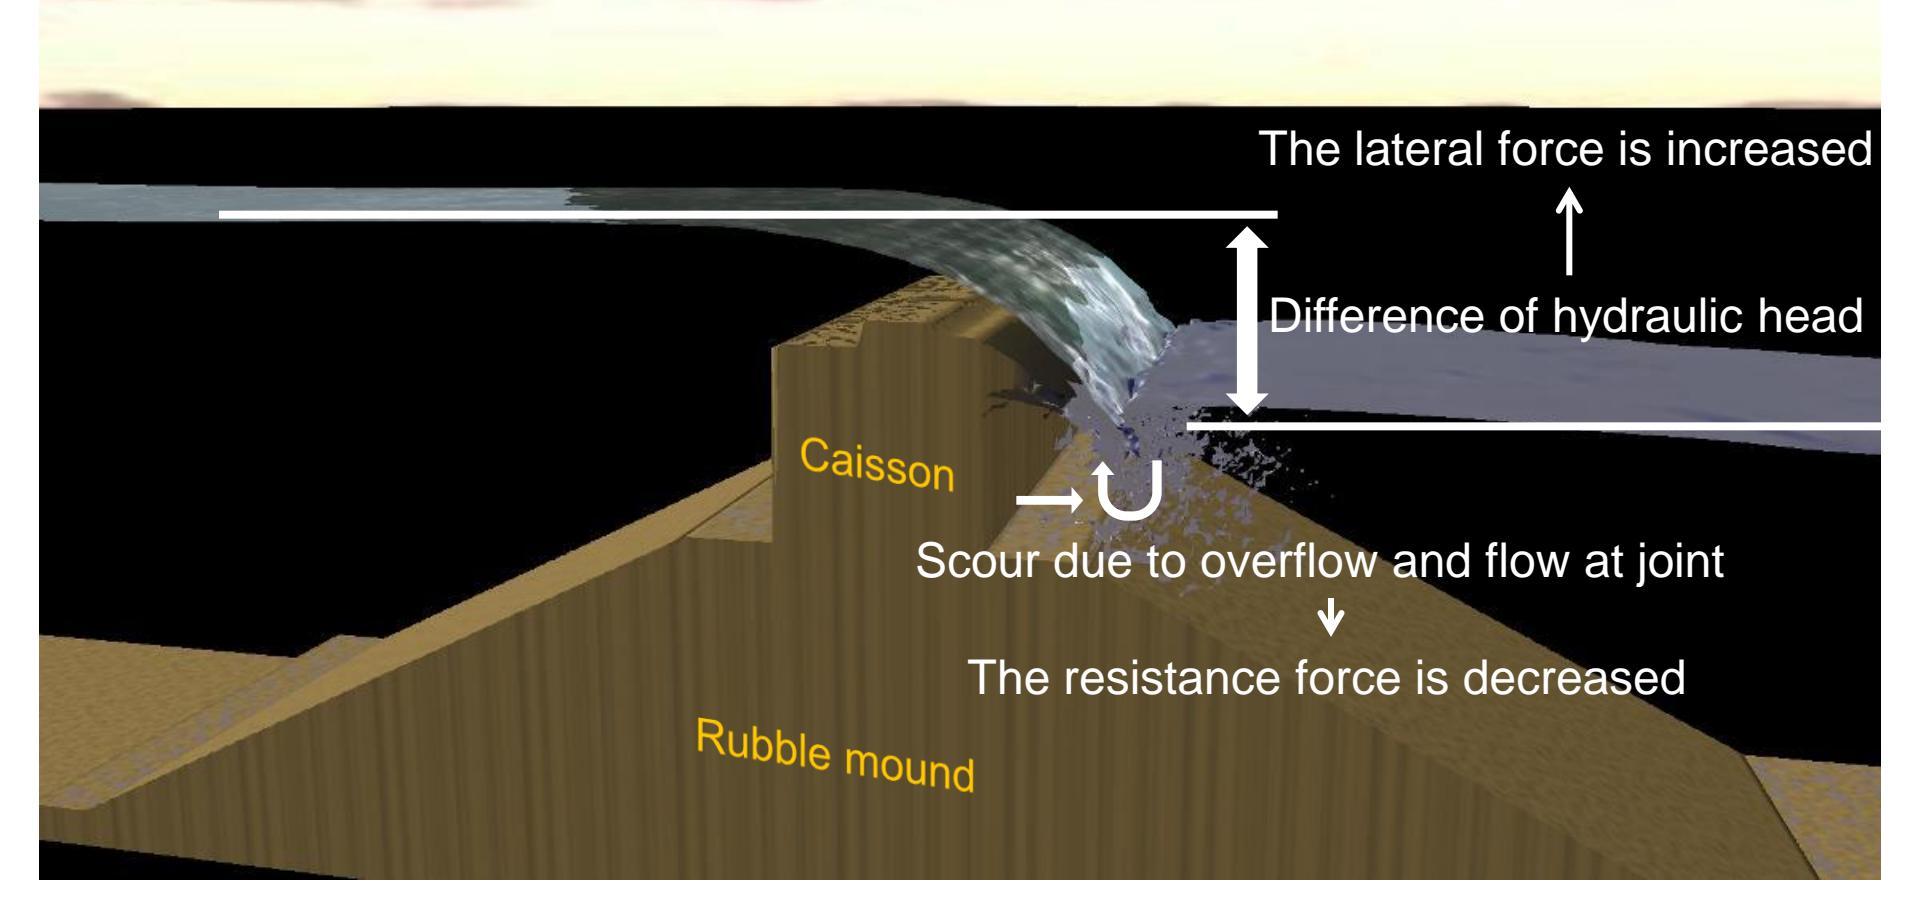
Major factors in the failure under overflow tsunami

Failure mechanism of breakwater at Kamaishi

Safety factor $= \frac{\text{LateralForce}}{\text{Resistance}}$

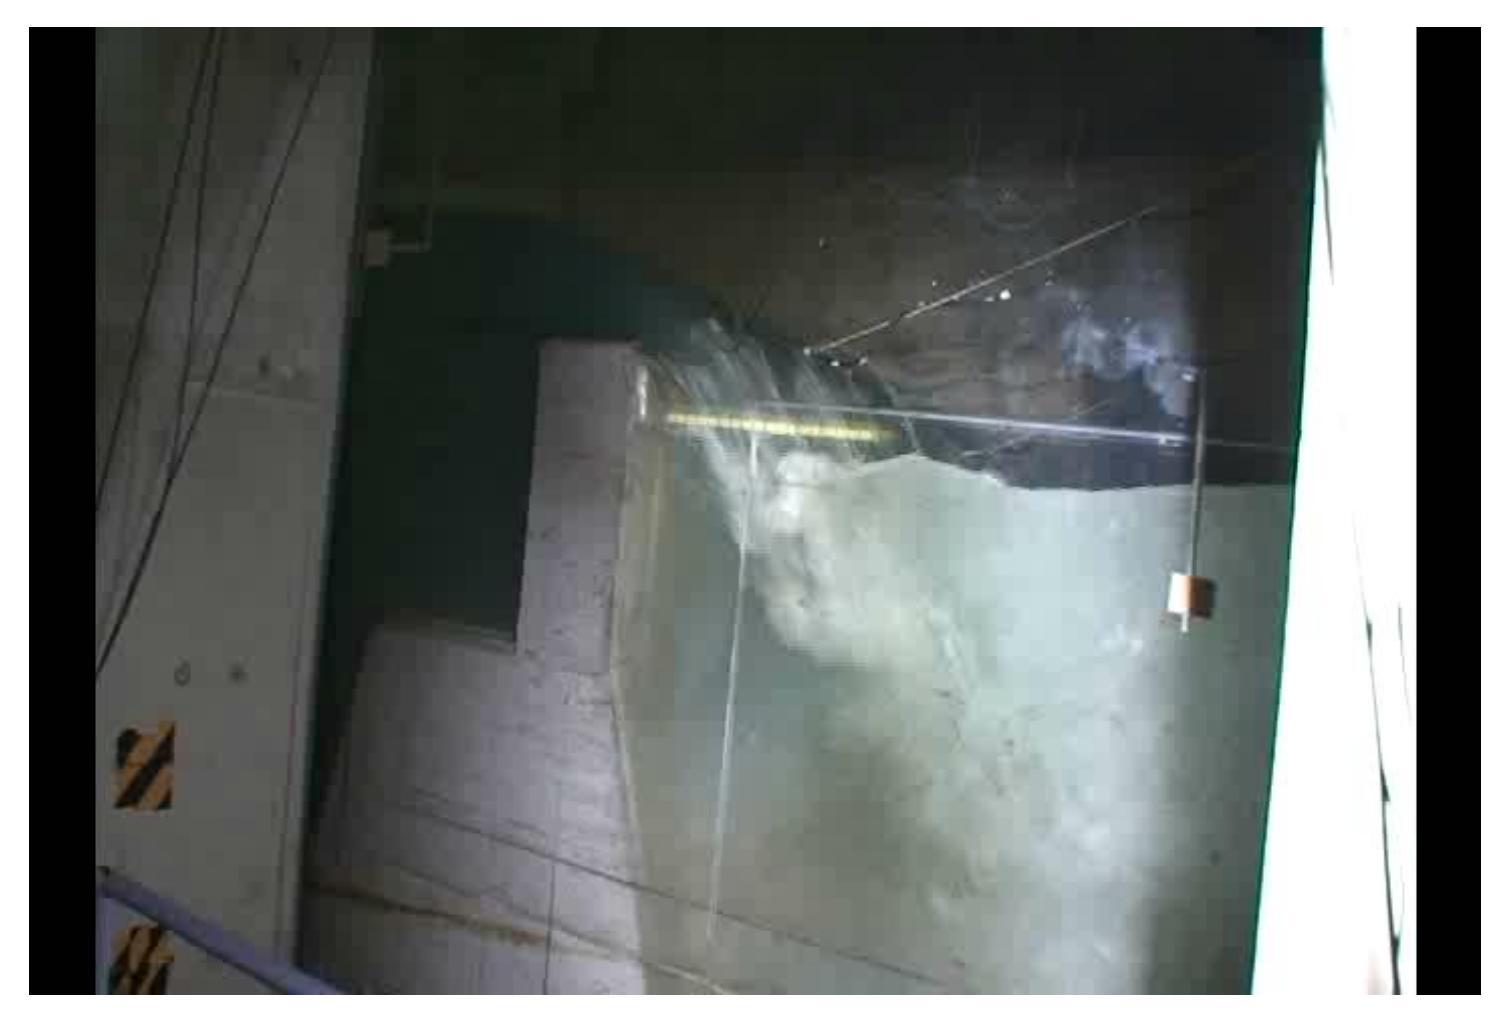
Experimental Video under overflow tsunami

Failure mechanism of breakwater at Kamaishi

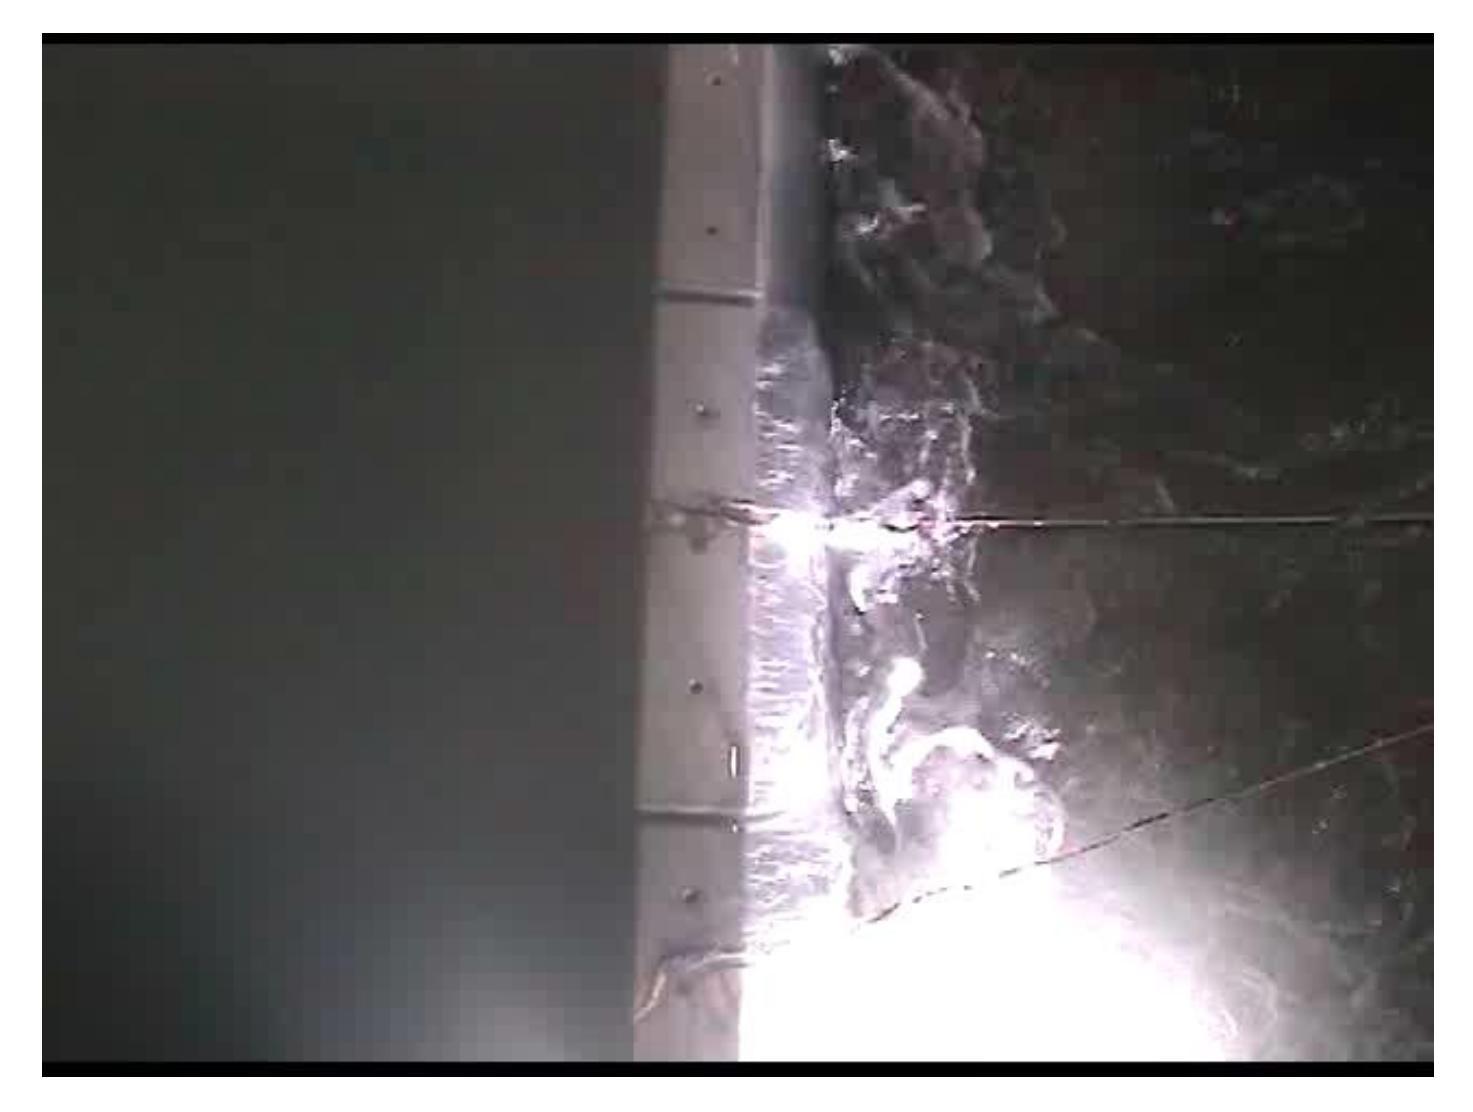
Experimental Video under overflow tsunami

Failure mechanism of breakwater at Kamaishi

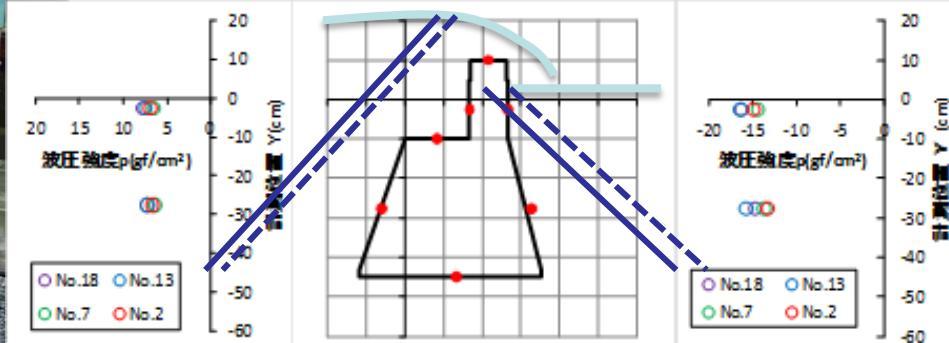
About the amount of increasing of the lateral force

The wave pressure is slightly higher at the front wall and about 10% lower at the rear wall than the hydrostatic pressure.

Two out of 17 caissons were slid and one was tilted.
