STRUCTURE RATING DATA SHEET

BRIDGE NO: 53C1744 LA County Br. No : 2446
Facility Carried : ARTESIA BLVD
Location : 0.3MI W/O SANTA FE AVE
BRIDGE NAME: SP/UP,COMPTON CR.ALAMEDA

Name: SP/UP,COMPTON CR,ALAMEDA
 Struct-Def: Bridge Span Ten (Fire Damage 2020)

Fire Damage Inspection

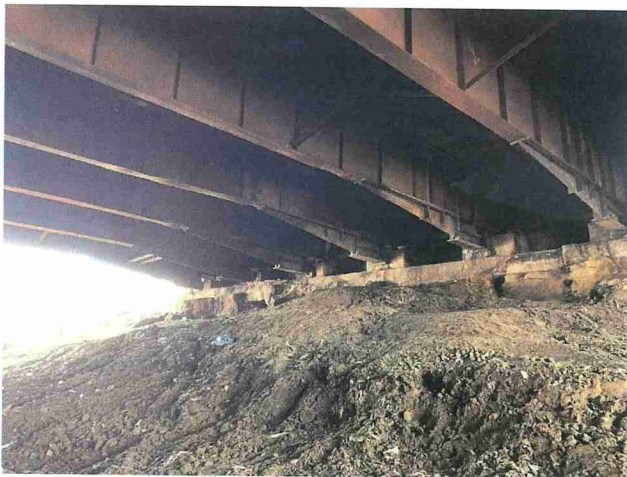
| Elem No. | Defect/Prot Defect | Element Description | Env | Total Qty | Units | Qty in each Condition State | | | |
|---|---|---|---|---|---|---|---|---|---|
| <p>Many scupper drains along the deck surface are plugged with debris. (06/10/2003). (Verified 06/08/2021)</p> <p>Fire damaged the steel girders in span 10, between pier 10 and east abutment and caused the south half of bride deck bulkled up to 2.5 inches. (04/19/2020)(Verified 06/08/2021)</p> | | | | | | | | | |

| Elem No. | Defect/Prot Defect | Element Description | Env | Total Qty | Units | Qty in each Condition State | | | |
|---|---|---|---|---|---|---|---|---|---|
| Compression joint seal in east abutment were damaged by fire. (04/19/2021)(Verified 06/08/2021) | | | | | | | | | |

Photo 13
East Abutment Fire Site

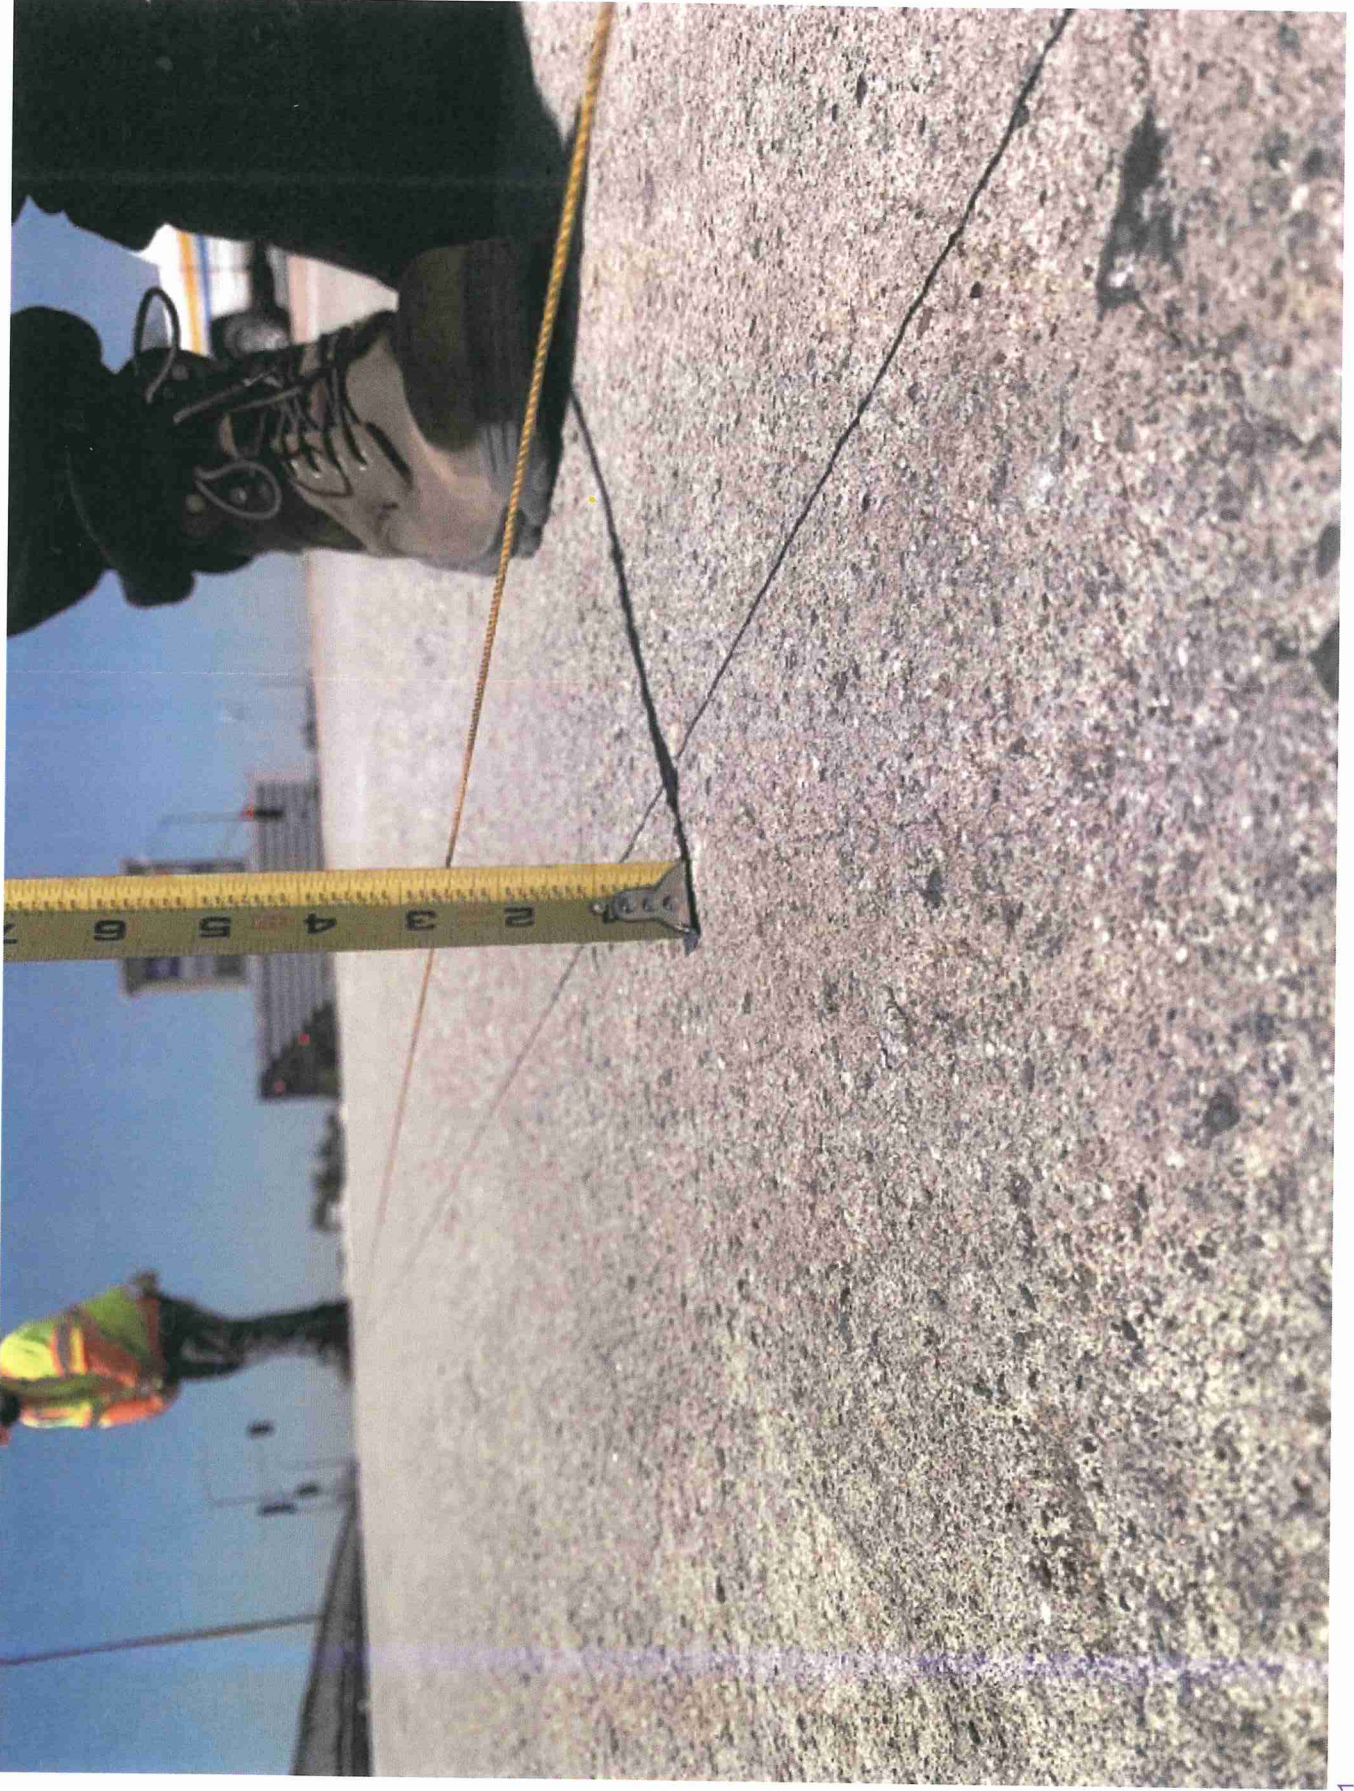
Photo #1

53C1744 SP, COMPTON CR, ALAMEDA 0.3MI W/O SANTA FE AVE
102 - Deck-Damage/Deterioration

PROBLEM (Be Brief) :
In 12-18-2020 fire damage covered whole area under span 10. Fire damaged and distorted all the girders except girder 11 (South end) in span 10, between pier 10 and east abutment. And it caused the south half of bridge deck bulked up to 2.5 inches.

| Replace south half of bridge deck in span 10, between pier 10 and east abutment. | | | | | | |

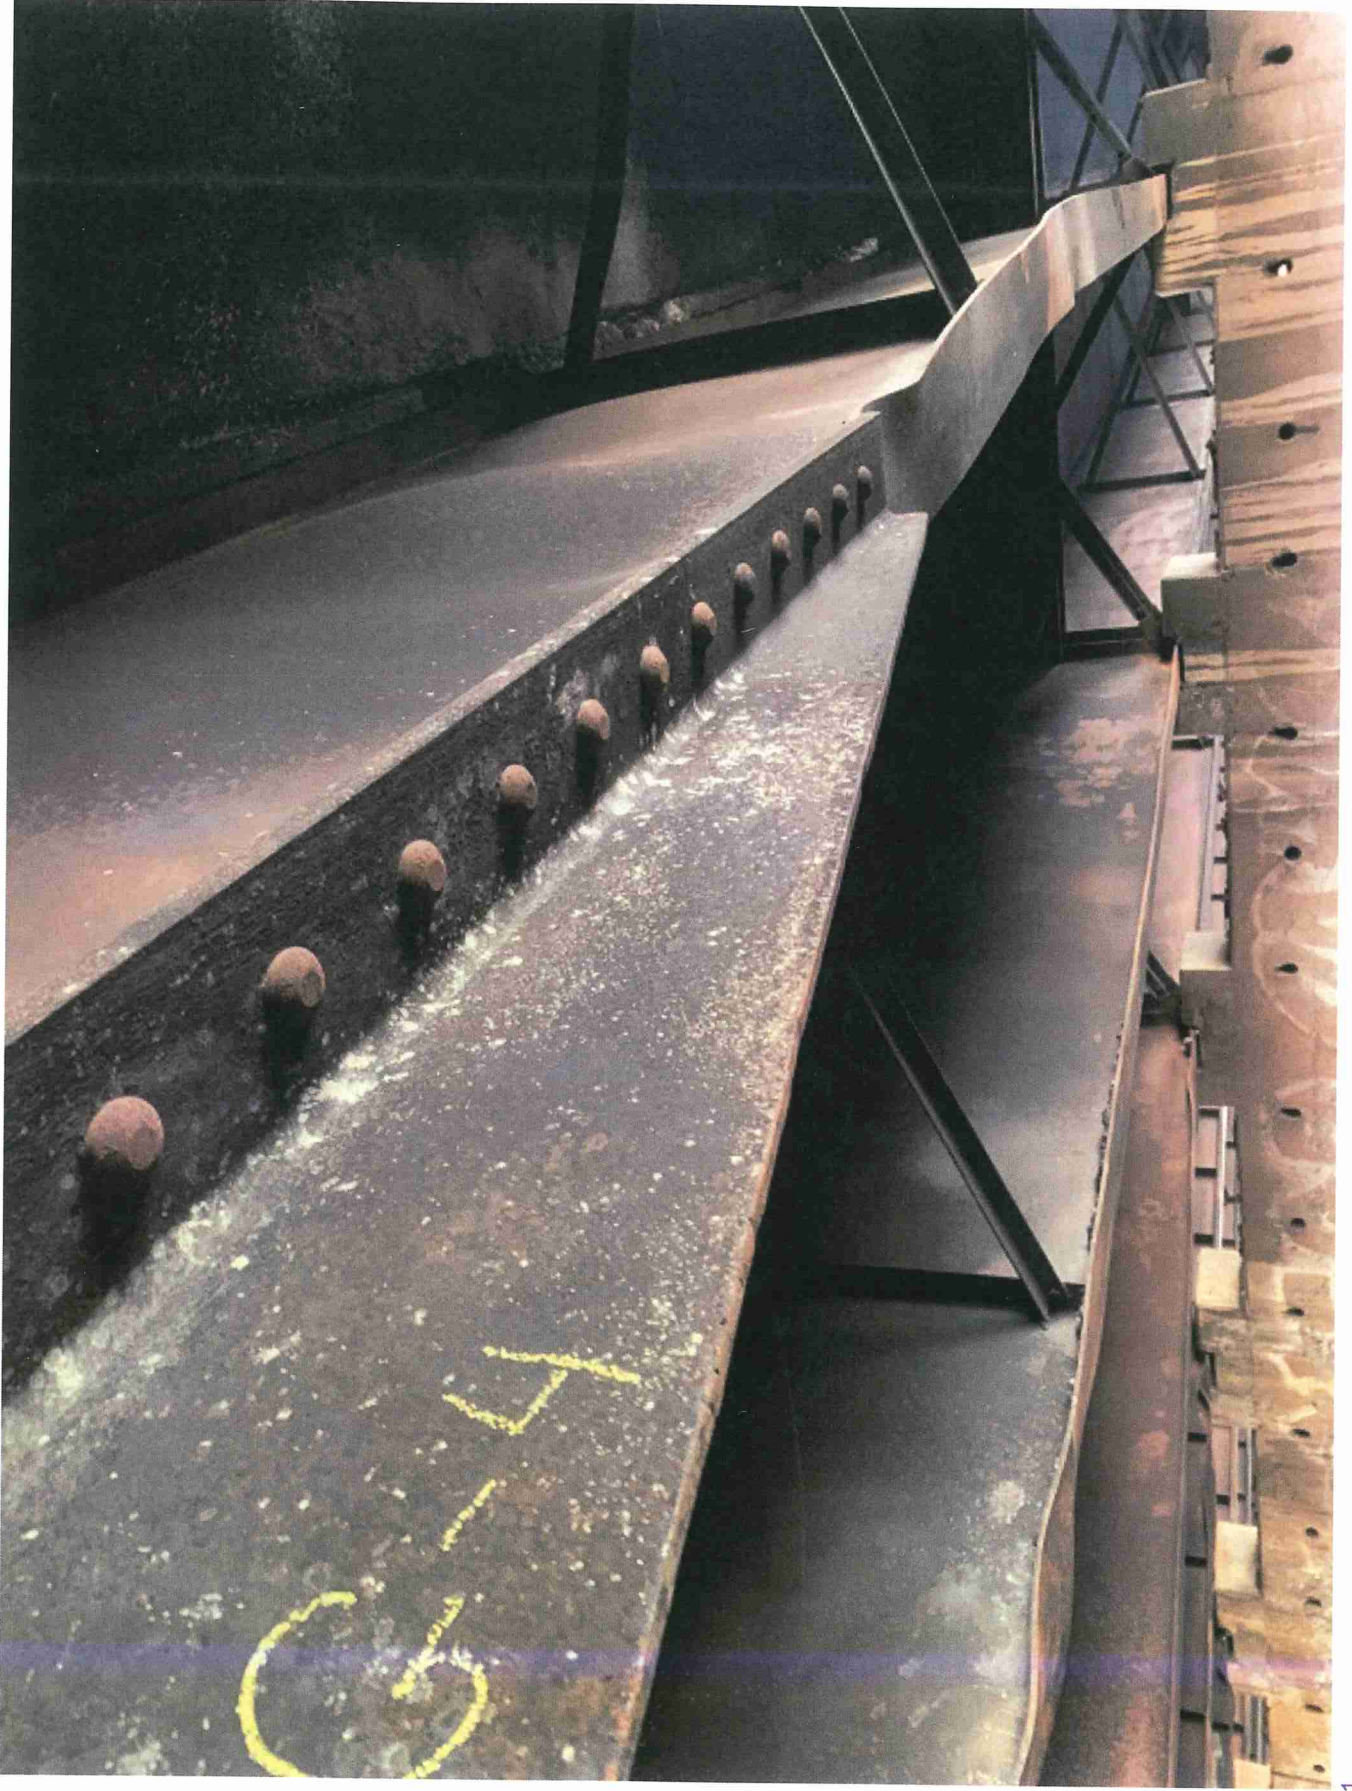
Photo #1

53C1744 SF. . . . COMPTON CR, ALAMEDA 0.3MI W/O SANTA FE AVE
107 - Super-Damage/Deterioration

Replace damaged girders (girder #1, 2, 3, 4, 5, 6, 7, 8, 9, 10) in span 10, between pier 10 and east abutment,

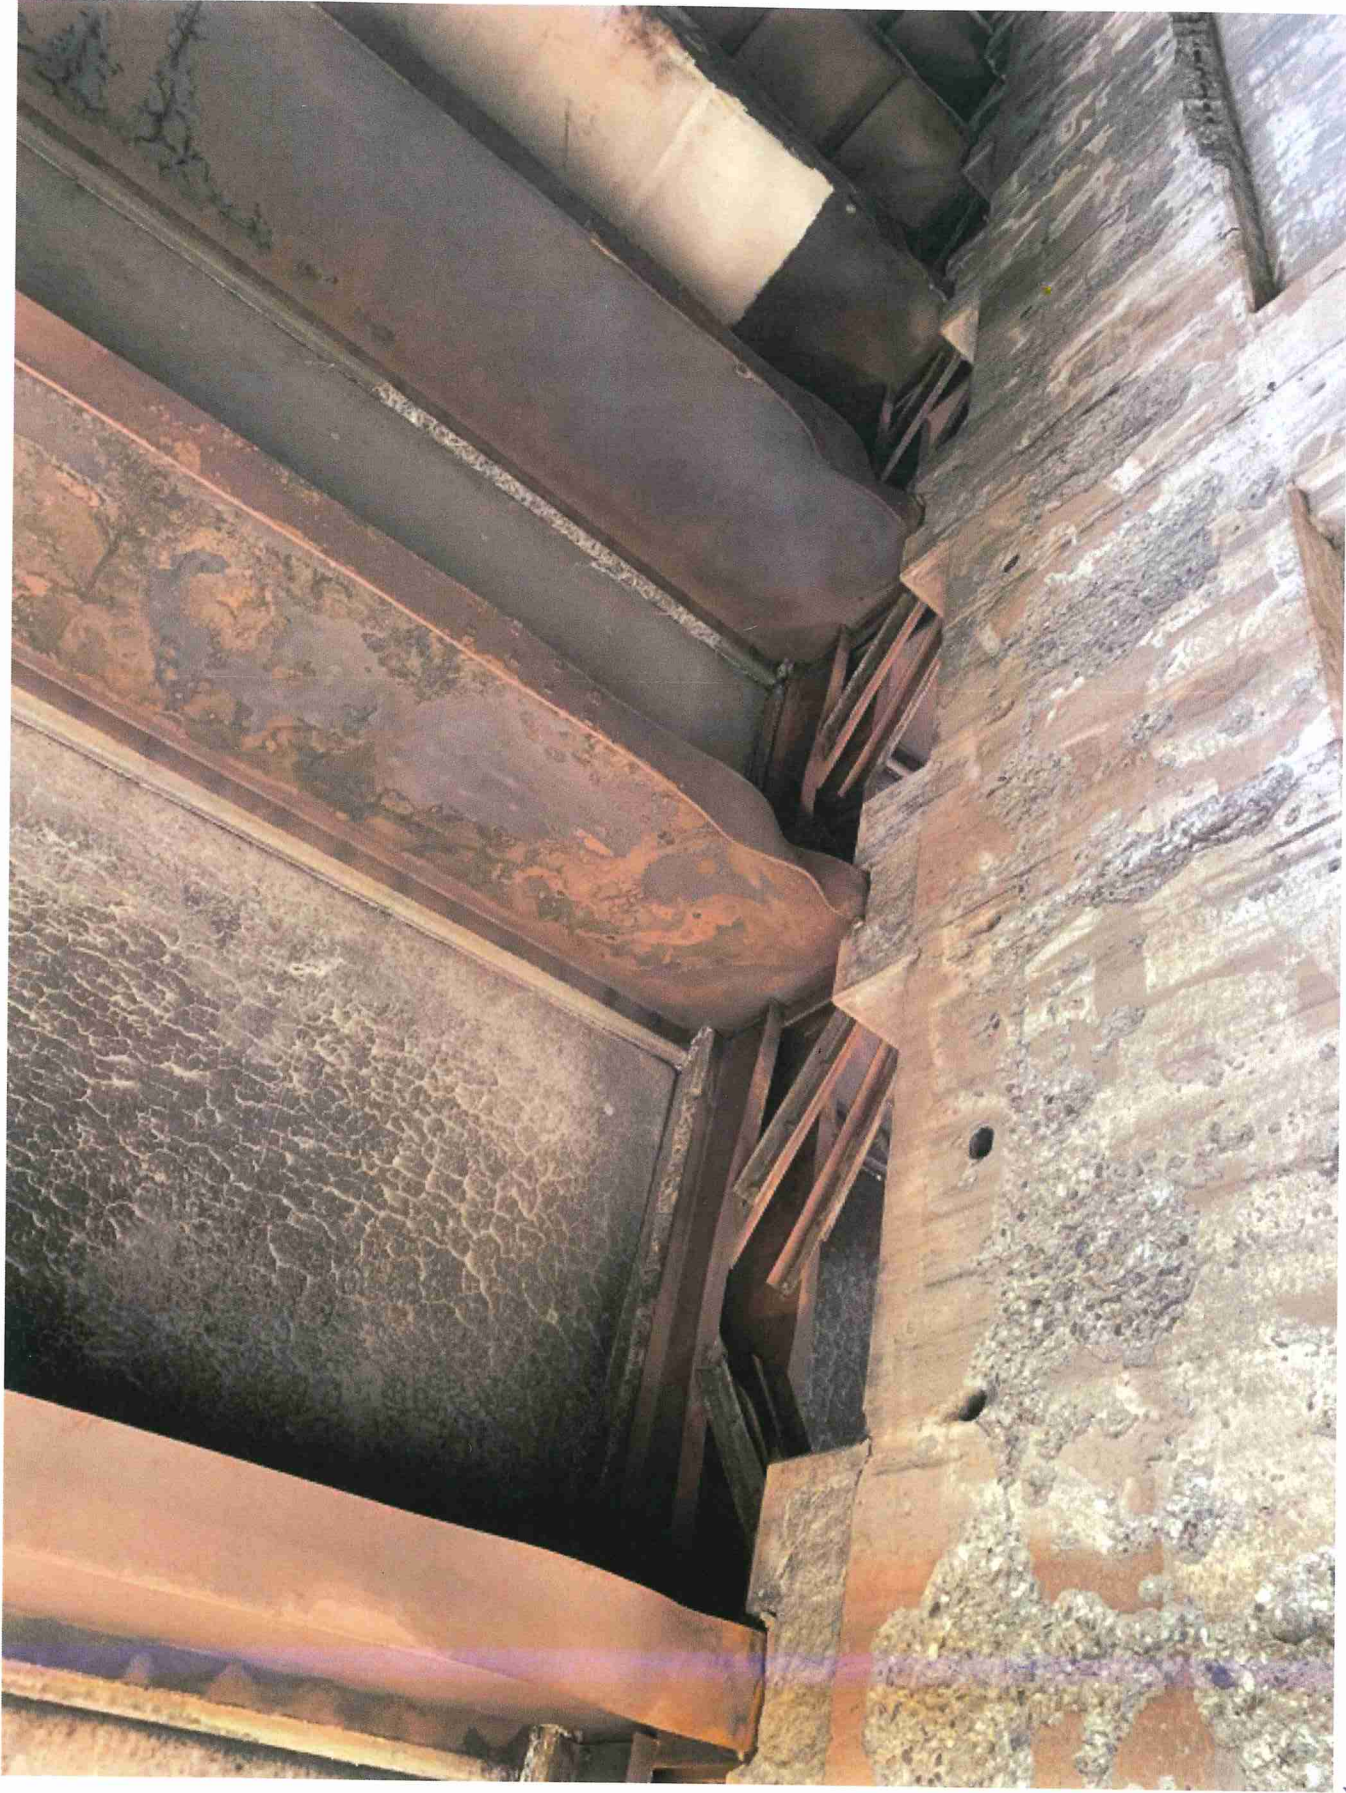
Photo #1

53C1744 SF. . . COMPTON CR, ALAMEDA 0.3MI W/O SANTA FE AVE
113 - Sub-Damage/Deterioration

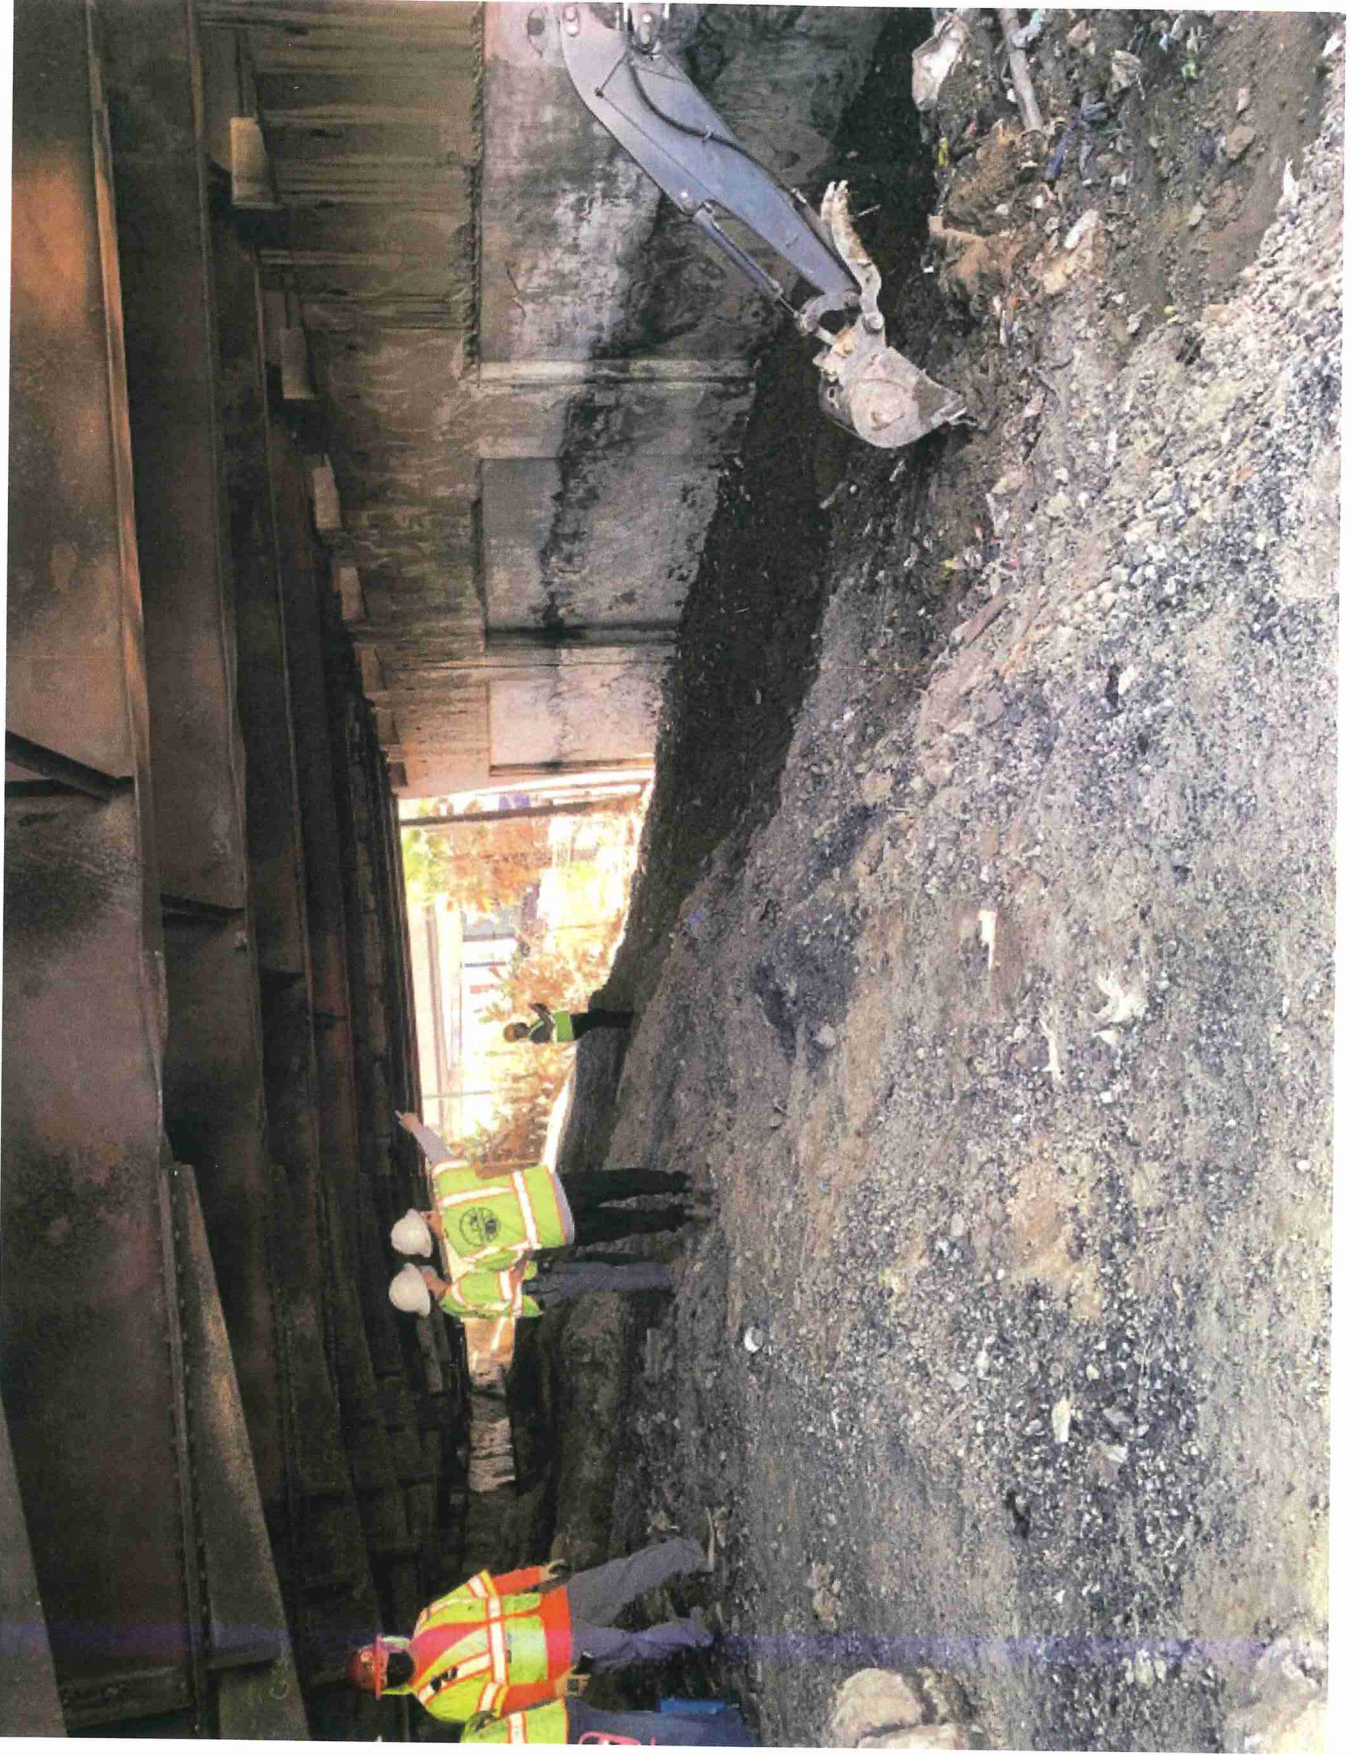
Photo #1

53C1744 SF, COMPTON CR, ALAMEDA 0.3MI W/O SANTA FE AVE
101 - Routine-Elevation View

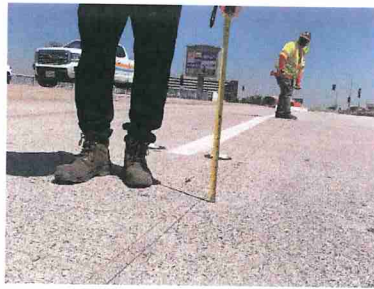
2.5" buckled downward in eastbound roadway portion of span 10

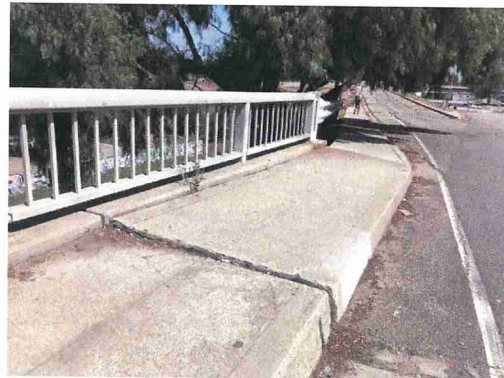
P5_Approach sidewalk settlement at N/E of bridge

ACTION RECOMMENDED (By SM&I) :
 Add addition k-rails to channelize existing east bound traffic to Alameda St Ramp together with additional warning signs. Fix the gap between north handrail panels. Repair approach sidewalk settlements. Replace the missing utility box cover on sidewalk and traffic light post. Install/replace missing balusters in north sidewalk pedestrian handrail.
