# 參加 第十九屆國際客艙安全研討會 報告

服務機關：行政院飛航安全委員會  
出國人姓名：戎 凱、方粵強、任靜怡  
出國人職稱：執行長、調查官、飛安官  
出國地區：美國加州 環球城  
出國期間：民國九十一年三月三日至九日  
報告日期：民國九十一年五月十五日

出國報告名稱：參加第十九屆國際客艙安全研討會報告

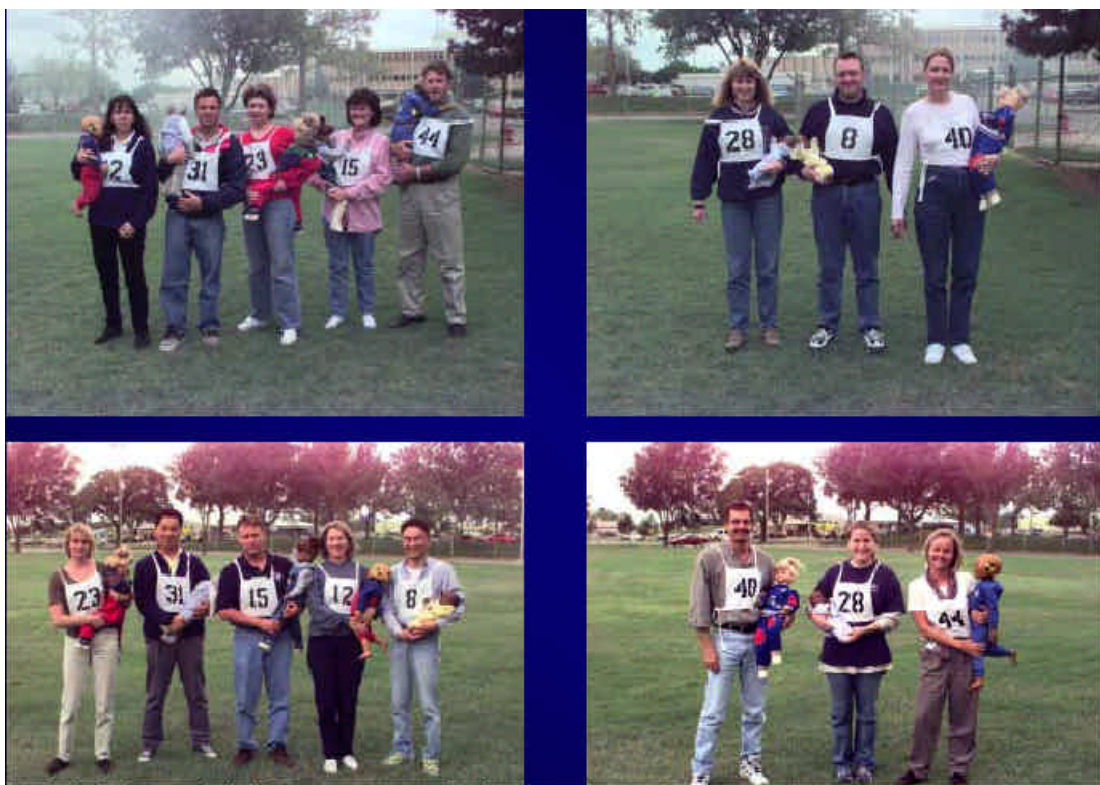
本論文由德國柏林大學人體工學教授 Helmut Jungermann 提出，其重點在如何安全地懷抱嬰兒使用疏散滑梯。曾經試驗挑選 32 位成人，分別抱玩具嬰兒溜下滑梯測試，提出各人心得看法，希望藉此找出最快疏散方式及如何避免嬰孩頭部足部創傷之姿勢。詳如圖七之一、二。

圖七之一 部分實驗代表

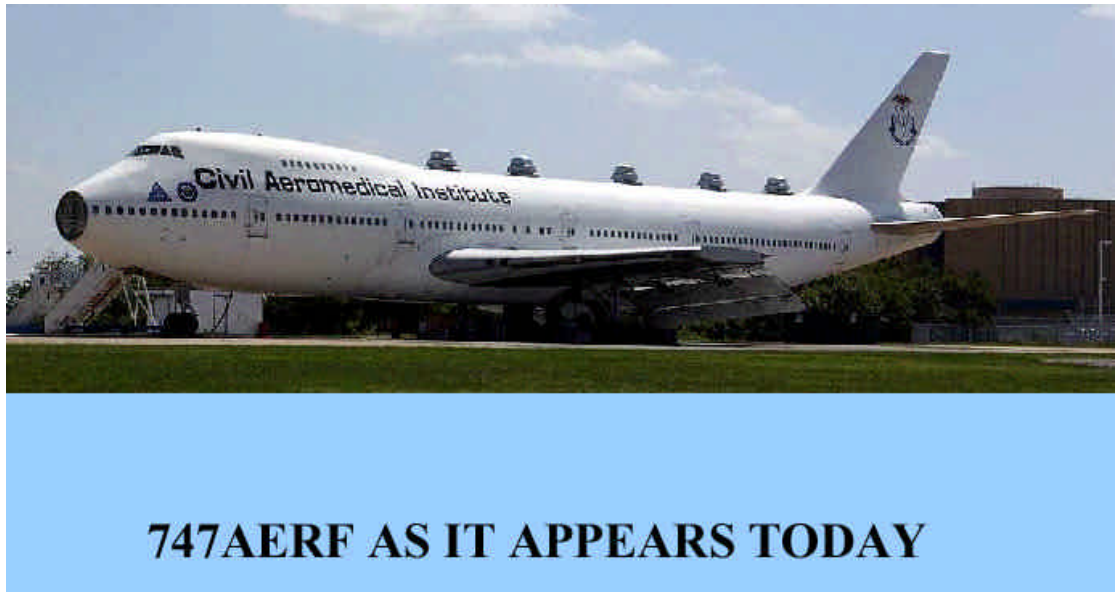
該模擬客艙（如下圖八之一）與波音 747 航機尺寸相同，產權經數度易主後現屬美國 FAA。

圖八之一 客艙模型機

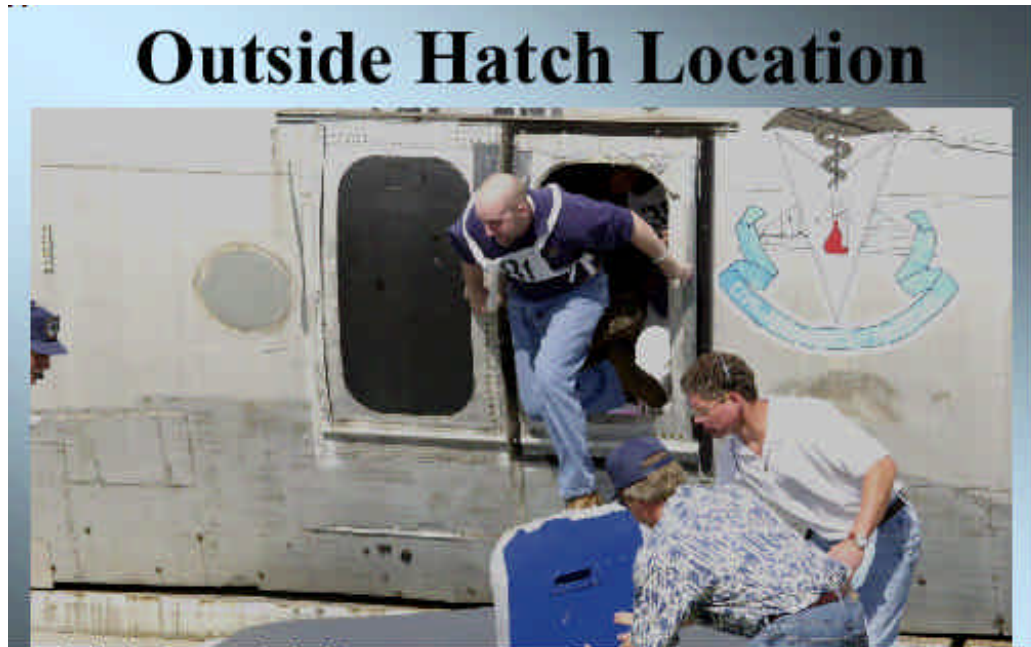
英國克蘭飛爾大學飛安研究部門進行對第 III 類出口之安全疏散研究。FAA 據 FAR 25.813(C) 資料提供資助，並藉以回應 NTSB 對第 III 類出口之改善建議。第 III 類出口如圖九之一、二。

圖九之一 第 III 類出口疏散作業

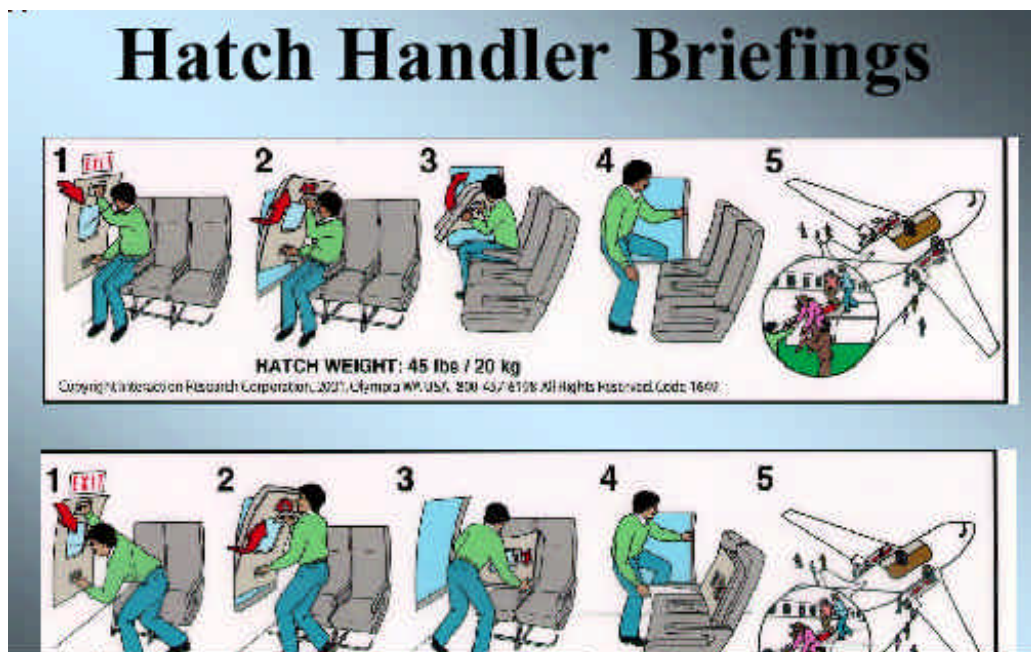
圖九之二 第 III 類出口作業程序圖例

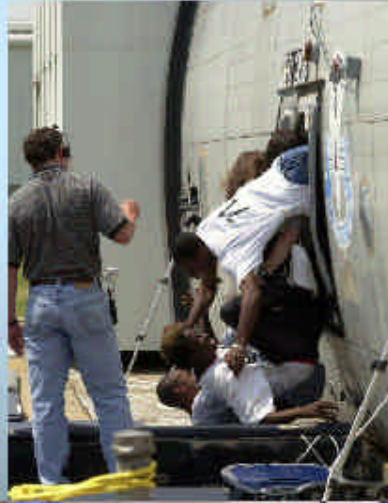
(一) 人性因素影響疏散之速度最明顯：在不同動機之下，將影響疏散速度。例如在疏散實驗中，雖每次給參與疏散實驗者一定酬勞，但如另給最先逃出者加倍酬勞，會導致在不同動機下，形成爭先恐後之態勢，必會造成出口擁塞。如圖九之四。

圖九之四 出口擁塞情況

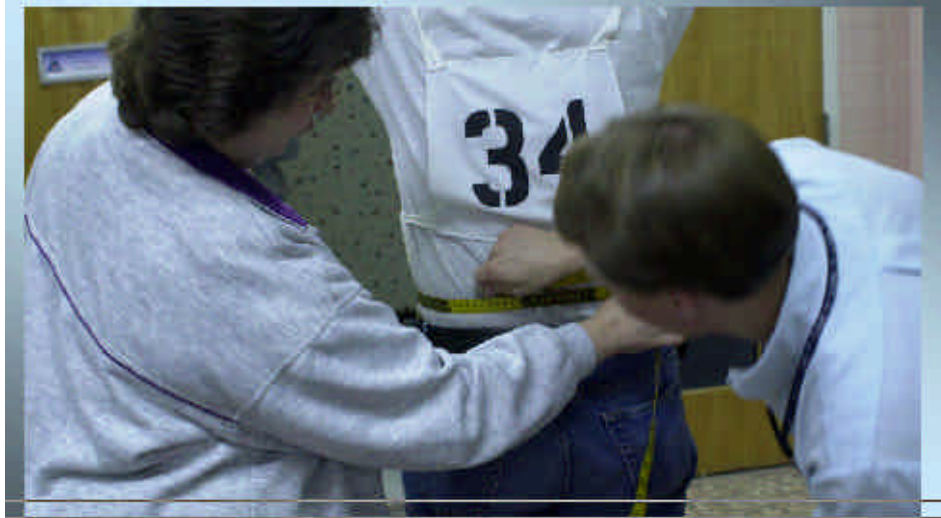
(二) 腰圍、年齡、性別影響疏散流量：經過實驗得知，肥胖年老之女性，最會影響疏散速度。腰圍量測如圖九之五。

圖九之五 腰圍量測

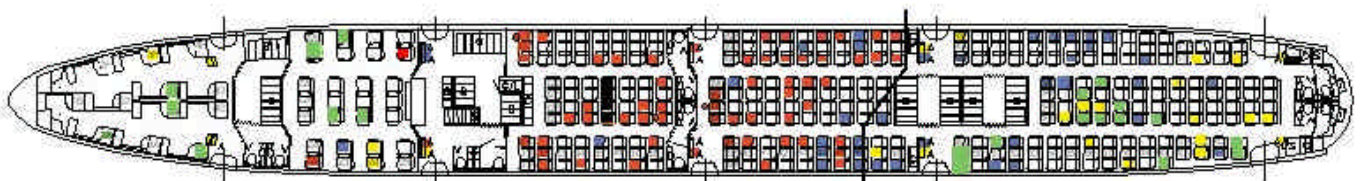
### Injury / Fatality Distribution

Singapore Flight 006  
747 - 400 Accident in Taipei, Taiwan  
October 31st, 2000

Fuselage Separation

- Fatal
- Serious Injury
- Minor Injury
- None Injury
