行政院及所屬各機關出國報告
(出國類別：進修)
ASC-TRT-03-09-001

赴美參加南加州飛安學院
直昇機事故調查訓練課程
報 告

行政院及所屬各機關出國報告提要 系統識別號 C09204049
出國報告名稱：赴美參加南加州飛安學院失事調查訓練課程報告
頁數：118 頁含附件：是

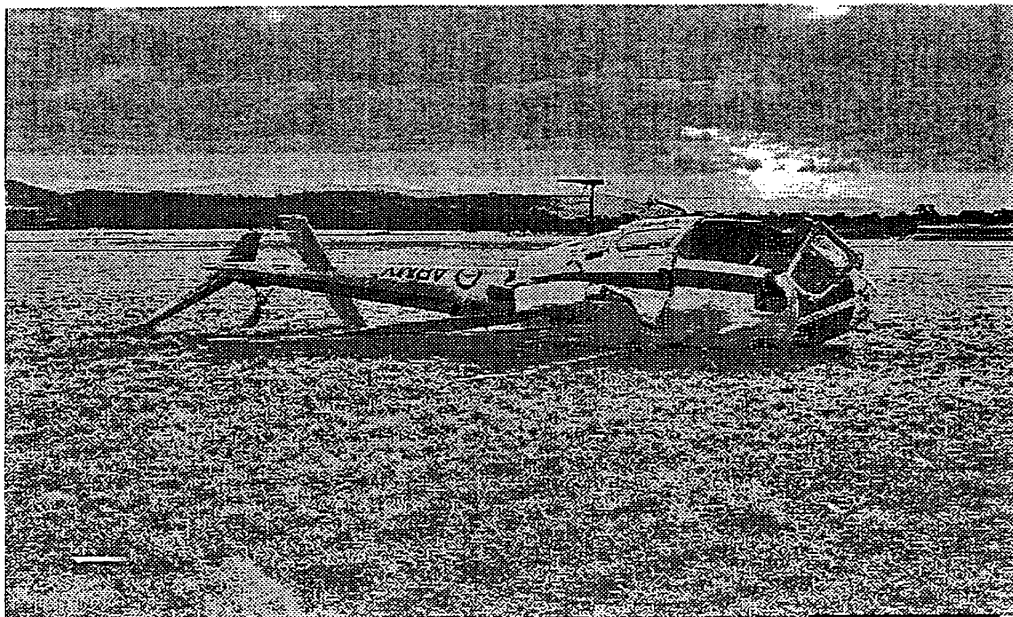
A22-004 as it came to rest after the accident.

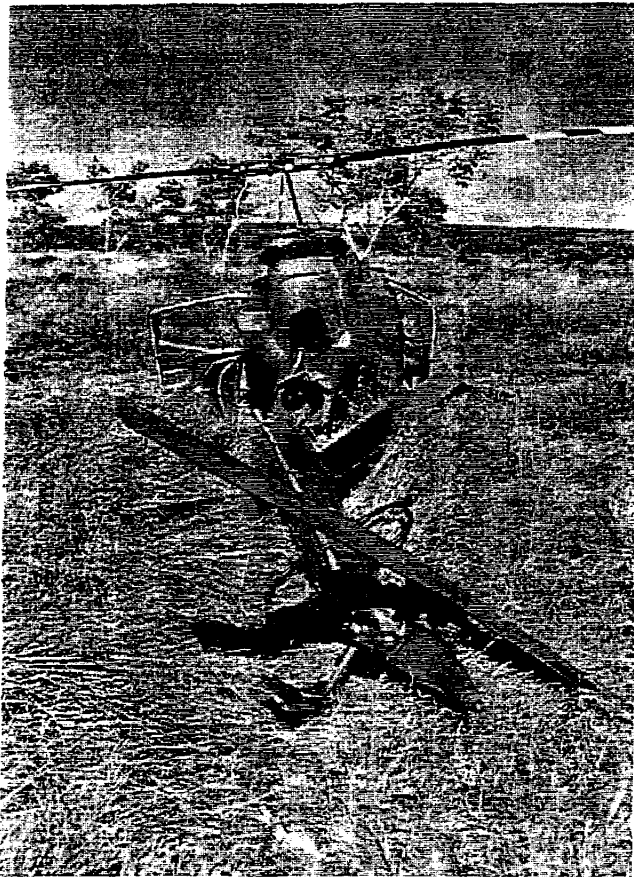
Rear view of A17-021 revealing severe damage to tail boom assembly.

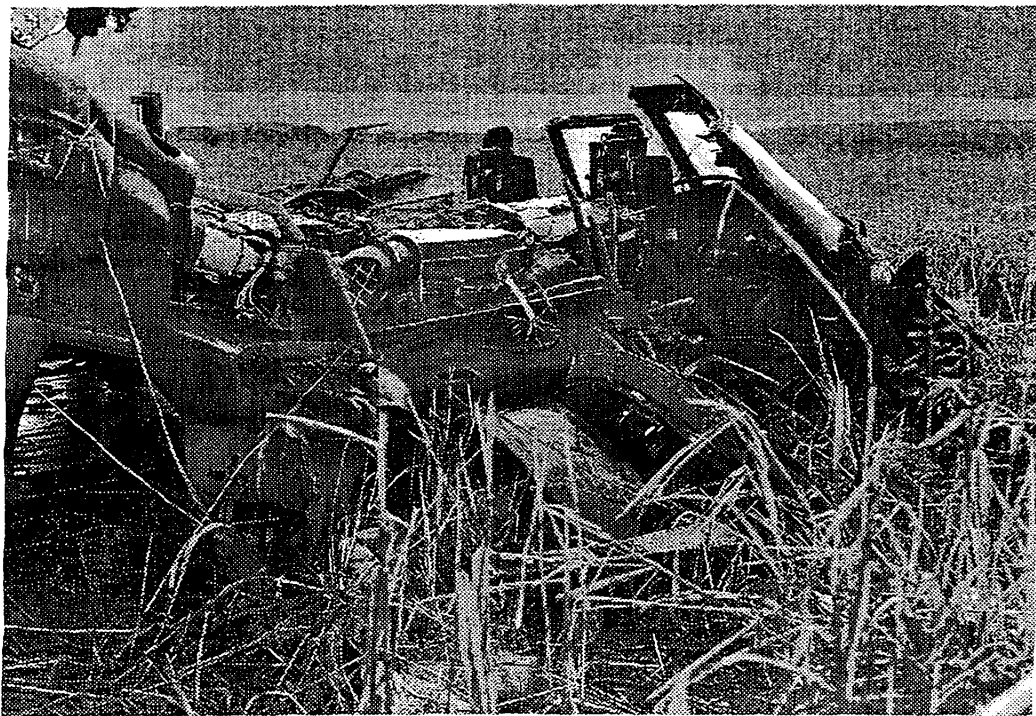
Destruction of cockpit and forward cabin area of A25-217 is clearly evident.

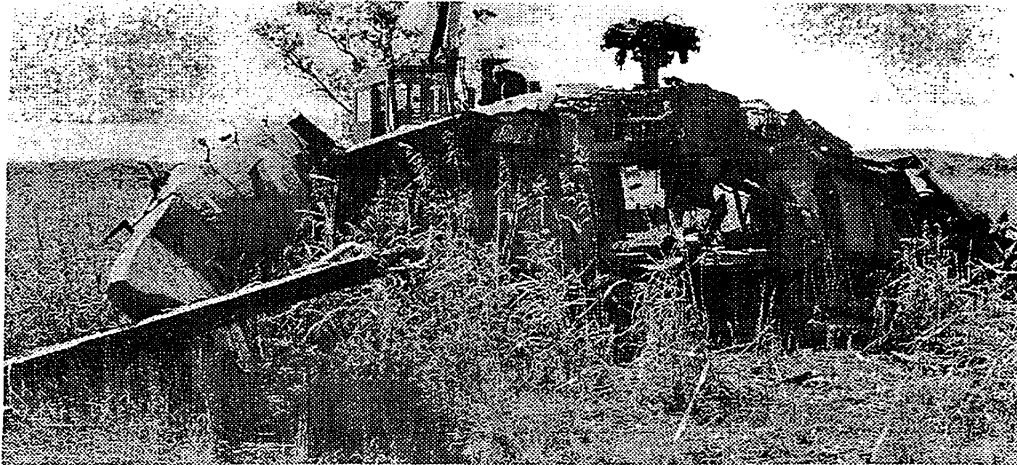
Rear view of A25-217 depicting almost complete destruction of the airframe.

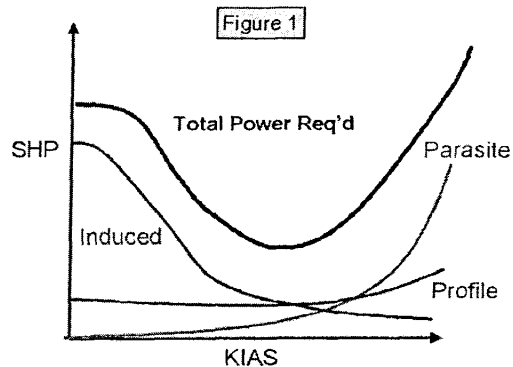
The curves shown in Figure 1 represent the contribution of each type of power to the power required charts that we find in the back of most helicopter NATOPS manuals. These charts are normally represented as a family of curves corresponding to various aircraft gross weights, temperatures and pressure altitudes or DA and are also based on level, unaccelerated flight. From the Figure, it becomes apparent that induced power dominates the power required in the low airspeed regime to include the hover and decreases as the airflow through the rotor system increases providing for better rotor performance. Now, as the helicopter progresses through translational lift, airspeed increases and profile power kicks in. Again, the lifting surfaces such as the rotor blades fight the resistance as they slice through the air resulting in this increased power demand. As we continue to pull collective and approach cruise speeds, the parasite power requirement takes off! As seen in Figure 1, the power required to move a helicopter to velocity-not-to-exceed airspeed (V_{NE}) is quite significant and usually greater than hover power, but not always. This discussion on the power requirement curves will now help us analyze helicopter performance in the worst of fly conditions such as the high, hot and heavy environment.

All helicopters with either a single main rotor or a tandem rotor configuration display a similar power required curve. This power required curve is made up of three power requirements - induced, profile and parasite, each demonstrating a dominance in a particular airspeed range. First, let's discuss the induced power requirement. Induced power is what people are referring to when they say helicopters "beat the air into submission." Newton's 2nd law concerning action-reaction applies in this regime where we must force air down to keep the aircraft aloft. In fact, approximately 70 - 80 % of the power required in a hover is induced power and is directly proportional to weight and DA; therefore, as aircraft gross weight or DA increases, so does the induced power required.
