Root Cause Analysis Cases Studies with Causal Tree Analysis

TRAINING SEMINAR Medical Device Adverse Event Investigation and Management 2013

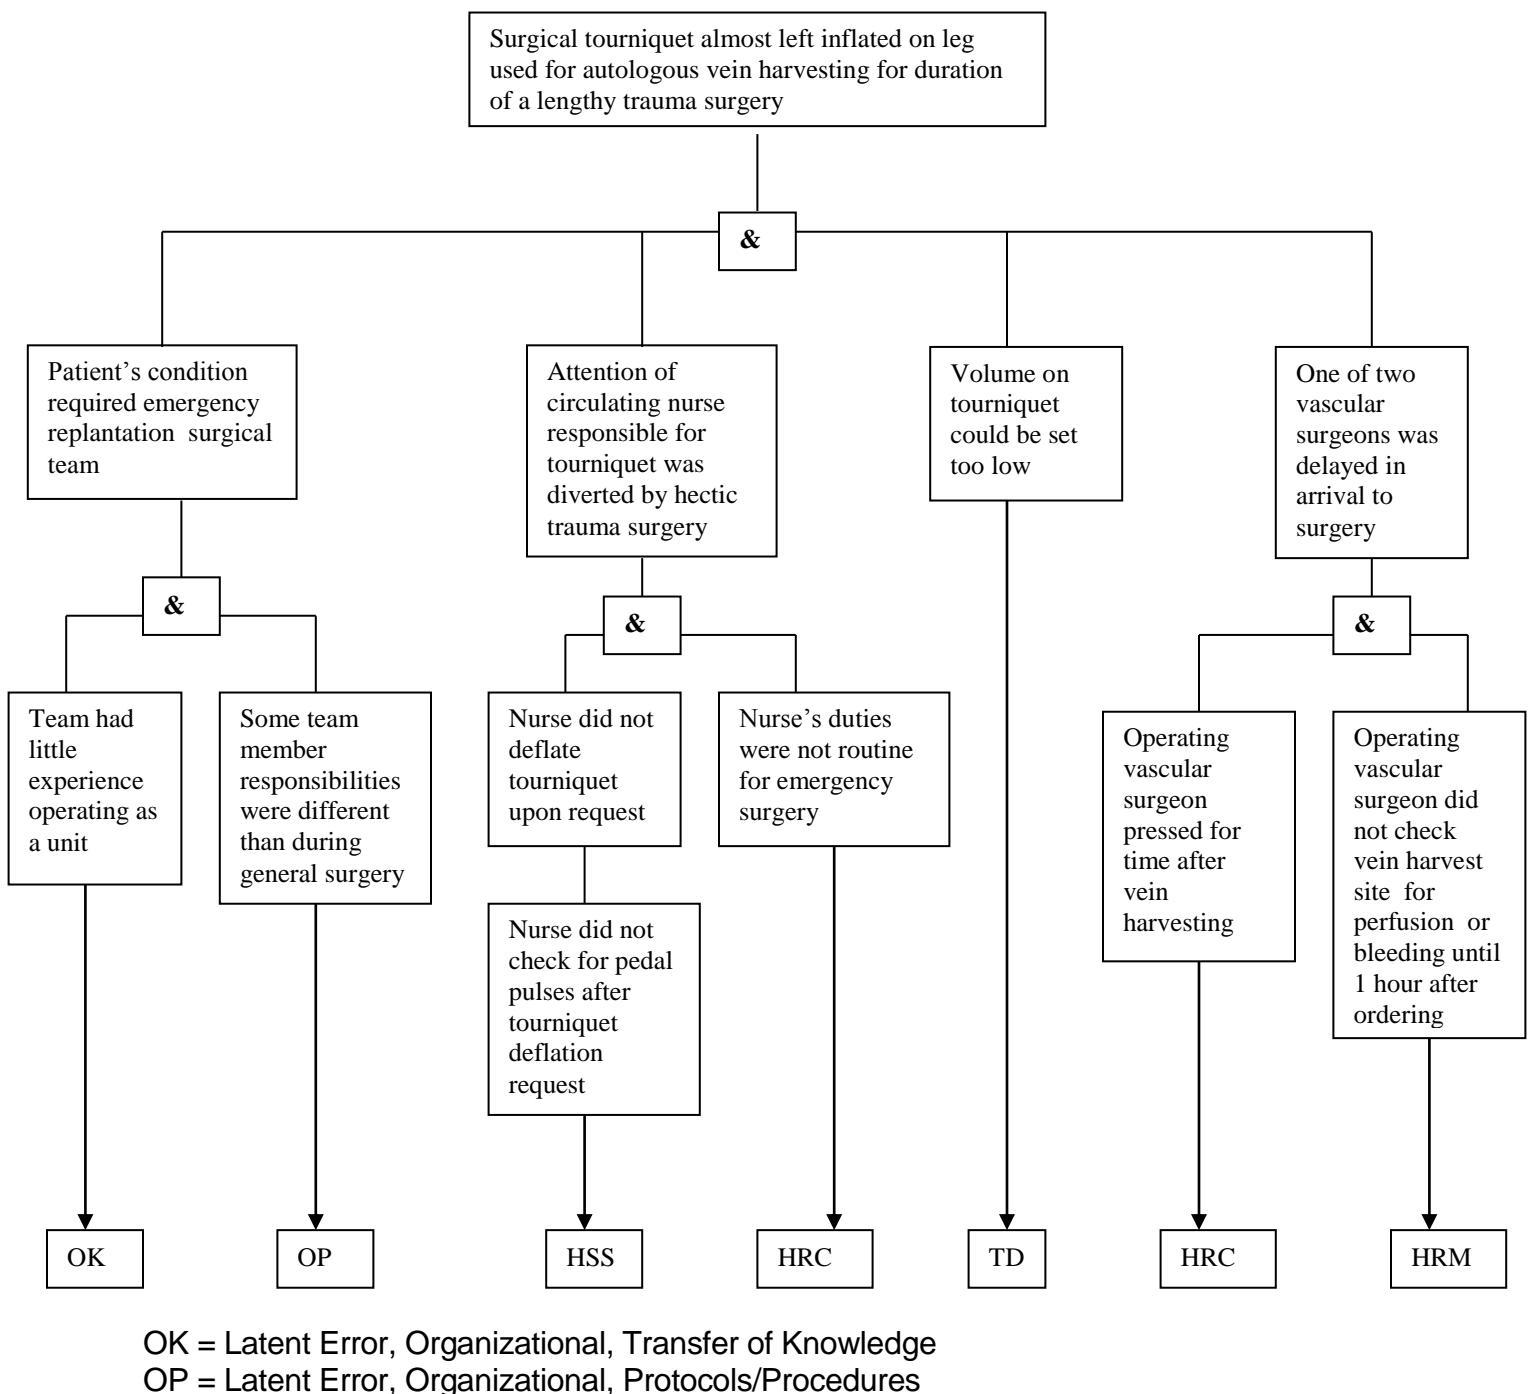
Case 1 Causal Tree Analysis No-harm Event

After autologous vein harvesting from one of the patient's legs for use in revascularization of the arm, the microprocessor-controlled pneumatic leg tourniquet was not deflated despite an order by the vascular surgeon to do so. At that time, the tourniquet had been inflated for 25 minutes at a pressure of 250 mm Hg. An hour later, when the vascular surgeon checked the closure of the vein-harvesting incision site, she saw that the leg was still exsanguinated and discovered that the tourniquet was still inflated. The tourniquet had remained inflated for more than 90 minutes. Although the 60-minute alarm on the tourniquet triggered, it was not heard because the volume was adjusted below an audible level.

In general surgery at this hospital, the anesthesiologist is responsible for tourniquet inflation and deflation and for monitoring the inflation time. In emergency trauma surgery, these tourniquet responsibilities are delegated to a circulating nurse. Although the nurse knew her duties for the surgical tourniquets in this case and had heard the request for the tourniquet to be deflated, that duty was not routine for her and was not carried out in the rush of the first three hours of the surgery. The tourniquet was removed, and the leg was allowed to passively perfuse. Despite concerns over the potential for development of compartment syndrome, the affected leg recovered and was not harmed. The event was reported as an incident by the circulating nurse. Initial suspicions that the tourniquet had malfunctioned proved incorrect during subsequent investigation. This is classified as a close-call event because the patient's leg would have been seriously injured or lost if the tourniquet remained inflated for the duration of the long procedure.

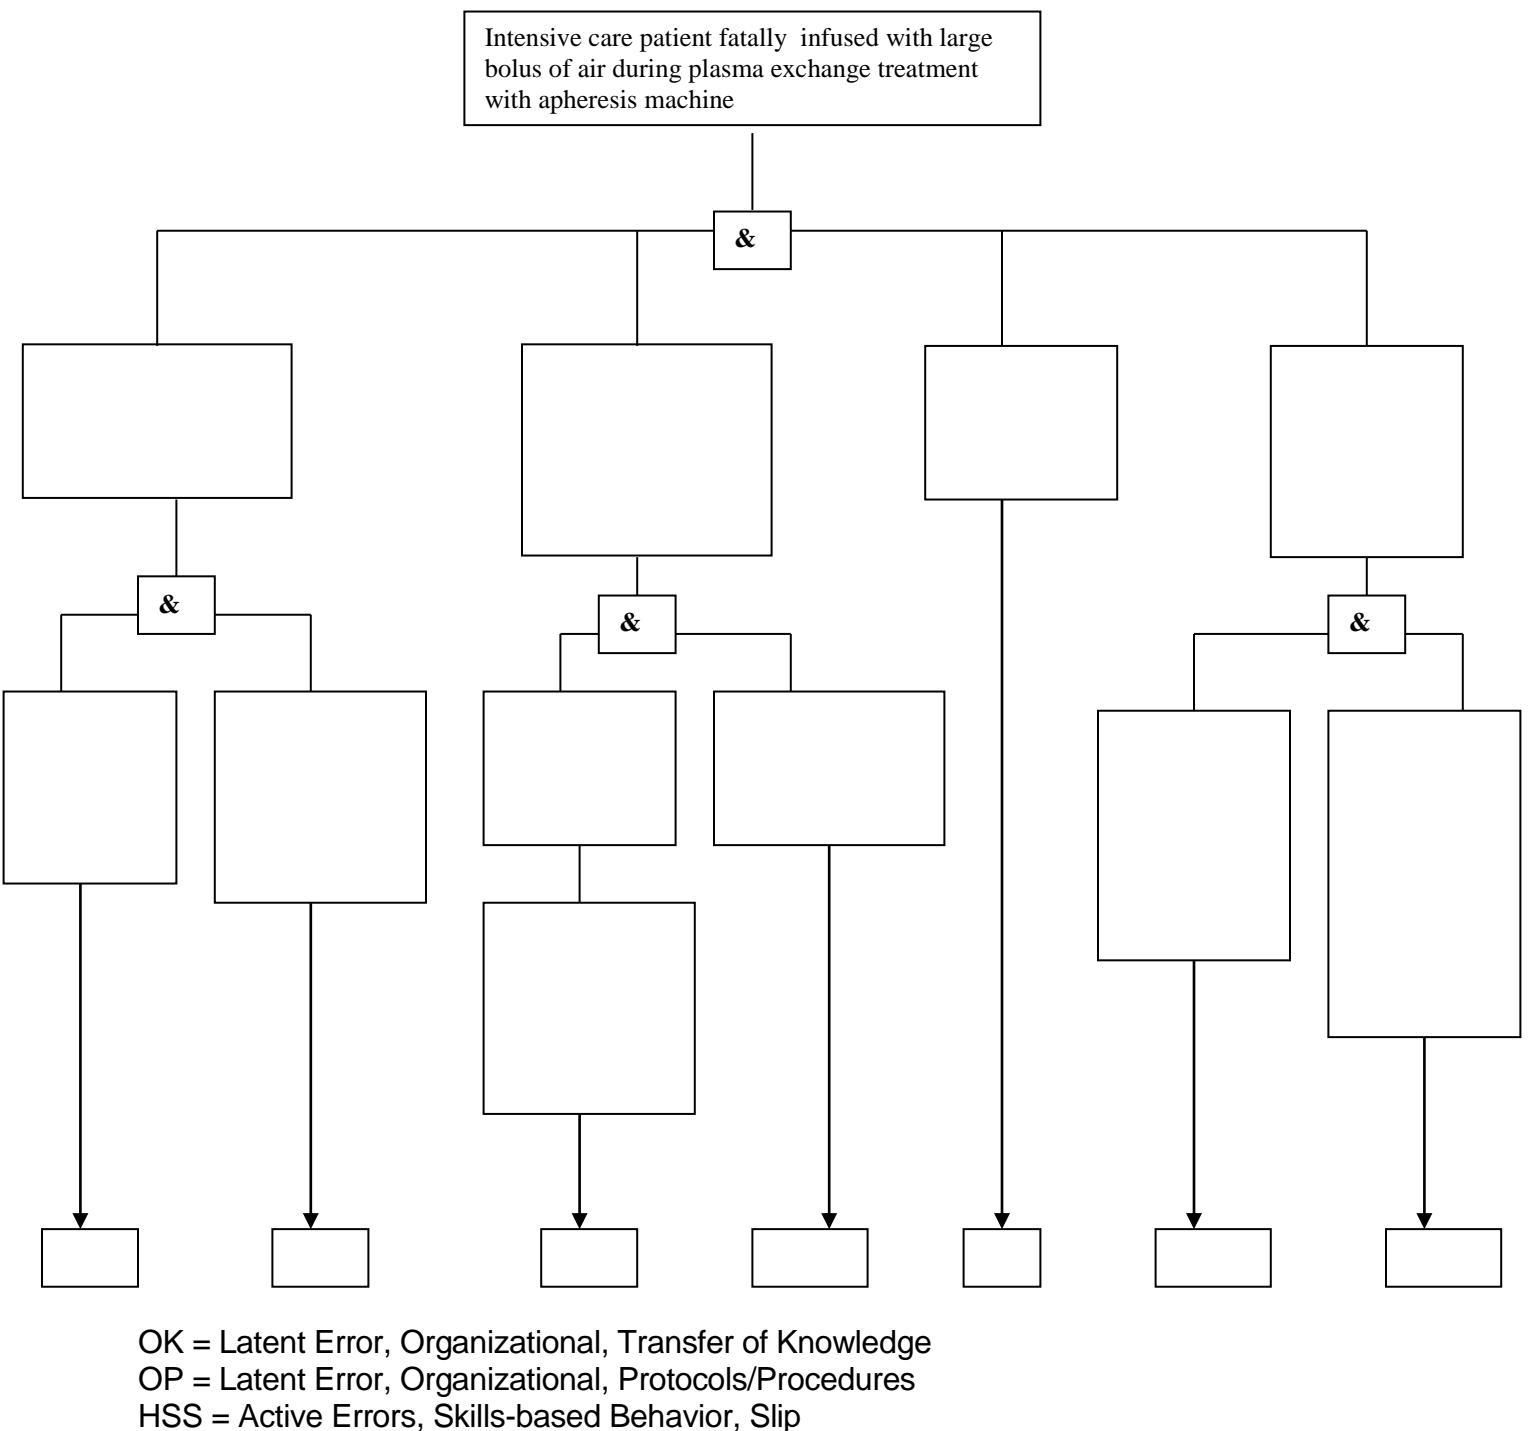
Case 2 Causal Tree Analysis Near Miss Event

Just as treatment began, the blood level in drip chamber of the tubing set on the machine dropped and triggered an alarm that stopped the treatment. The physician raised the blood level in the drip chamber by pulling back on a 50cc syringe attached to one of the chamber's ports. As the blood level rose to an appropriate level, the machine automatically resumed treatment at which time a large bolus of air was seen moving toward the patient in the blood return line. During treatment, segments of air bubbles were seen in the venous PE line that was returning blood to the patient by the treating physician and by an attending nurse. This air was then seen entering the patient.

About two minutes later, she went into respiratory arrest, and cardiopulmonary resuscitation (CPR) was initiated. During CPR, air was reportedly again seen in the venous blood line. Despite the resuscitation attempts, the patient died. Postmortem examination indicated that the patient died of a fatal venous air embolus, probably of a volume greater than 250 ml. Air was determined to be in the brachiocephalic veins, superior vena cava, inferior vena cava, and the right ventricle. At the time of the treatment, the patient was in a semireclining position with the back of the bed raised to about 40° . It was also found that the patient had inadvertently dislodged the return line from a safety clamp on the machine.

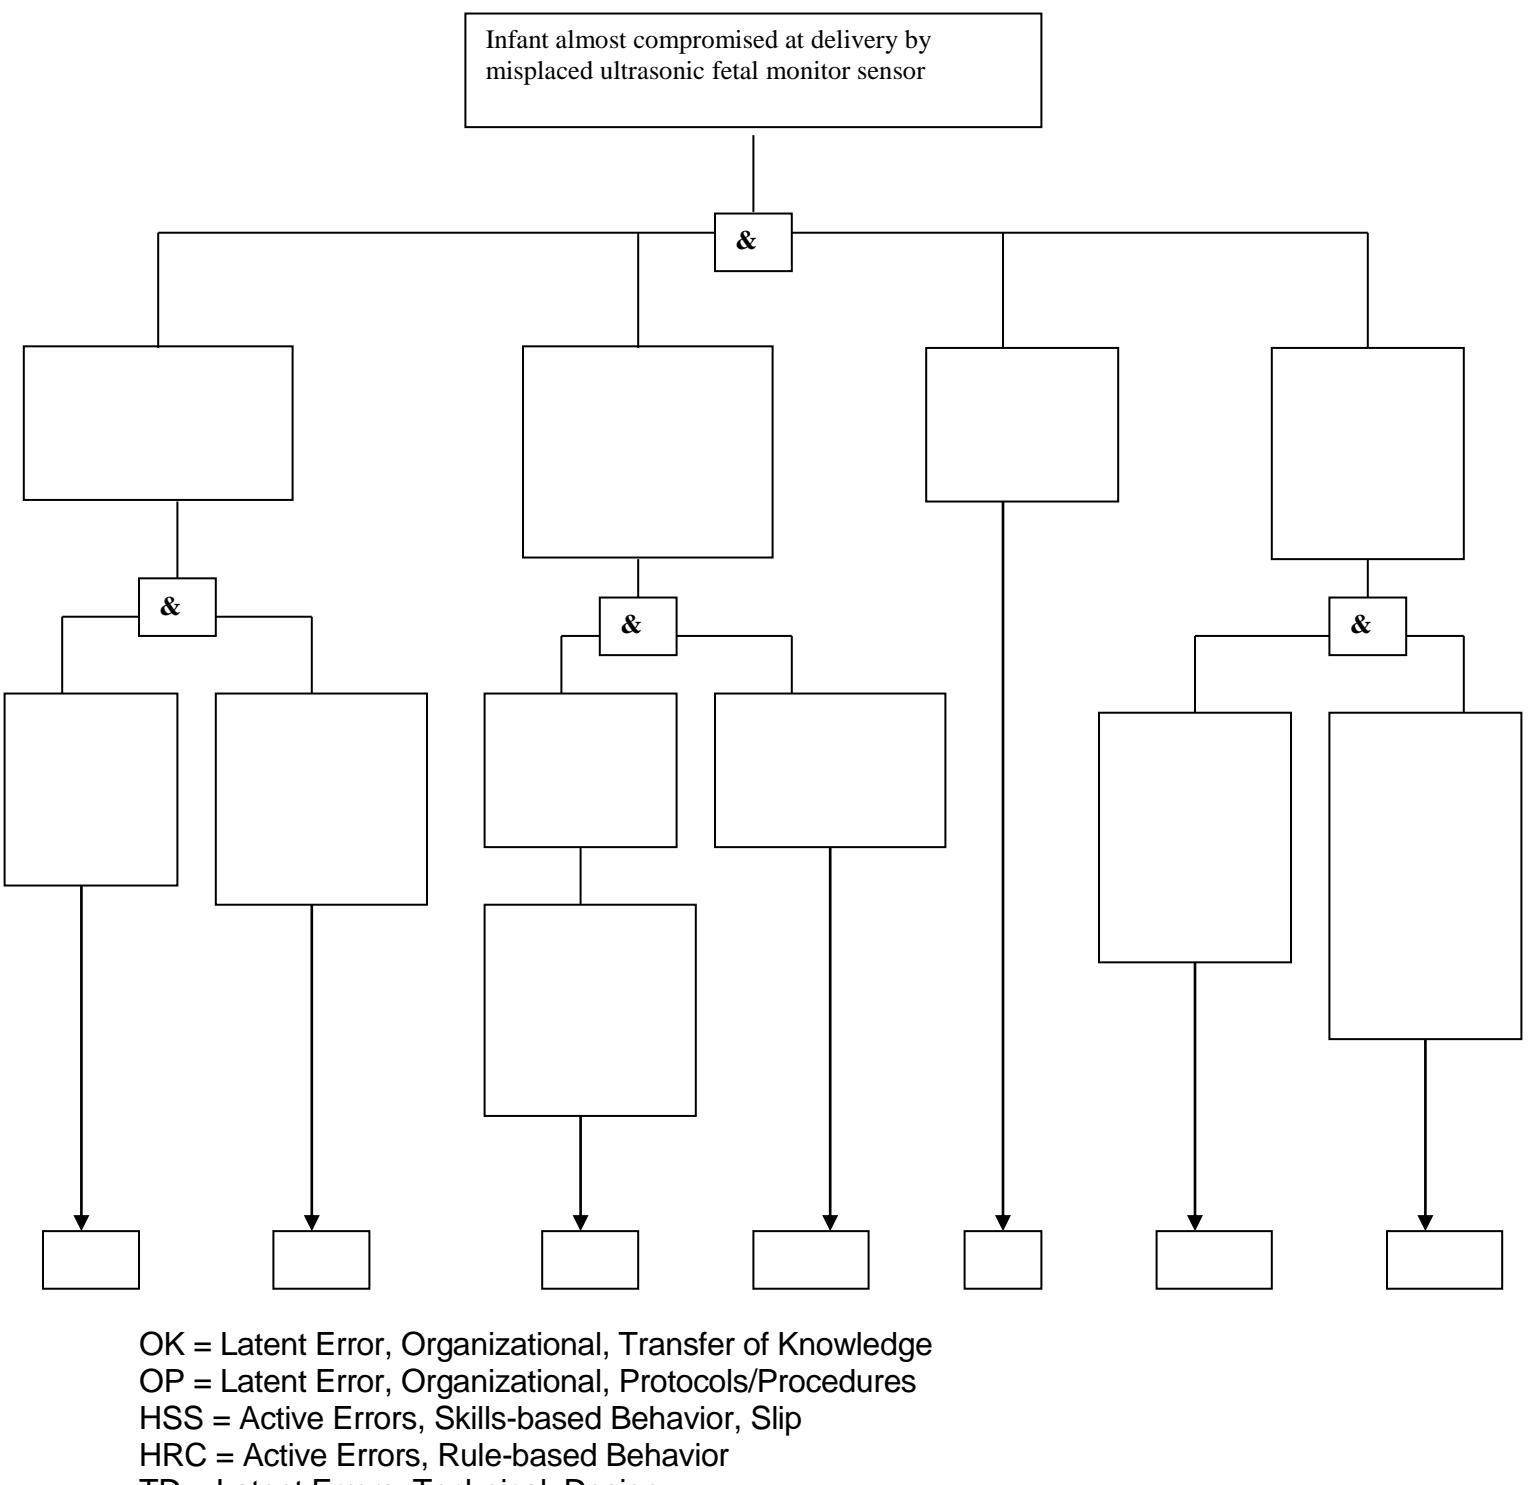
Case 4 Causal Tree Analysis No-harm Event

Review of the fetal monitoring strips found them to the reasonably unremarkable with just a few decelerations with compensatory accelerations. Subsequent testing of the monitor revealed it to be working satisfactorily. The suspicion that the monitor was not working was based on the initially poor fetal Apgar scores and the continuing "fetal tracings" after delivery. It was noted that the post-delivery suspect fetal tracing was at a baseline heart rate of approximately 130 beats per minute. This contrasts with the fetal heart rate of 150 beats per minute that was seen throughout most of the rest of the strip until about 5 minutes before delivery where the rate was approximately 135-140. It was determined that placement of the ultrasonic transducer on the mother's abdomen had not been checked during the later stages of labor. The two minutes of 130 beats per minute heart rate seen on the strip immediately after delivery of the infant, as well as the 135-140 seen just prior to delivery, was the maternal heart rate presented by the mother's pulsing aorta.

The resident obstetrician had not recognized that toward the end of labor that the maternal and fetal heart rates were virtually identical and had not checked the placement of the ultrasonic transducer. Had the fetal distress during delivery been more prolonged, this no-harm event could have had a much more problematic outcome for the child.
