**CHINESE PETROLEUM CORPORATION
M/T'YU TSAO II' 2008 DOCKING
DAILY & MAINTENANCE REPORT**

DATE : 2008/12/19-20

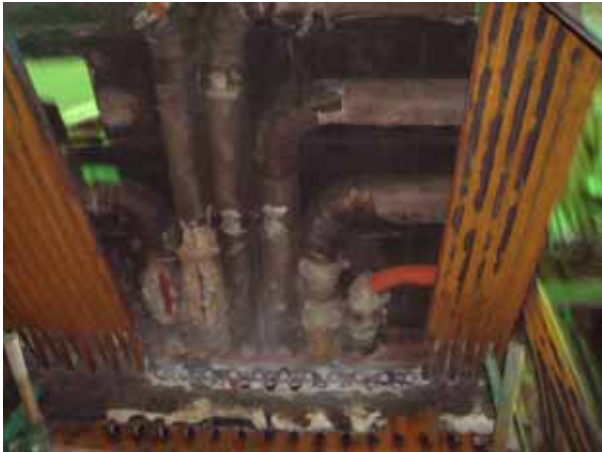
Cutting of the top side furnace wall tube

鍋爐爐管切除工作已接近完成，爐管管路也已經完成，等細部修整管口後即可開始安裝新爐管，鍋爐議價於 19 日下午五點完成議價手續，議價價格為新加坡幣 146740 元，相關之決標記錄及驗收通知單已經於議價完成後 EMAIL 回辦公室進行陳核。

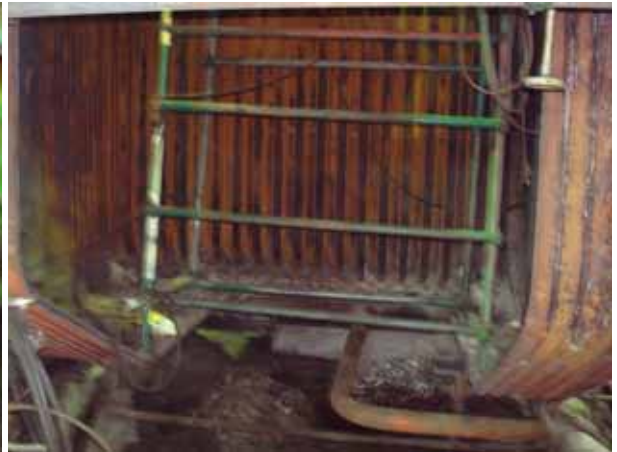
Cutting of the bottom side furnace wall tube

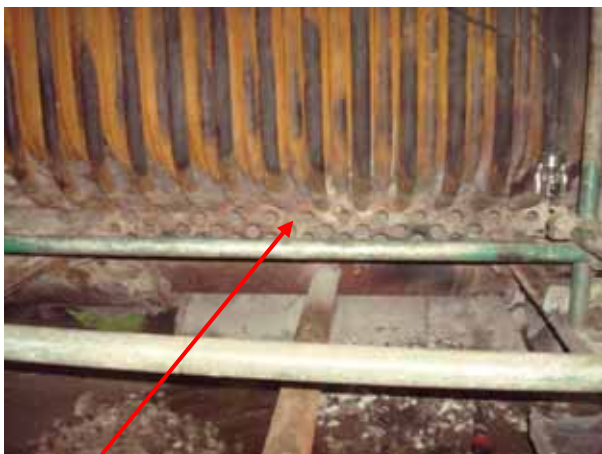
water drum for boiler furnace wall tube

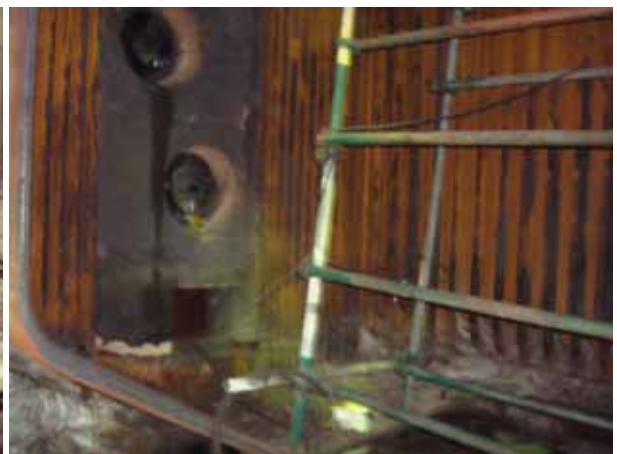
Furnace for boiler

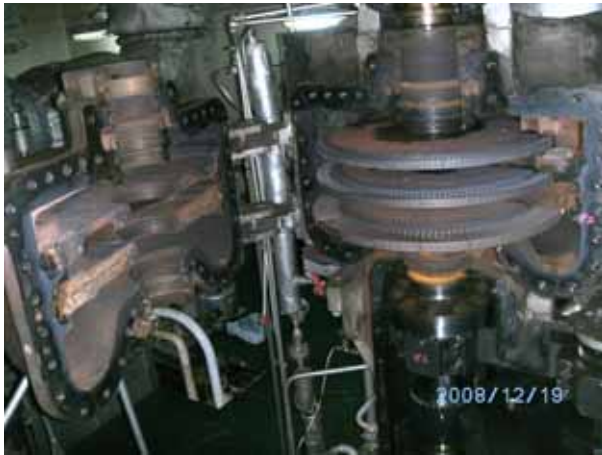
CARGO PUMP TURBINE SIDE

CARGO PUMP, BALLAST PUMP, TURBINE FOR SHAFT GENERATOR, CARGO PUMP & BALLAST PUMP 均已經開始施工。

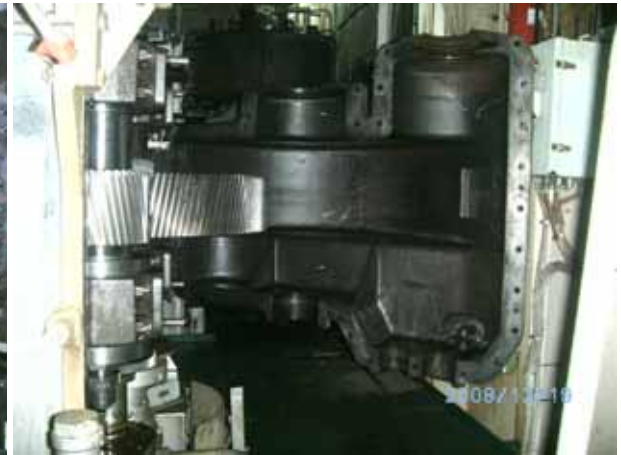
CARGO PUMP 減速齒輪

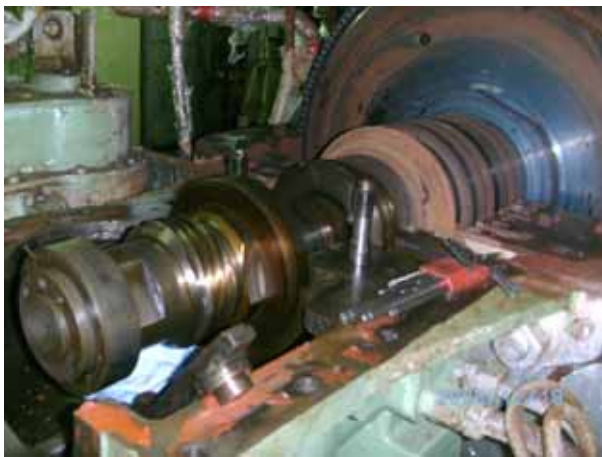
Turbine Generator

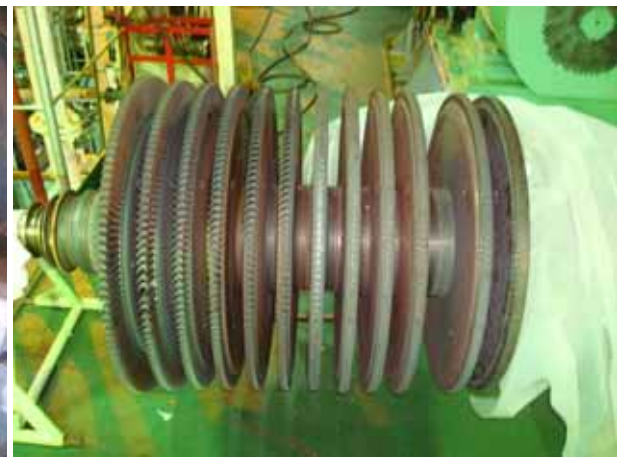
Rotor for T/G

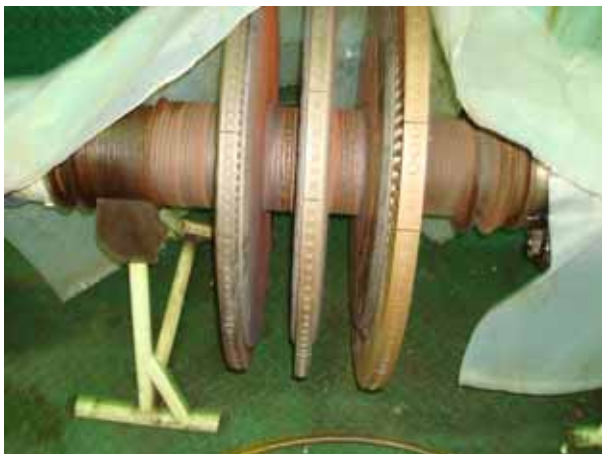
Rotor for Cargo pump

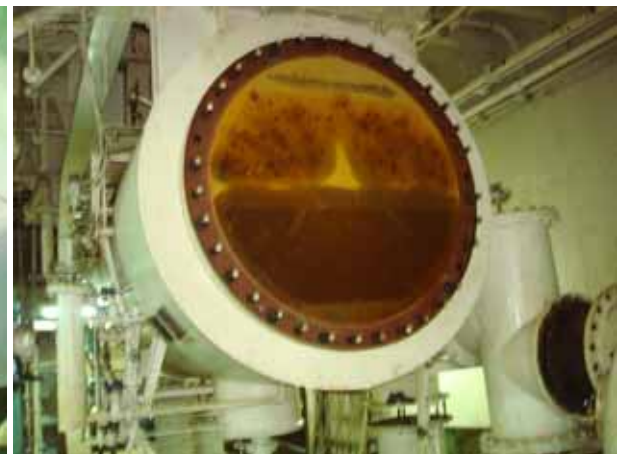
Condenser for T/G

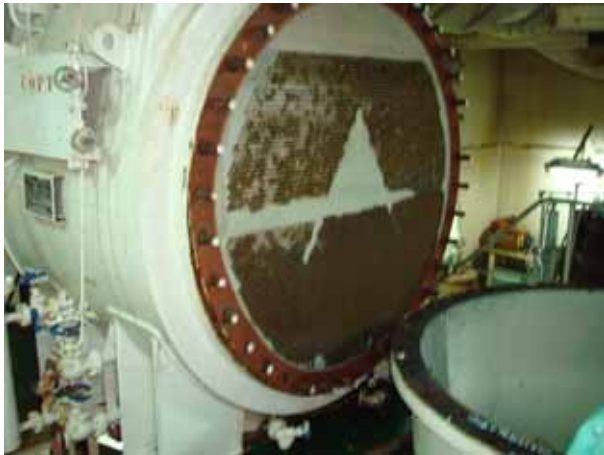
Condenser for T/G

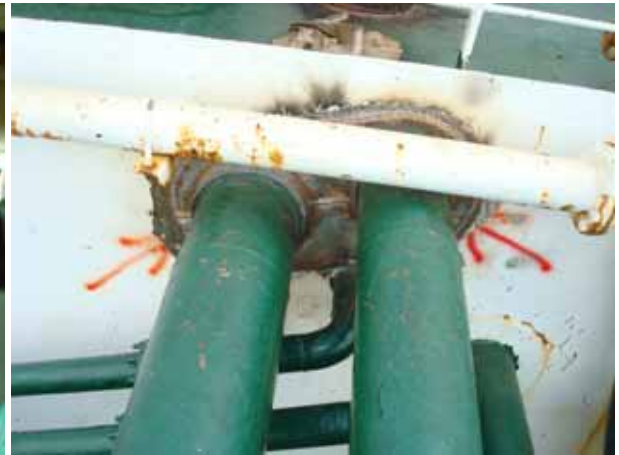
cable pipe double plate for penetrate P/R

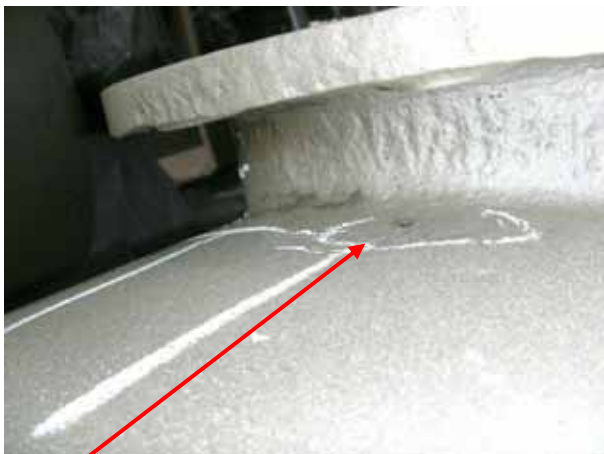
PV BREAKER 檢查油漆前噴砂，發現有破洞，將安排修理後再油漆。

PV Breaker blasting & found hole

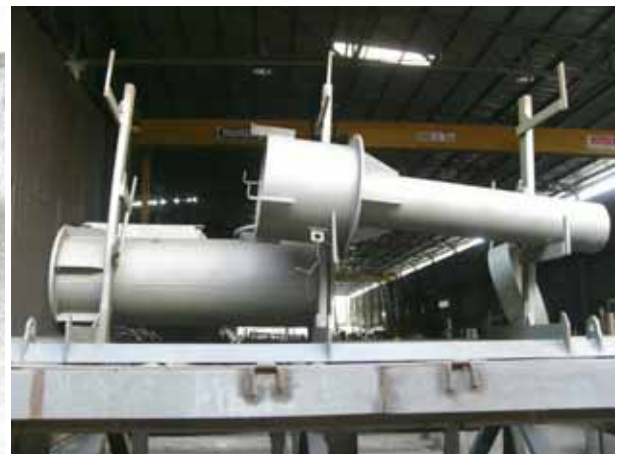
PV BREAKER

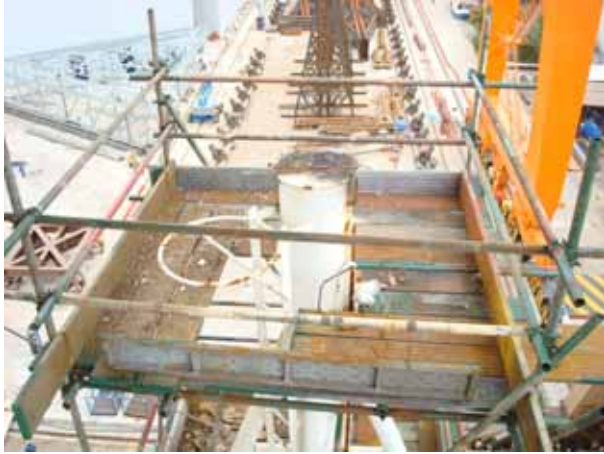
Navigation light cutting for renewal

BRIDGE WING 除銹開始施工，航行燈座切除，準備更新。

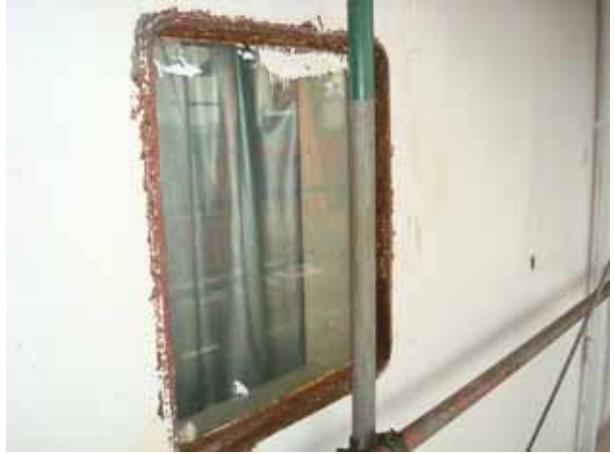
駕駛台兩邊底下結構除銹油漆今天檢查未通過，No.1P 檢查也沒有通過，新加坡政府規定船廠每月之第一及第三個星期星期天不得有太多人加班，所以目前船廠晚上不加班，假日有時也不加班，進度時在很難掌空，希望能夠如期開船，進塢時間可能會延後至 27 日。

Bridge wing under side

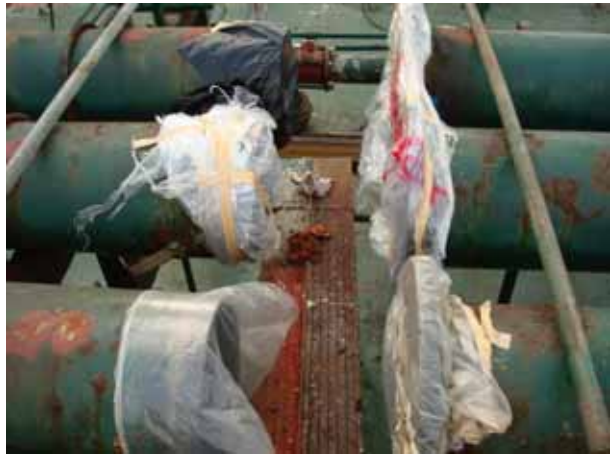
Expansion joint renewal for cargo line

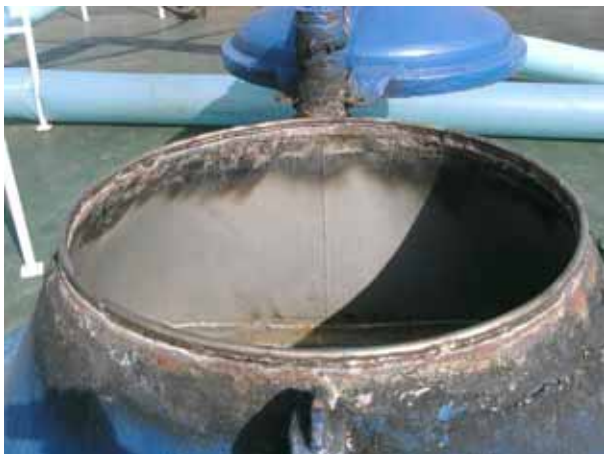
Hatch cover for ballast tank
