赴美國考察土石流防治工程 報 告

服務機關：交通部公路局

赴美國考察土石流防治工程報告

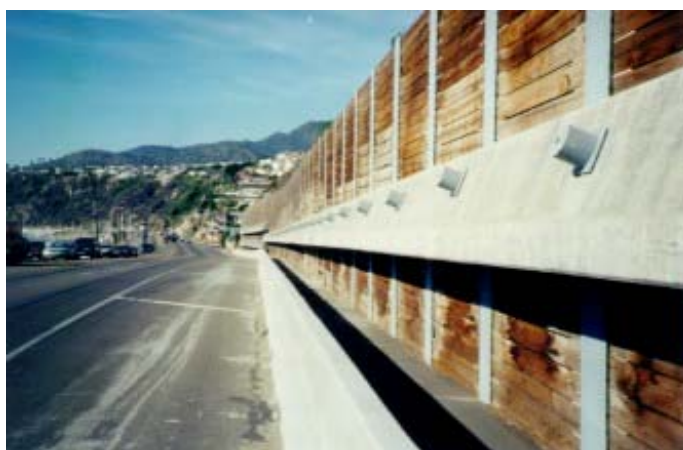
照片 (十)

加州海岸公路沿線風景優美，假日交通量甚大，山側邊坡土質極不穩定，常受暴風雨雪及溪流侵蝕而產生崩塌，部份路段以岩錨擋土牆加襯板工法保護。

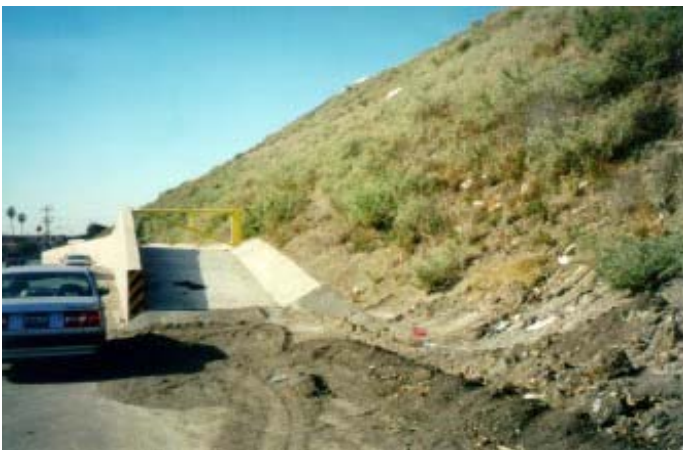
照片 (十四)

部分邊坡風化受雨水沖蝕嚴重，以加強地下排水及設台階截流溝防治。

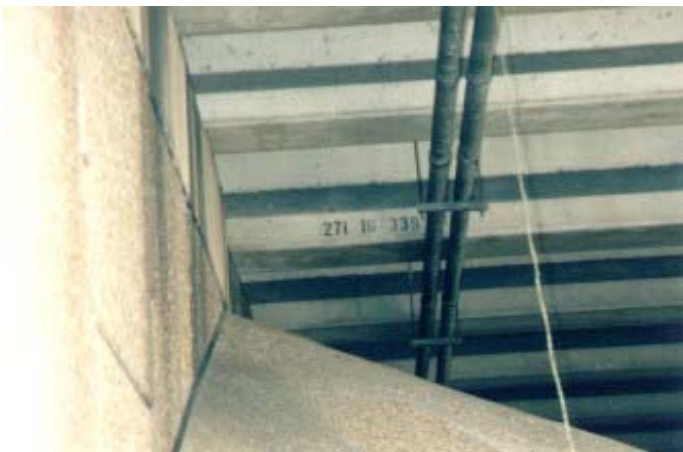
照片 (四十一)

實地勘查休士頓地區之公路橋樑，並由當地承辦橋樑檢測之顧問公司現場說明作業之執行及應注意之重點。圖中部分橋樑有混凝土剝落及鋼筋銹蝕之情形。

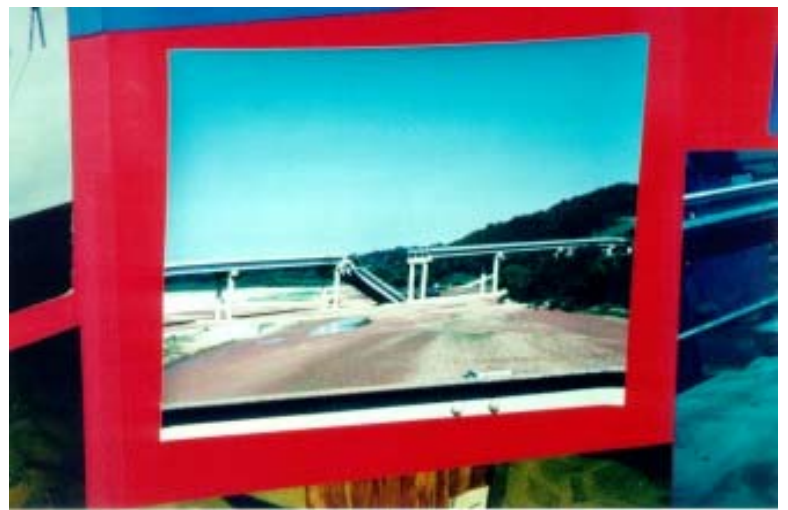
照片 (五十八)

加州公路橋樑遭洪水沖毀

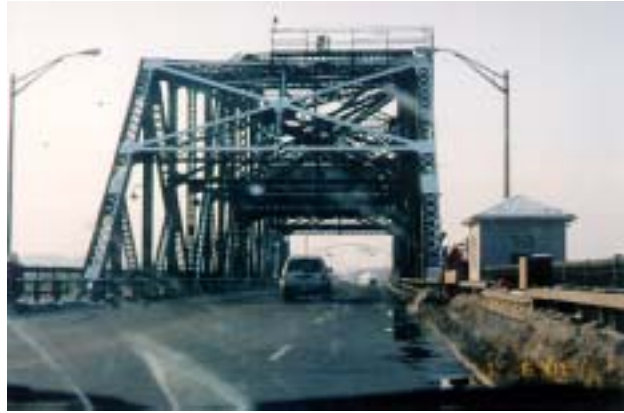
照片 (七十五)

紐約地區常見之鋼橋，橋齡甚長，維修保養不易。

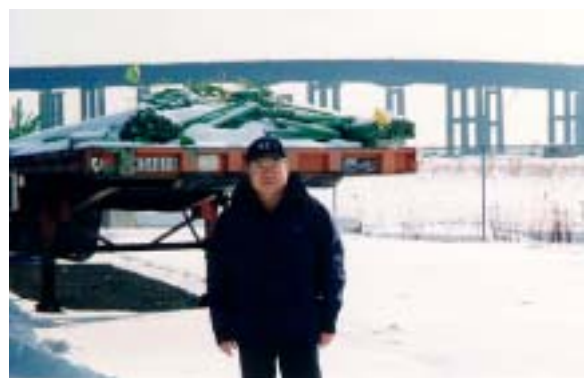
照片 (七十八)

約市南端 Raritan River Bridge, 為 Garden State Parkway (Between Ext 125-127) 跨越 Raritan River 之大橋，跨徑及高度均屬可觀，惟年代已久，正在進行橋樑加固補強施工中。
