出國報告(出國類別：國外承攬)

關島 CABRAS 電廠#1 機汽機大修

服務機關：台灣電力公司電力修護處

2017 關島 CABRAS # 1 STEAM TURBINE 大修報告

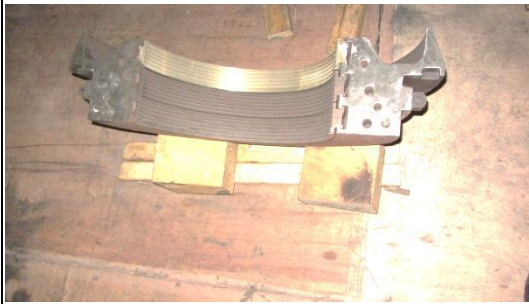
在動葉與靜葉檢查，並未發現葉片或葉根有裂縫需更換。僅有中壓第十一級上下半靜葉環與中壓第十級靜葉環下半葉片有些吹蝕現象，經過焊補磨修與 PT 檢查後，將其回裝。汽機汽封更換方面，本次檢查發現只有 HP7 之 Packing ring 有些微變形，將其更換為新品。因應電廠要求，低壓外缸安全膜片也做了更換。因電廠輔機系統與飼水泵在大修後啟動有些問題，第一次並聯時間為 8/28 19:42，發電量為 0.4MW。

HP7 汽封更換

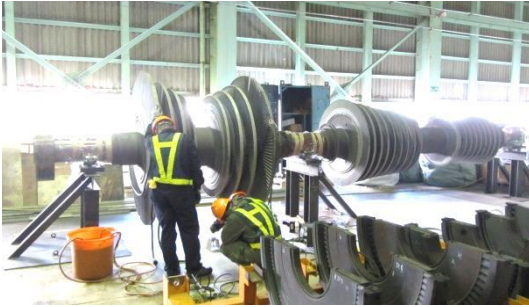
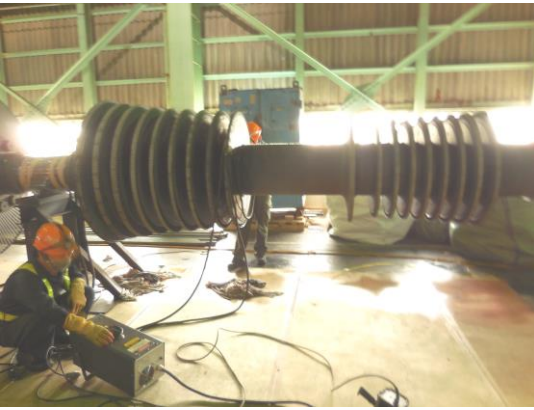
低壓段動葉片 MT check	高中壓段動葉片 MT check

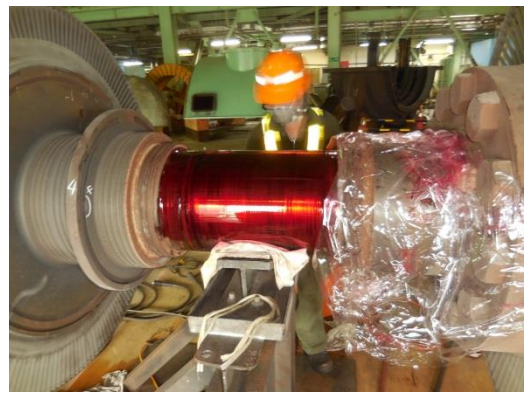
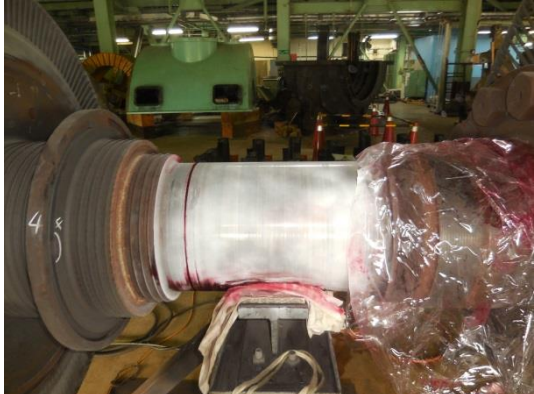
#2 軸頸 PT	#2 軸頸 PT

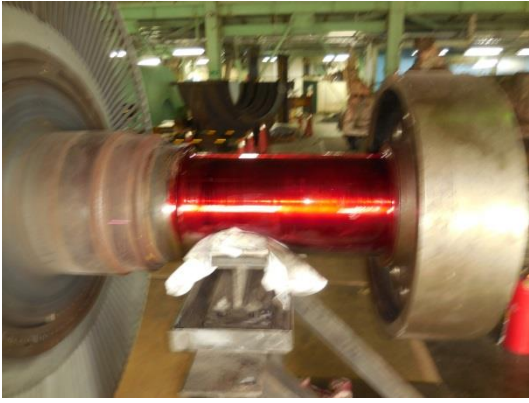
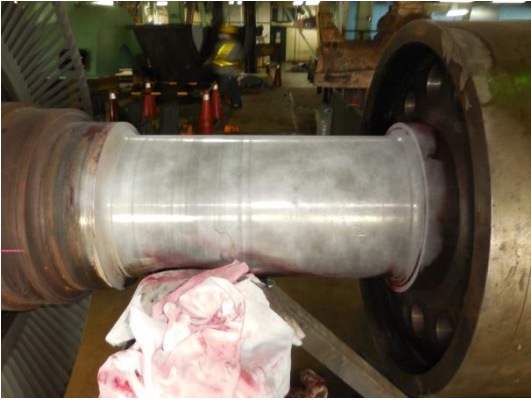
<p>#3 軸頸 PT</p>	<p>#3 軸頸 PT</p>

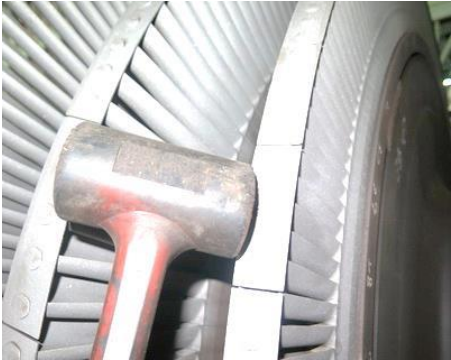
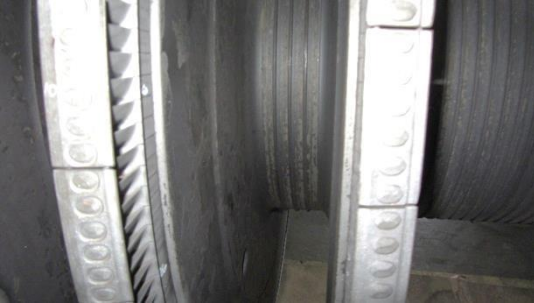
<p>動葉片葉根檢查</p>	<p>Shrouds inspect</p>

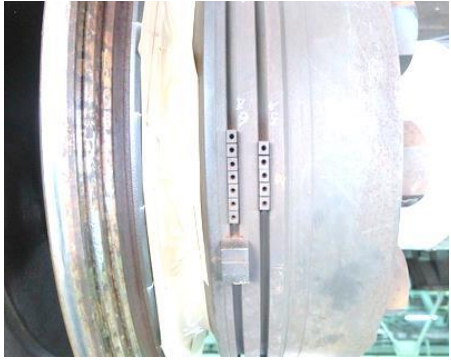
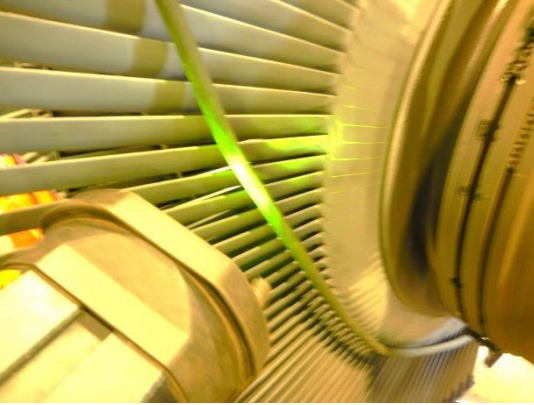
<p>配重塊相對位置確認</p>	<p>動葉片葉根 MT 檢查</p>

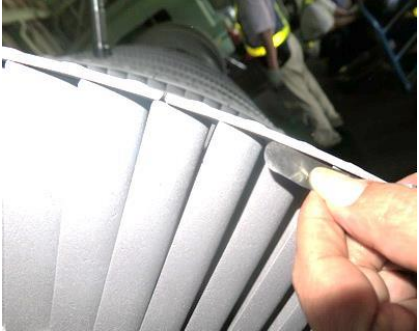
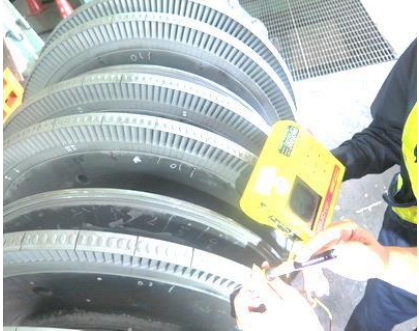
<p>動葉片與護環間隙核測</p>	<p>打鉚處硬度檢查</p>

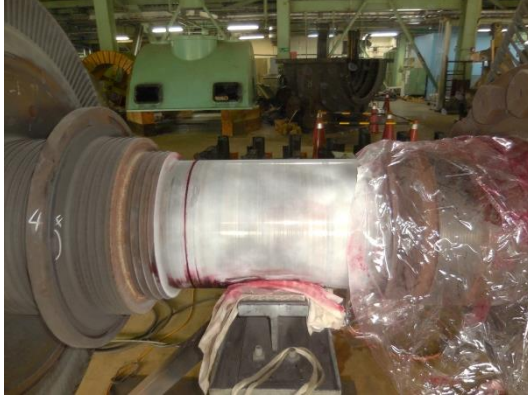
#2 軸頸 PT	#2 軸頸 PT

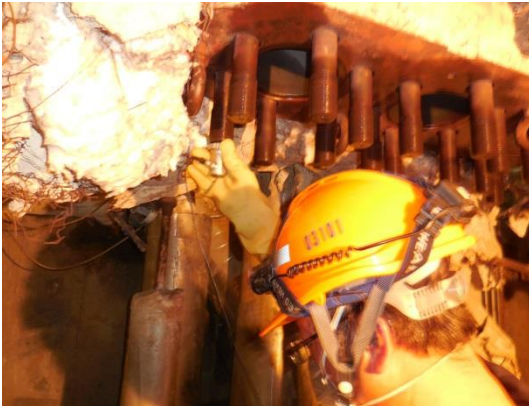
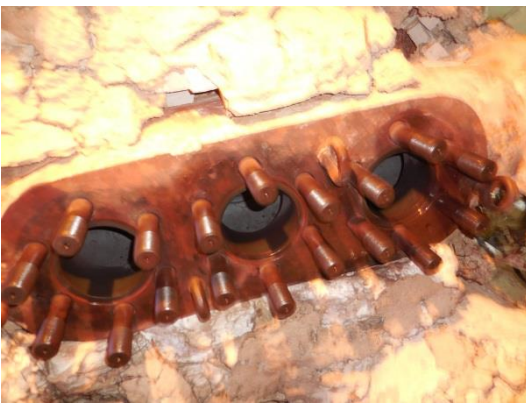
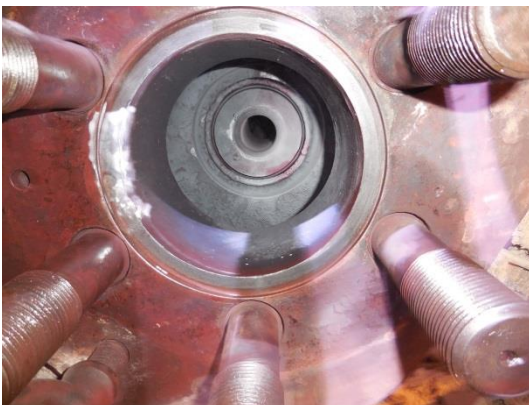
CV 閥座 PT check	CV 閥座 PT check

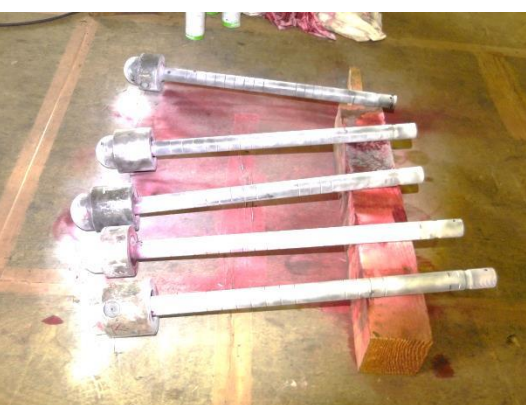
CV disc 與閥桿 PT check	CV disc 與閥桿 PT check

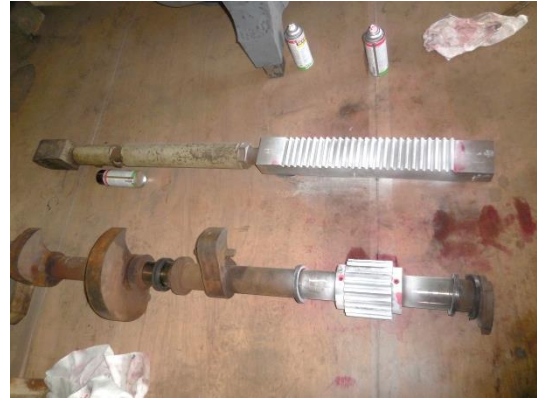
CV 連桿 PT check

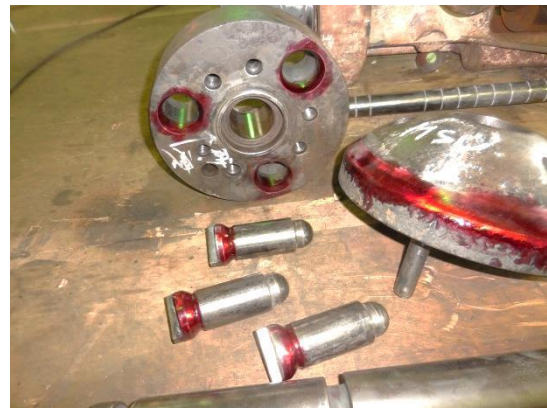
轉子吊出後，經由 NDT 檢查，確認並無任何葉片受損需更換，另汽機主閥全部拆卸檢修。MSV 嚮導閥 SEAT 與 RSV DISC 在經過 NDT 檢查後發現有裂痕(線性指示)，此次大修將 MSV 嚮導閥 SEAT 與 RSV DISC 更換成新品。此外因 CV#1 在拆解過程中無法將 STEM 從閥體中取下，所以將其切割取下後更換成新品(STEM 與 DISC)。

MSV pilot valve seat Disc PT

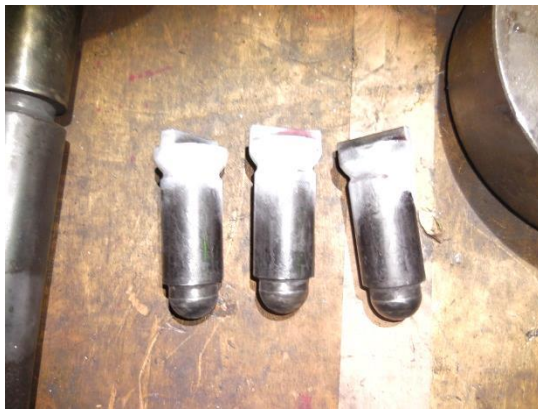
MSV pilot valve seat Disc PT

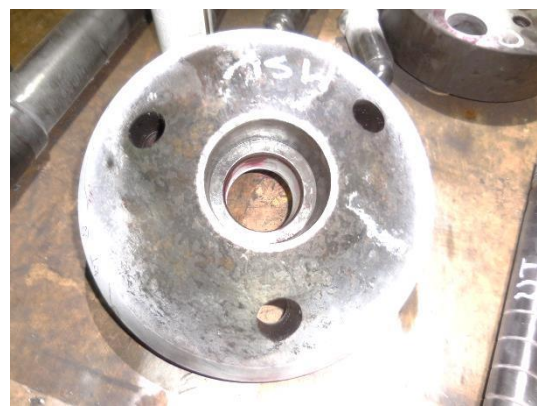
MSV pilot valve Disc PT

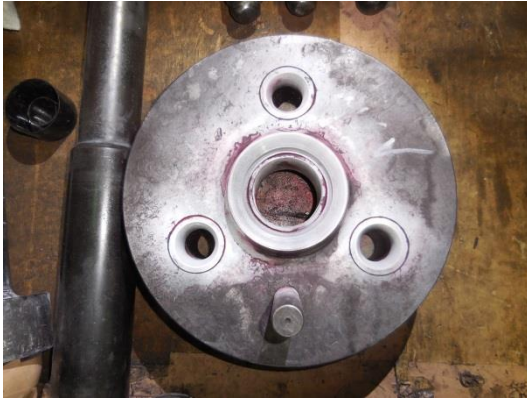
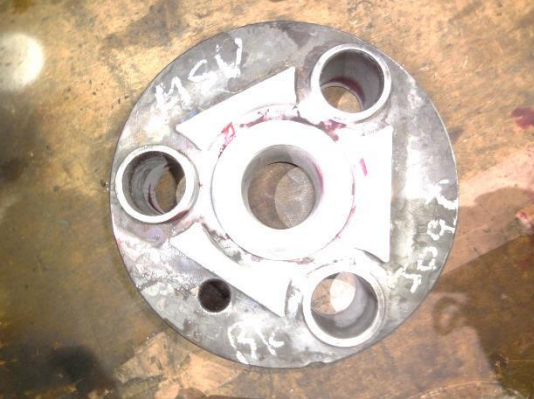
<p>MSV pilot valve 閥座 PT</p>	<p>MSV pilot valve 閥座 PT</p>

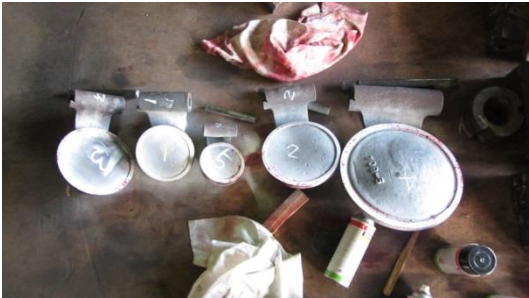
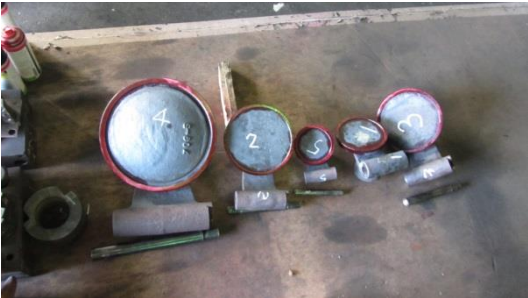
<p>Check Valve Disc PT check</p>	<p>Check Valve Disc PT check</p>

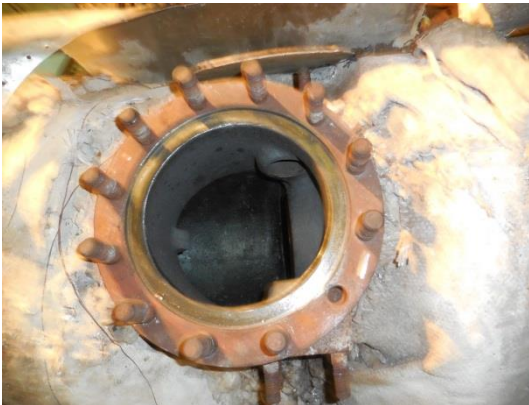
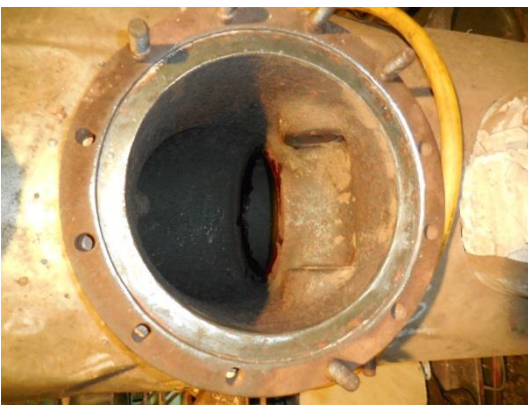
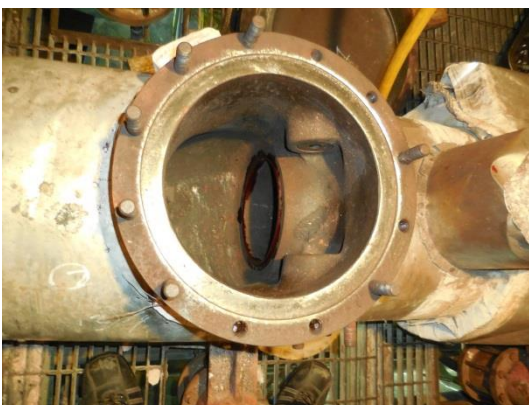
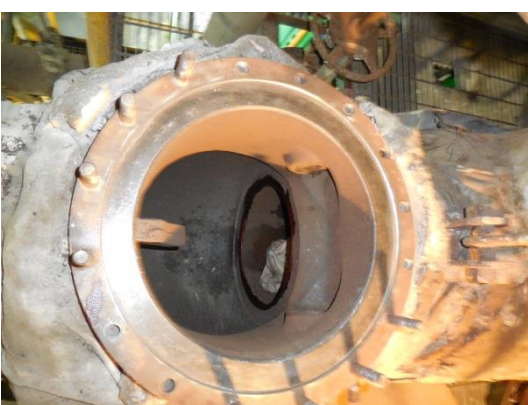
<p>Check Valve 閥座 PT check</p>	<p>Check Valve 閥座 PT check</p>

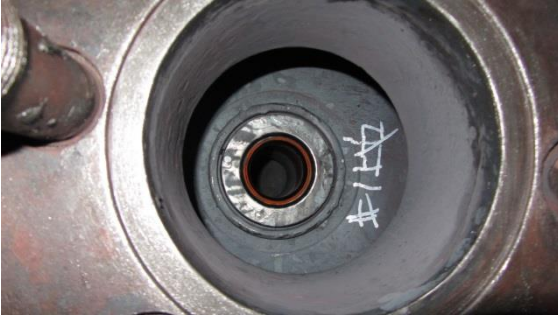
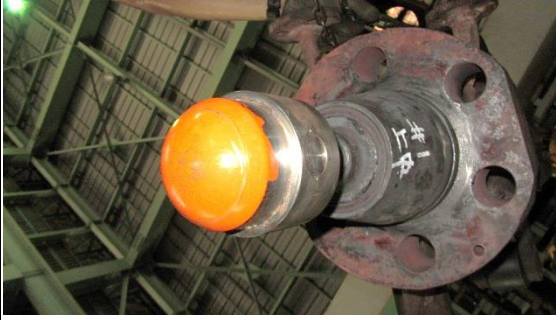
#1 CV 閥座 Blue Check	#1 CV Disc Blue Check

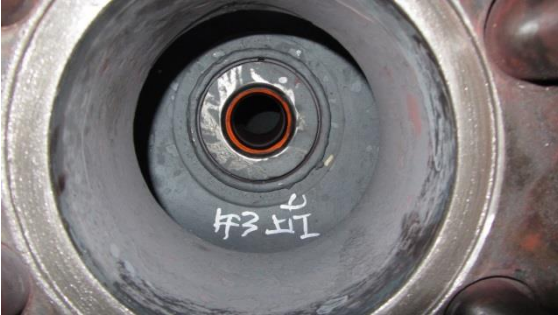
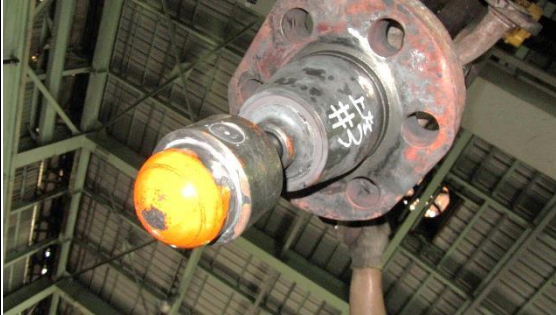
#3 CV 閥座 Blue Check	#3 CV Disc Blue Check

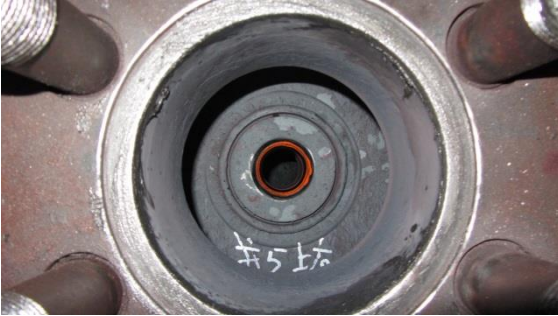
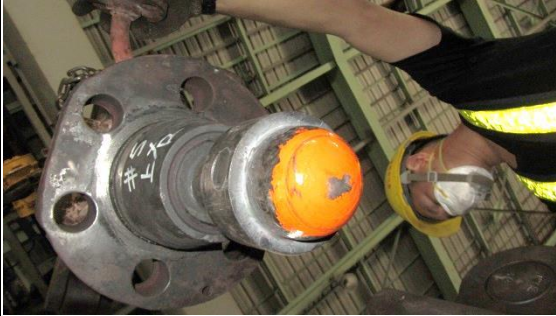
#5 CV 閥座 Blue Check	#5CV Disc Blue Check

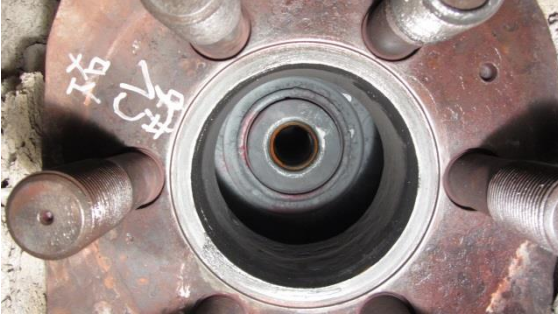
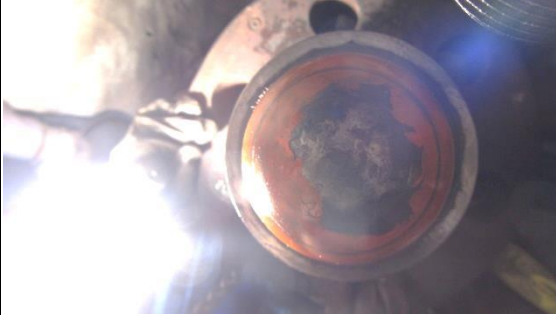
#6 CV 閥座 Blue Check	#6CV Disc Blue Check

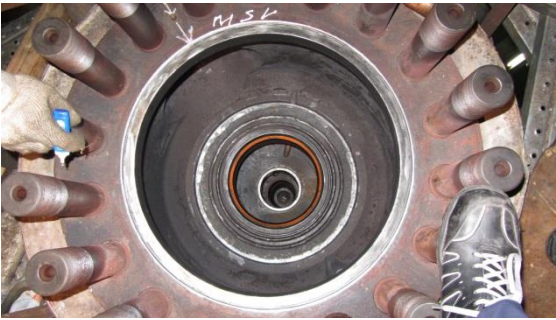
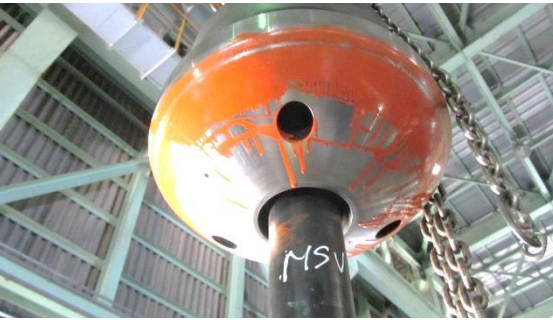
MSV 閥座 PT CHECK	Disc PT CHEKC

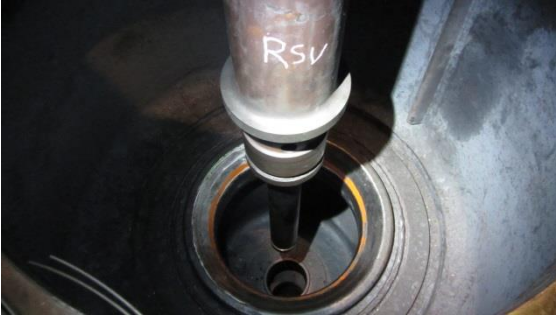
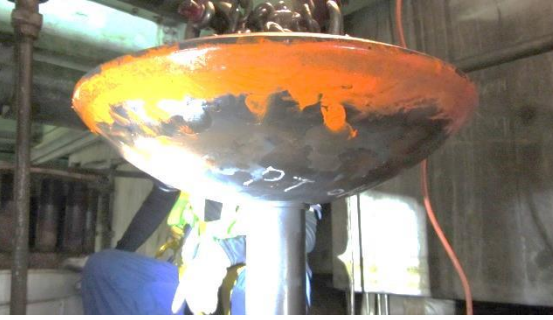
RSV 閥座 PT CHECK	RSV Disc PT CHEKC

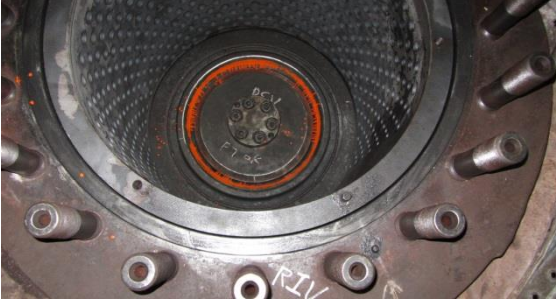
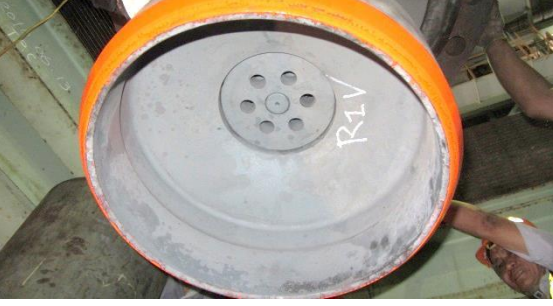
IV 閥座 PT CHECK	IV Disc PT CHEKC

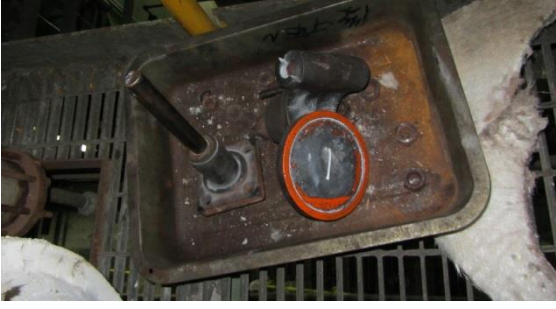
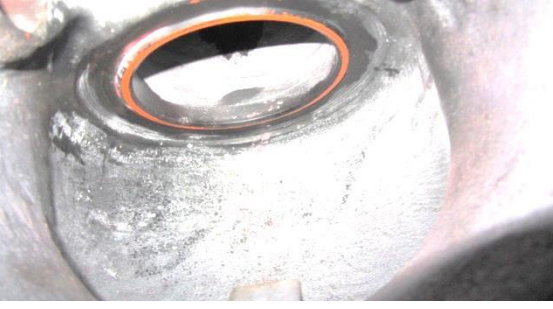
#1 Check Valve Disc Blue Check	#1 Check Valve 閥座 Blue Check

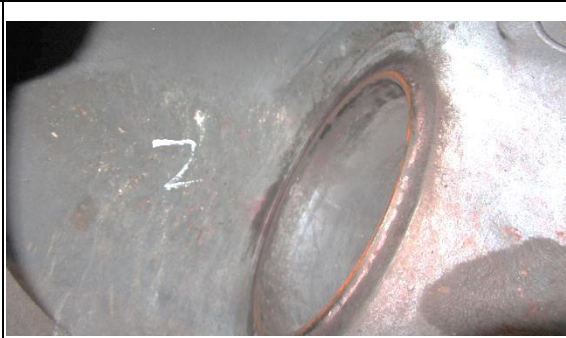
#2 Check Valve Disc Blue Check	#2 Check Valve 閥座 Blue Check

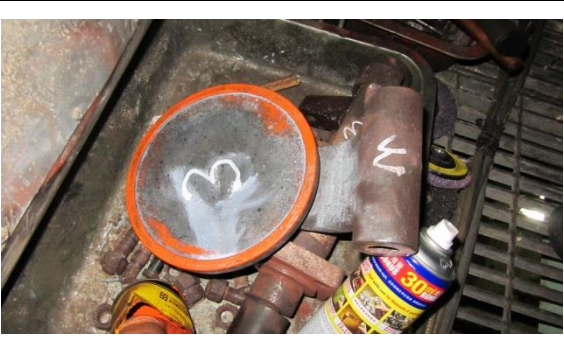
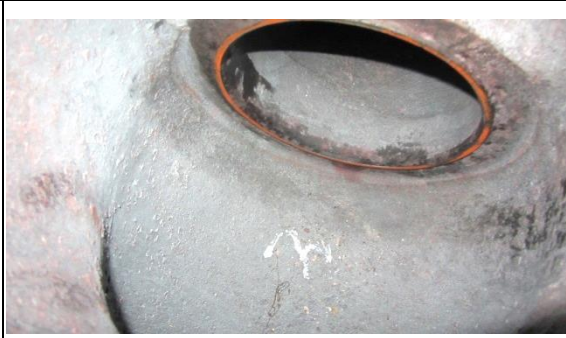
#3 Check Valve Disc Blue Check	#3 Check Valve 閥座 Blue Check

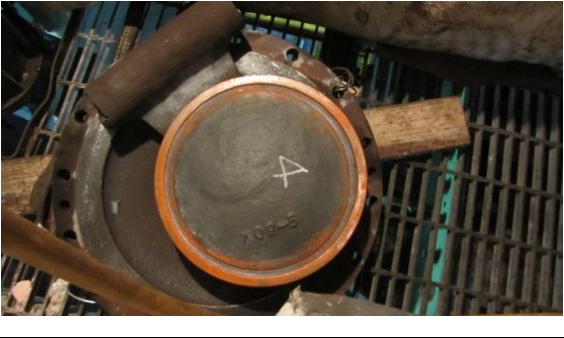
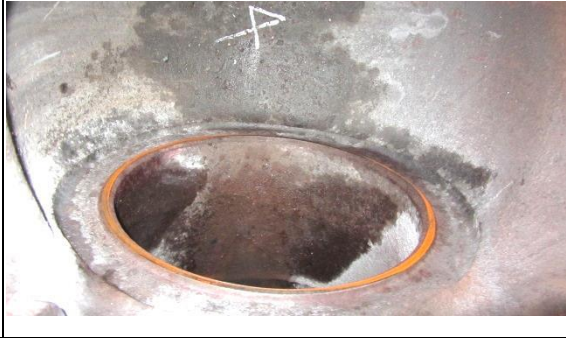
#4 Check Valve Disc Blue Check	#4 Check Valve 閥座 Blue Check

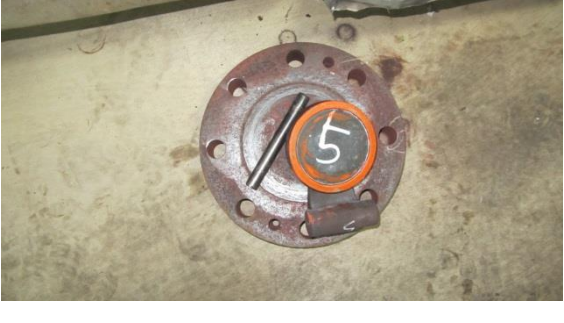
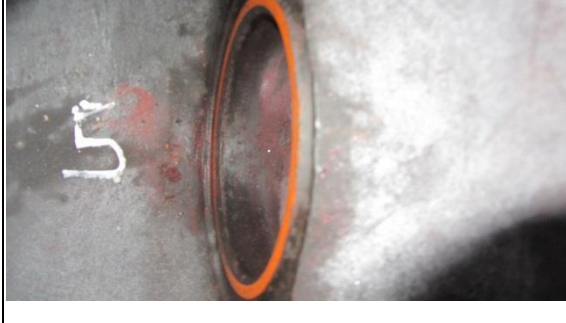
#5 Check Valve Disc Blue Check	#5 Check Valve 閥座 Blue Check

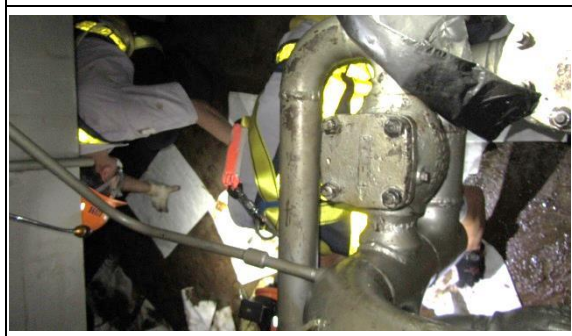
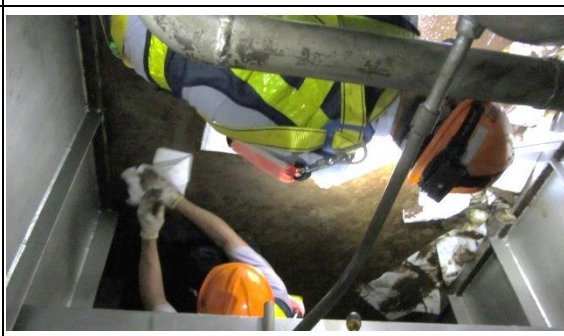
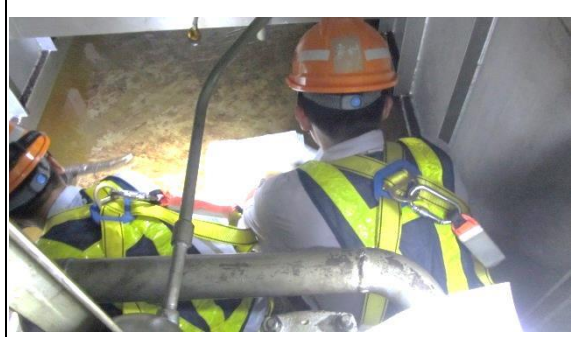
<p>潤滑油槽清理</p>	<p>潤滑油槽清理</p>

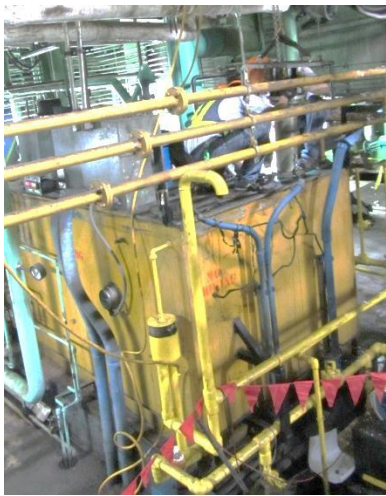
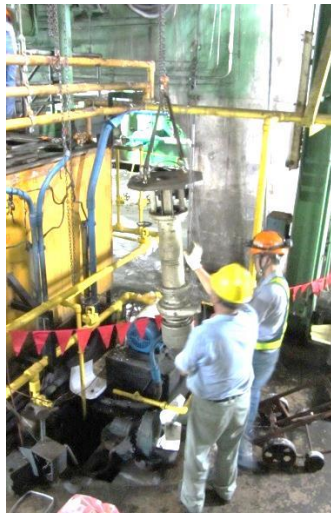
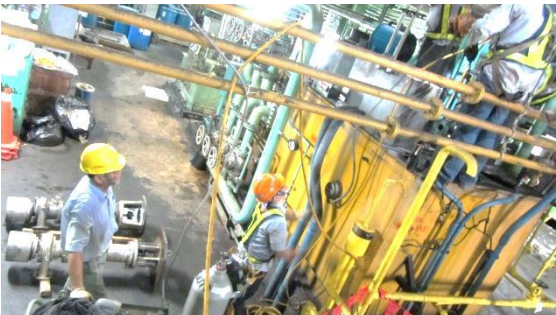
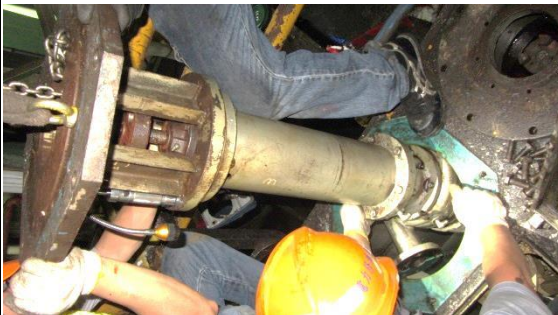
<p>拆除 AC & DC pump</p>	<p>拆除 AC & DC pump</p>

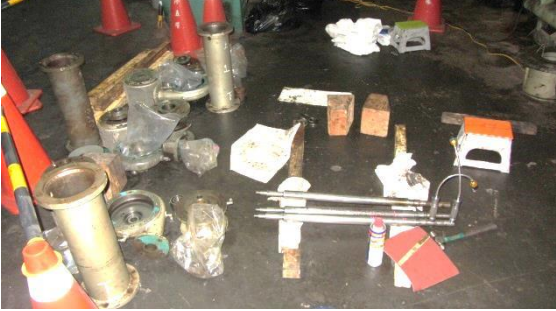
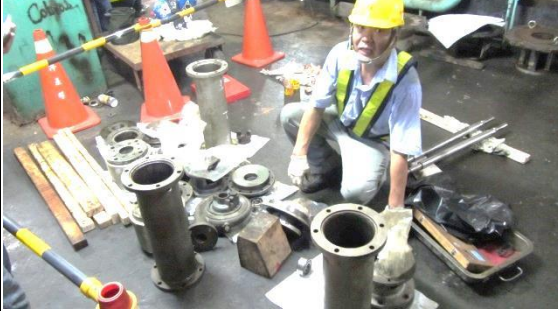
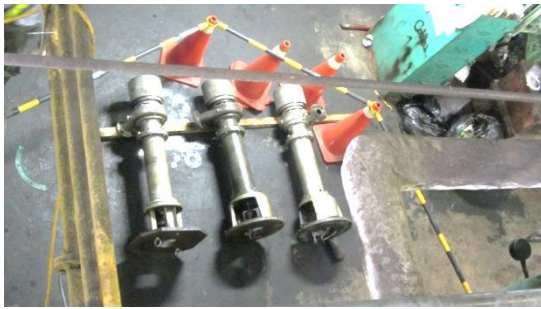
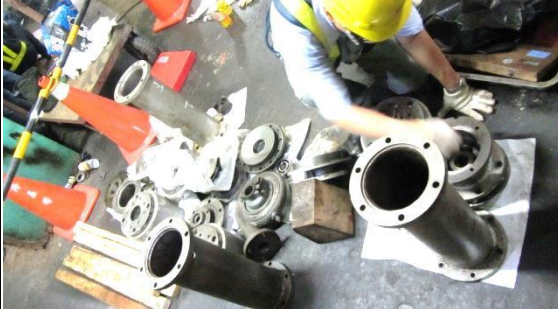
<p>分解 AC & DC pump</p>	<p>分解 AC & DC pump</p>

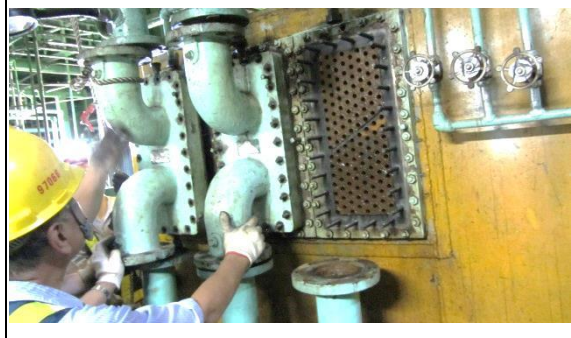
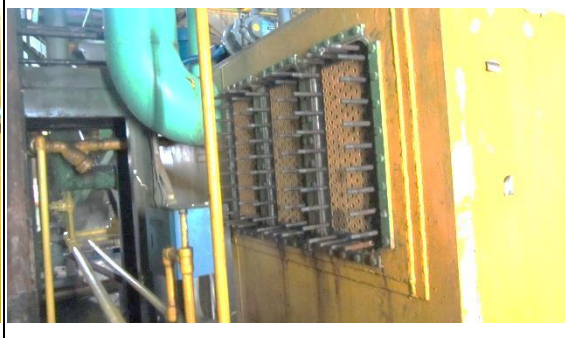
<p>分解潤滑油 cooler cover</p>	<p>分解潤滑油 the LUBE cooler cover</p>

6.3 : Clean the oil cooler by brushing tubes (LUBE & EH system)

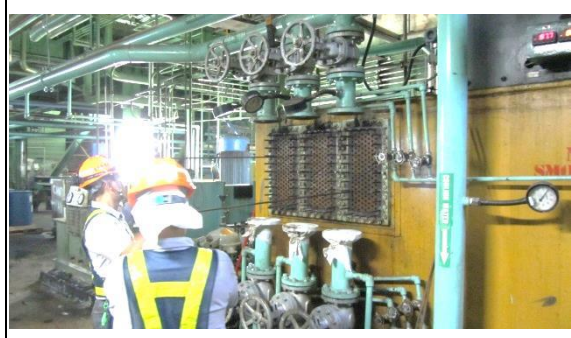
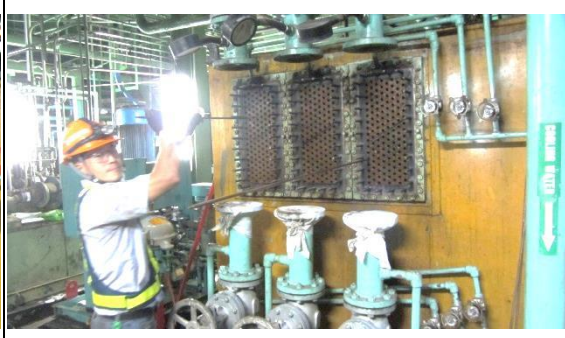
<p>使用毛刷清理冷卻管(潤滑油系統)</p>	<p>使用毛刷清理冷卻管(潤滑油系統)</p>

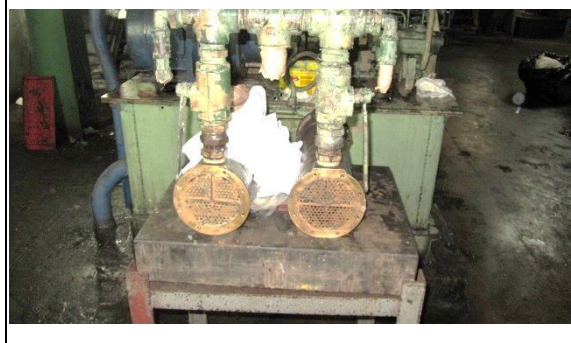
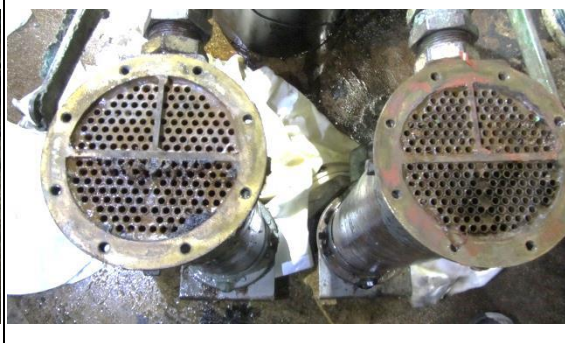
<p>使用毛刷清理冷卻管 (EH System)</p>	<p>使用毛刷清理冷卻管 (EH System)</p>

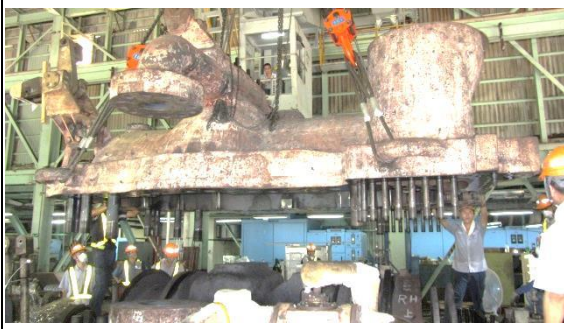
高壓外缸回裝

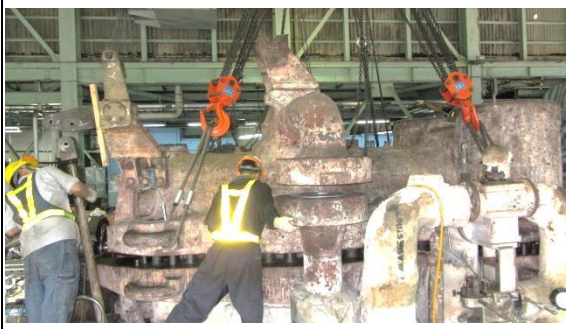
高壓外缸回裝

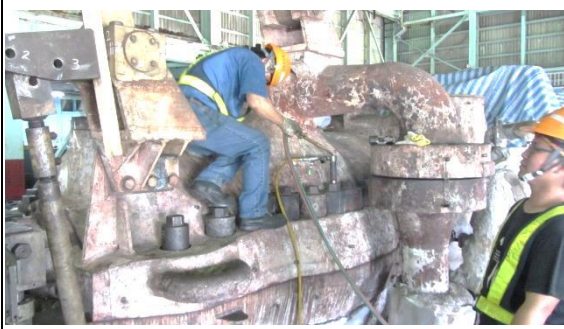
高壓螺栓回裝熱鎖

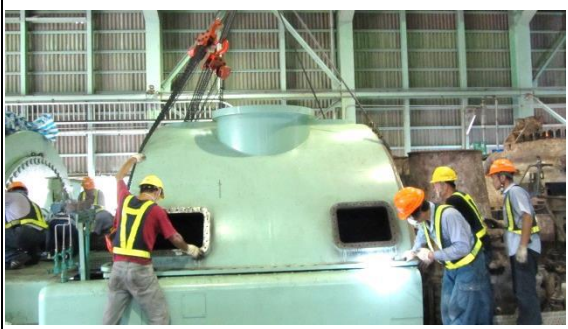
低壓外缸回裝

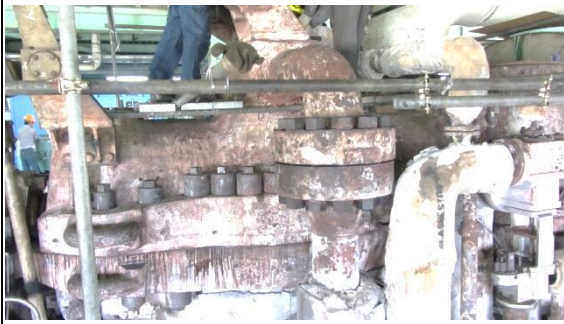
跨管回裝

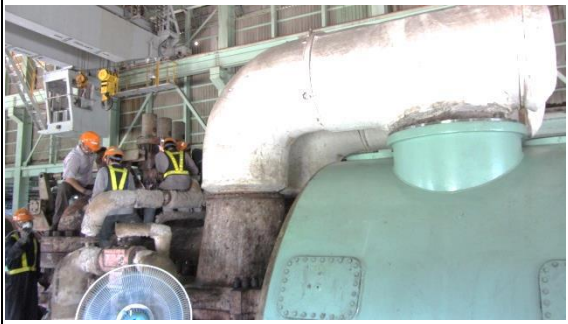
HP inlet pipe assembly
